U. S. NUCLEAR REGULATORY COMMISSION  
REGION I

Docket/Report: 50-317/86-09  
50-318/86-09

Facility: Calvert Cliffs Nuclear Power Plant, Units 1 and 2

Summary: May 1 - June 30, 1986: Inspection Report 50-317/86-09, 50-318/86-09.

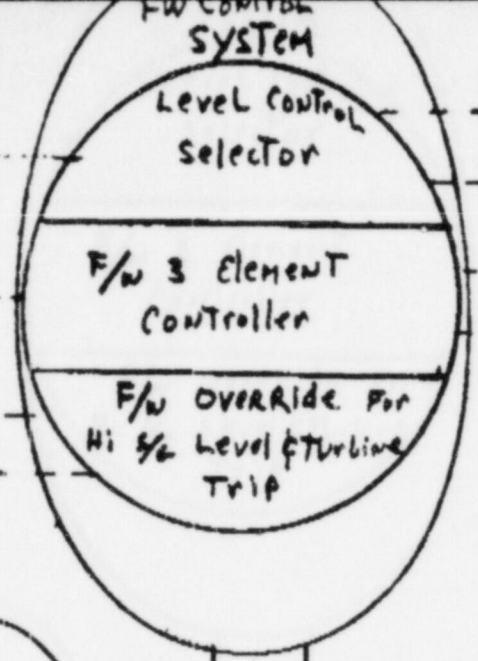
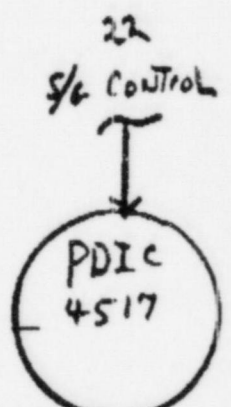
Reference: Attachment 1. The recorders previously connected to PDIC and PDT 4516 and 4517 were reviewed for response at the time of the event. At the time, PDIC-4517 was in automatic and 4516 was in manual, (a normal configuration during operation). PDIC-4517 a reverse acting controller showed a response in the full output direction initially, followed by a one quarter scale oscillation near the upper range of the scale. PY-4516 basically traced an exact image of PDIC-4517's output (as expected). Recorder traces for PDT-4516 and 4517 show an initial spike in the increasing signal direction followed by a full scale oscillation for PDT-4517 and three quarter scale oscillation for PDT-4516. The licensee concluded that the trace indicated a spurious signal originating at PDIC-4517 in the increasing direction was passed through PY-4516 which in turn caused an increase in the Lovejoy speed control signal to the feed pumps. As a result, feed regulating valve differential pressure increased causing an increase in PDT-4516 and 4517 output (normally this would have resulted in a decrease in the output signal). Based on this response it was believed that PDIC-4517 failed in the high direction eventually causing the feed pumps to over speed.

Instrument Maintenance began troubleshooting the PDIC and PY instrumentation. The PDIC was removed from the control room panel 2C03 and taken to the shop for bench testing. Technicians found one bad loop resistor for PY-4516 output. Terminal board inspections revealed broken strands of wire one strand intact leading to PDIC-4517 and PY-4516. (The licensee initially perceived that this caused the PDIC output problem.) Testing subsequently disproved this. Bench testing was completed and the instruments were reinstalled. Post installation testing of the PDIC at 2C03 determined that a positive ground existed on the 48V DC bus supplying power to the PDIC and PY.

supply was connected. The technician grounded the power supply and observed erratic output from the PDIC. Removing the ground caused the problem to go away. This confirmed that a ground existed in the PDIC. Subsequent bench testing determined that the ground was in a PDIC circuit board, which was eventually replaced with a spare board from stock.

Subsequently, Instrument Maintenance began an evaluation of the 2R01A (48V DC) power supply looking for the cause of the ground. The evaluation involved lifting leads to installed instrumentation and measuring the bus voltage to ground. When the leads to 2-PT-1447 (21A Feed Water Heater Extraction Steam Pressure transmitter) were lifted the ground voltage measured on the positive and negative side of the power leads indicated a -46v, suggesting a positive side ground (later confirmed to be a grounded motor in the transmitter). During the above test the fuse for the pressure transmitter blew. This same fuse had been replaced approximately 5 seconds prior to the time that the reactor trip occurred on May 27. Further testing (involving a check of all instrumentation supplied by 2R01A) between May 30 and June 2 resulted in one additional ground being found on the loop for 2-PT-3966 (22 steam generator feed pump discharge pressure transmitter) which provides a signal for a chart the recorder in the Control Room.

Discussions with the plant operators, engineers, supervisors and managers, as well as independent observation of feed system performance, indicate that the root cause of the feed system control problems was due to grounds on the power supplies and aggravated by additional grounds on instruments and numerous minor control oil and valve problems. The problems have been identified and corrected. The licensee approach to the resolution of this technical issue initially demonstrated a lack of understanding and pursuit of the problem was delayed. However, once they recognized that the problem was repetitive in nature, a clear understanding of the root cause was sought and a technically sound, thorough approach to the problems was carried through to completion.

Subsequently, modifications were made on 2R01A to separate the bus supplying power to the two steam generator feed system control loops. These modifications consisted of lifting the power leads at 2R01A and installing two new power supplies.
