NUCLEAR REACTOR LABORATORY
AN INTERDEPARTMENTAL CENTER OF
MASSACHUSETTS INSTITUTE OF TECHNOLOGY

Subject: Reportable Occurrence 50-20/1999-1, Failure of Main Ventilation Damper to Close on Receipt of a High Radiation Test Signal.

1. Report No.: 50-20/1999-1
- 2a. Report Date: 19 March 1999
- 2b. Date of Occurrence: 10 March 1999
3. Facility: MIT Nuclear Reactor Laboratory
138 Albany Street
Cambridge, MA 02139

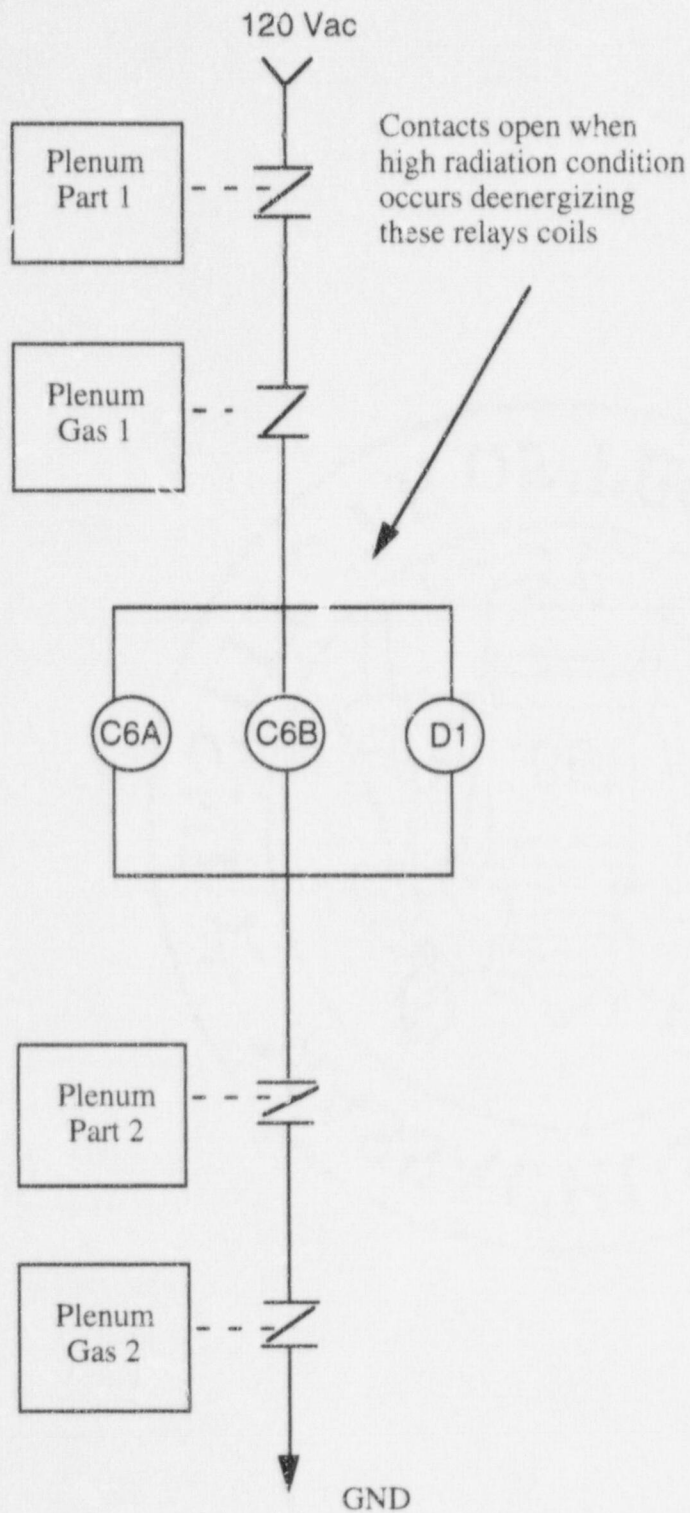
Figure One: Schematic of Effluent Monitor - Interlock Damper

6. Description of Occurrence: Figure One is a diagram of the circuitry associated with the plenum gas and particulate monitors and the ventilation dampers. The system is redundant in that there are two sets of plenum gas and particulate monitors, a main and auxiliary intake damper, and a main and auxiliary exhaust damper. The main and auxiliary dampers are in series. The system is interlocked so that receipt of a high radiation signal on any one of the four plenum monitors will stop the ventilation fans and cause the main ventilation dampers to close. Also, if those dampers fail to close within ten seconds, the auxiliary dampers will close as the result of a second interlock. The main damper interlock is tested by lowering the trip on one of the plenum monitors to the background level.

- d) Physical inspection and testing of the ratemeters (the plenum monitors) showed no defects. These are all newly installed equipment. As is evident from Figure One, a failure in the ratemeter would have resulted in the auxiliary dampers remaining open also.

- e) Physical inspection and testing of the relays that control the exhaust damper/fans, intake damper, and auxiliary dampers revealed no defects. However, an intermittent failure of the first two of these relays could not be eliminated as a possible failure mechanism.

C6A - Deenergizes the exhaust fan and core purge blower. Closes both main dampers.

C6B - Deenergizes the intake fan.

D1 Closes auxiliary dampers if associated main damper is still open 10 s after receipt of a trip signal.

9. Corrective Action: The immediate corrective action was to replace the relays associated with the main exhaust damper/fans and the main intake damper. Subsequent testing showed all interlocks to be functional. However, given the intermittent nature of this problem, it can not be assumed that the situation has been corrected. Accordingly, the closing time for the auxiliary dampers has been reduced to meet the requirements of Technical Specification No. 3.8.2(a).
