FINAL REPORT

RHR PUMP WEAR RING
SURVEILLANCE EXAMINATION RESULTS
PIGGRIM NUCLEAR POWER STATION

WORK PERFORMED FOR
BOSTON EDISON COMPANY

January 23, 1987

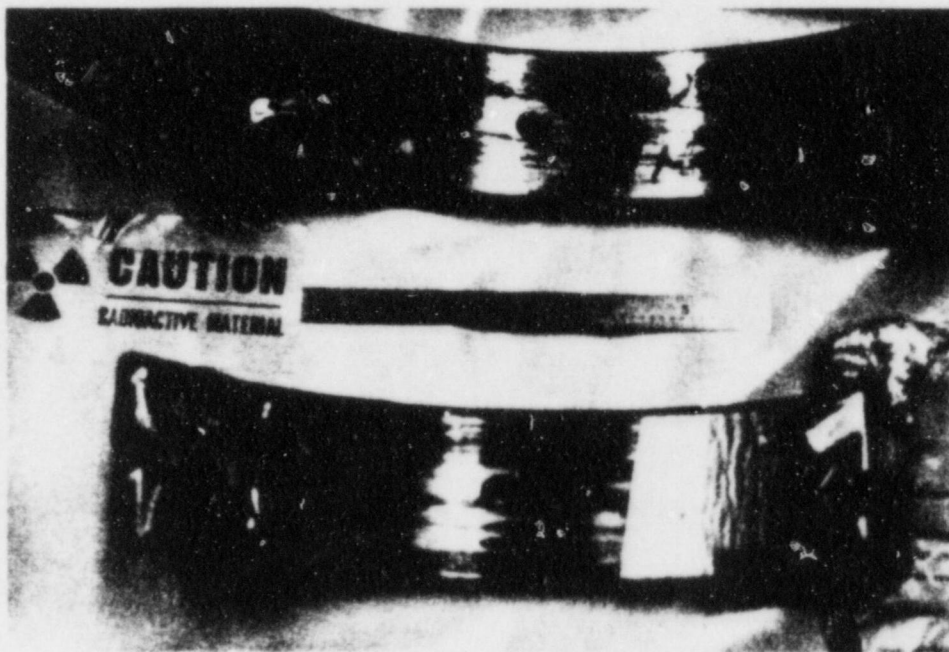
The pump "A" wear ring segment was penetrant examined for evidence of crack indications. All surfaces of the segment were examined and no relevant indications were found.

Figure 3. Closeup photo of wear ring segment removed from RHR pump "A" impeller.

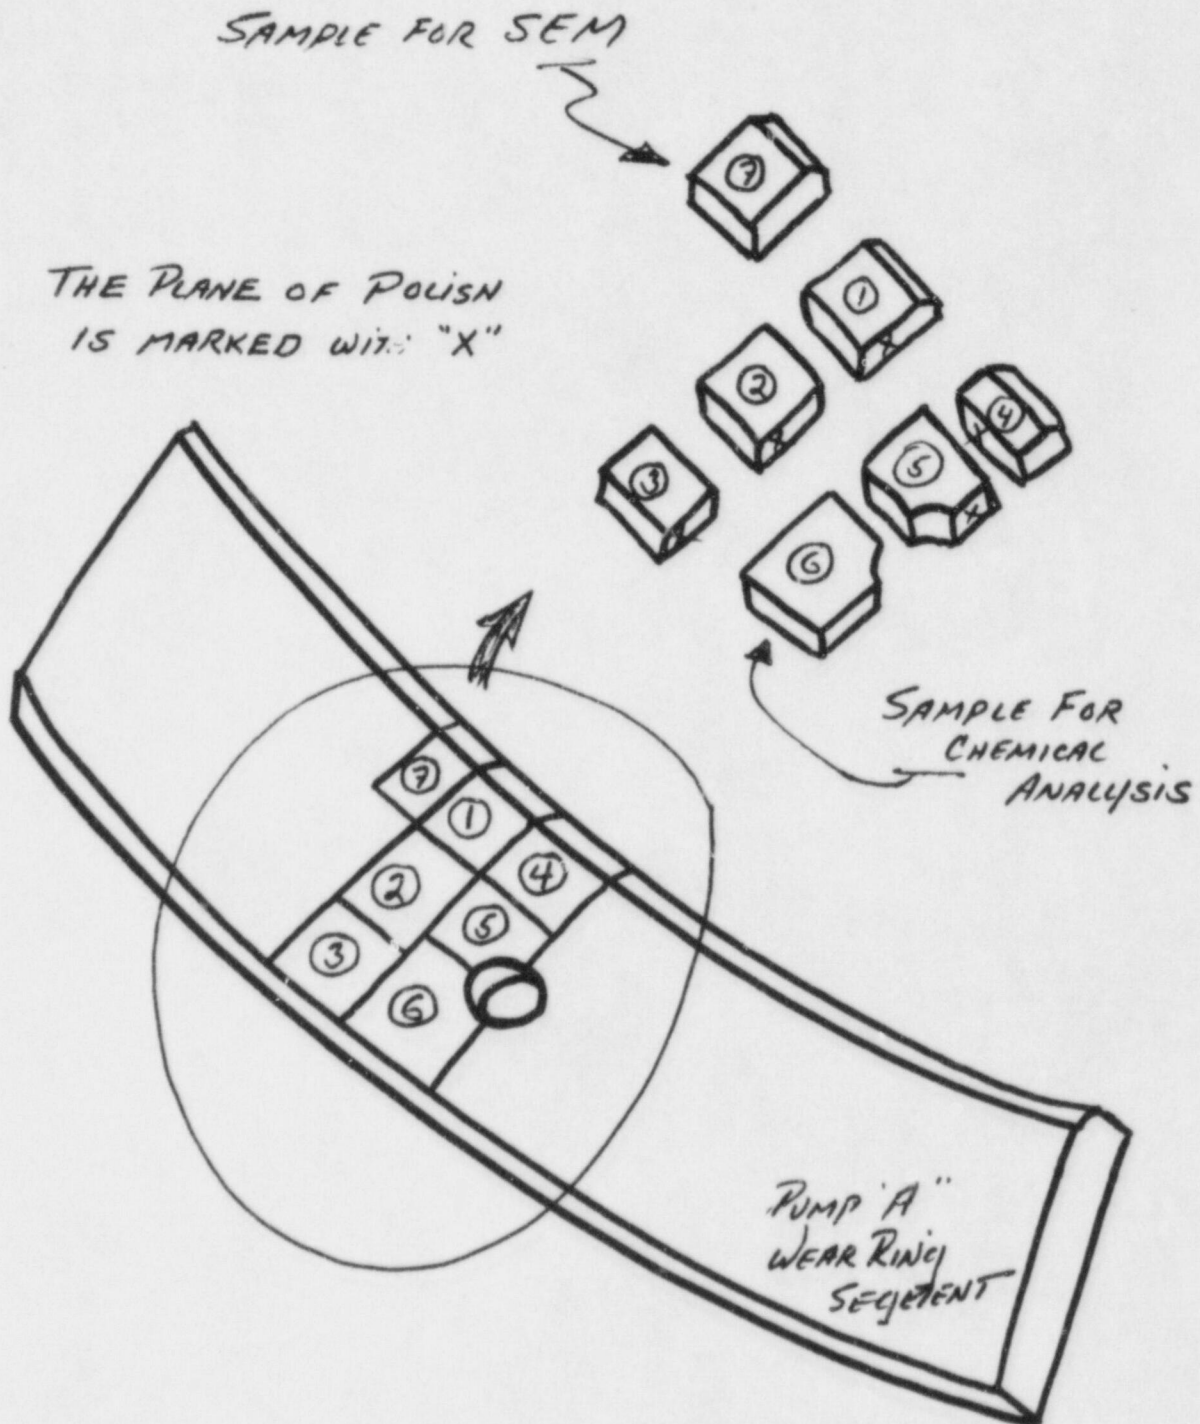
Following visual examination, the segment of RHR Pump "A" wear ring was sectioned for metallographic examination. Figure 5 is a sketch of the sectioning plan. Since no relevant indications were found, a random "typical" area was selected for sampling. As indicated in Figure 5, seven samples were cut for metallurgical characterization. Five samples were used for optical microscopy, one for scanning electron microscopy, and one for chemical analysis.

Figure 5. Sketch of sectioning plan for RHR pump "A" wear ring segment metallographic examination.

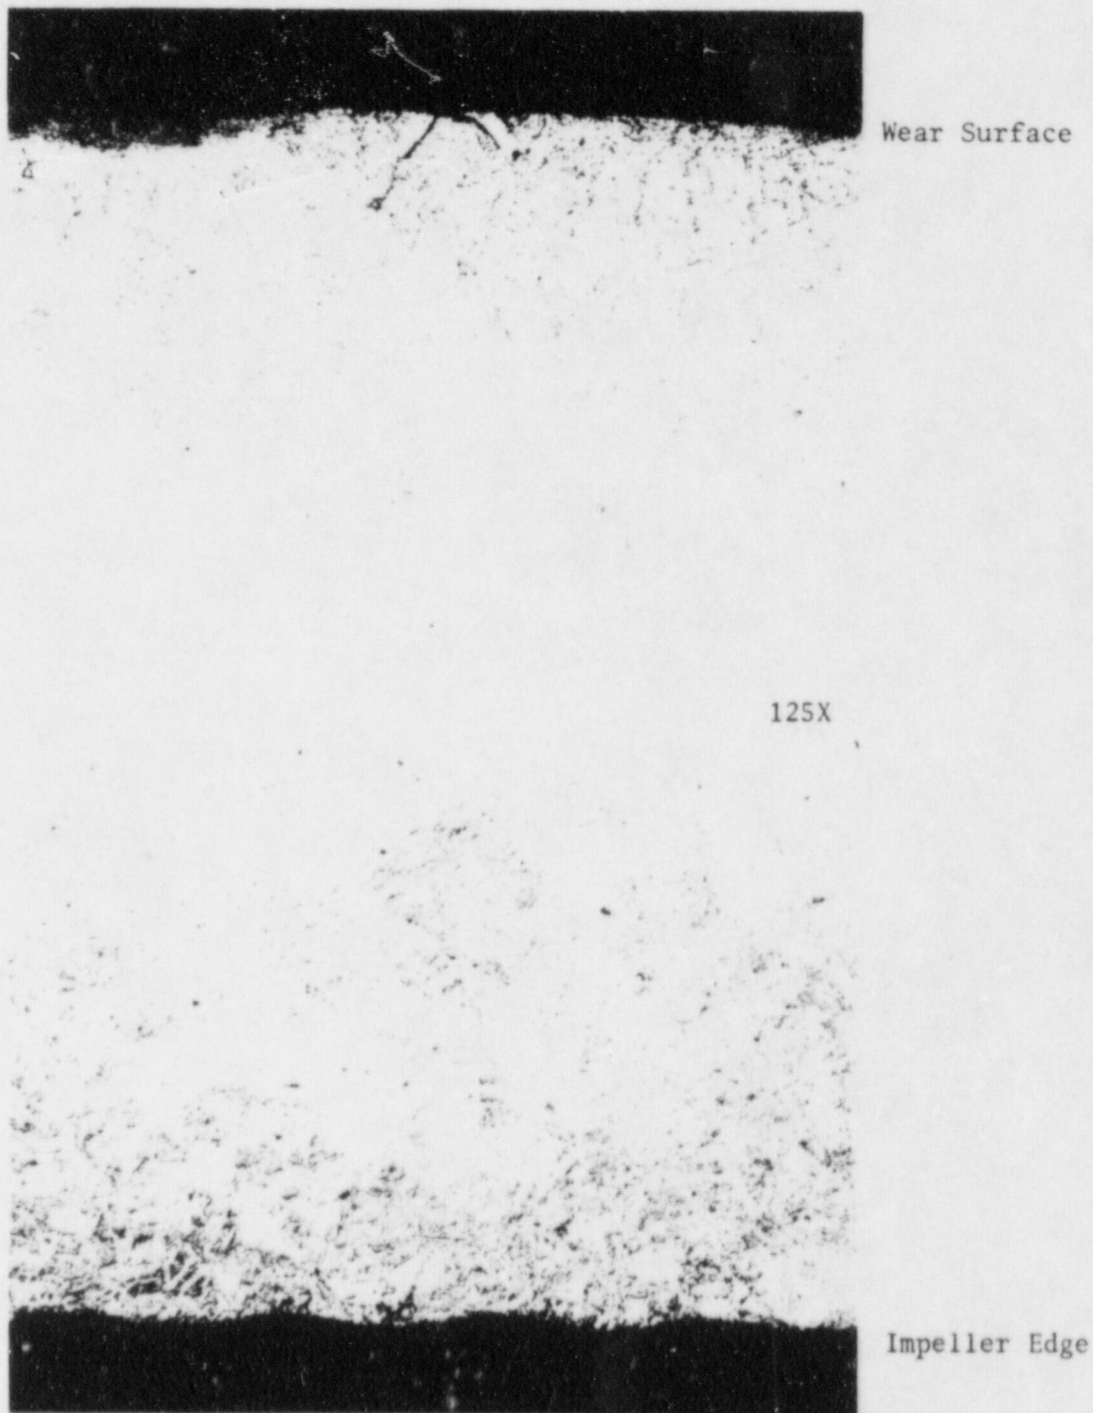
On Section 3 (Figure 8), a shallow (1/8 inch) intergranular crack was noted at the wear surface. Since the sections were randomly selected, it must be presumed that the presence of other shallow cracks is not uncommon and in time these cracks could propagate through the wear ring thickness and cause impeller failure (seizure). Due to the similarity of the metallurgical (hardness) design, and service condition of these rings with those of Peach Bottom, with confirmed stress corrosion cracking, it is assumed that cracking in the Pilgrim ring is also due to stress corrosion. It must be noted, however, that fabrication related quench cracking (intergranular) could be a possible, albeit improbable, cause as SCC and shallow quench cracks have similar appearances.

The average hardness in the region of the crack at the wear surface edge on sample 3) is 42 to 43 Rockwell C and represents the highest values found on the samples. Since increasing hardness levels increase the propensity for IGSCC, it is consistent to have observed cracking in the highest hardness region.

Figure 8. Typical edge views of section 3 removed from RHR pump "A" wear ring segment. The edge in the upper photo was adjacent to the wear surface and the edge in the lower photo was adjacent to the impeller. Note shallow intergranular crack in upper photo. Hardness at this location is approximately 43 Rockwell C.

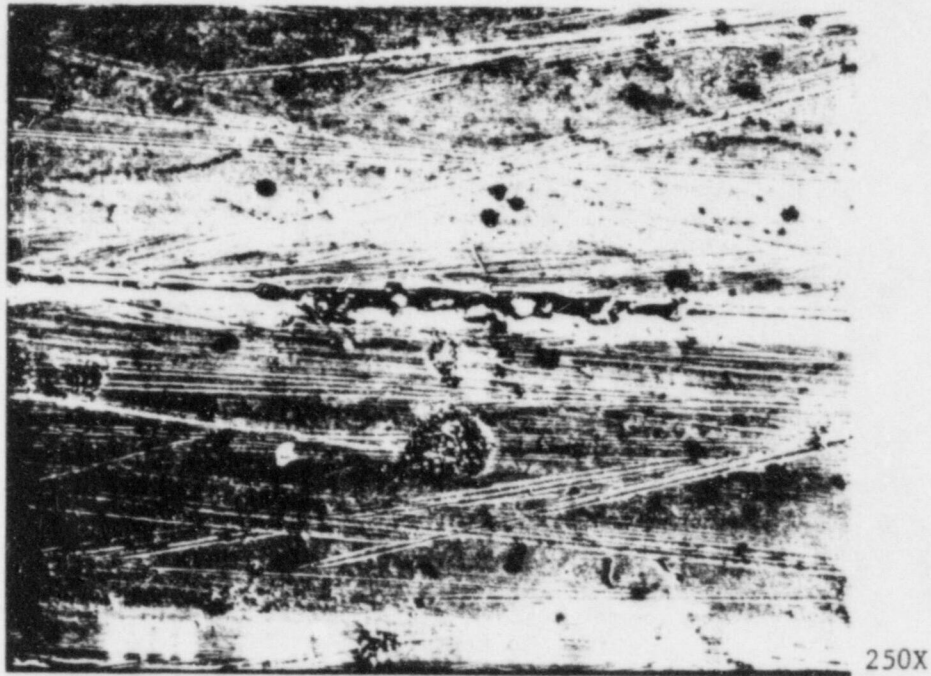
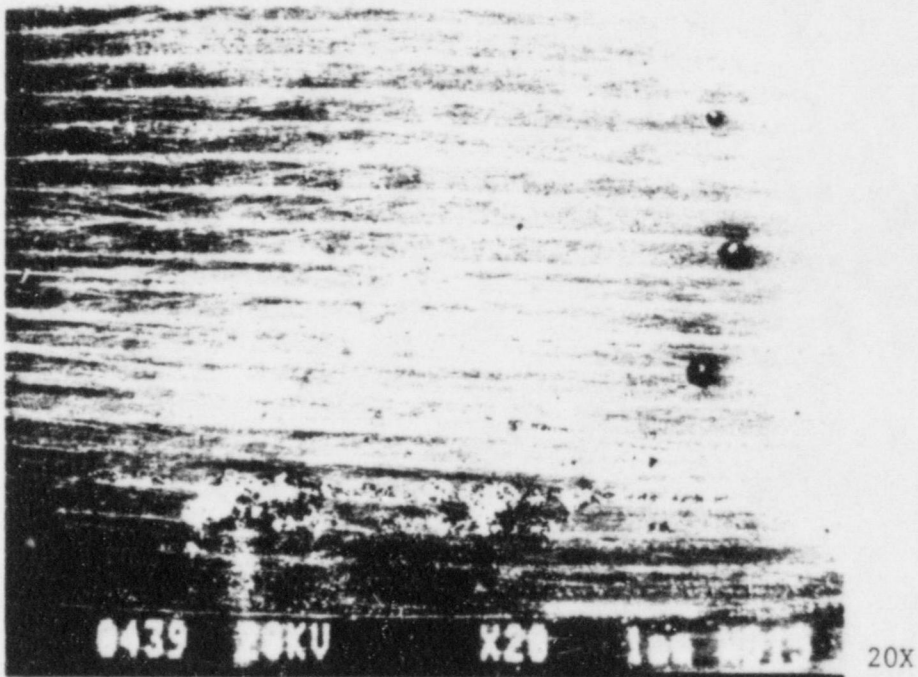
Sample 6, removed from RHR Pump "A" wear ring segment, was selected for study by Scanning Electron Microscopy (SEM). Figure 11 provides the results of the SEM evaluation. Figure 11 has low (20X) and high (250X) magnification views of the wear surface. Minor surface imperfections/degradation can be observed in the 250X view. This view is rather typical of the condition of the wear surface. Such imperfections tend to promote crack initiation (of the type observed in Section 3) in a susceptible material, if the stress and environmental conditions are favorable for SCC.

Figure 11. Low (20X) and high (250X) magnification views of wear surface of wear ring of RHR pump "A". Note the minor surface degradation in the 250X view. Such imperfections tend to promote crack initiation in a susceptible material if stress and environment conditions are favorable for SCC.

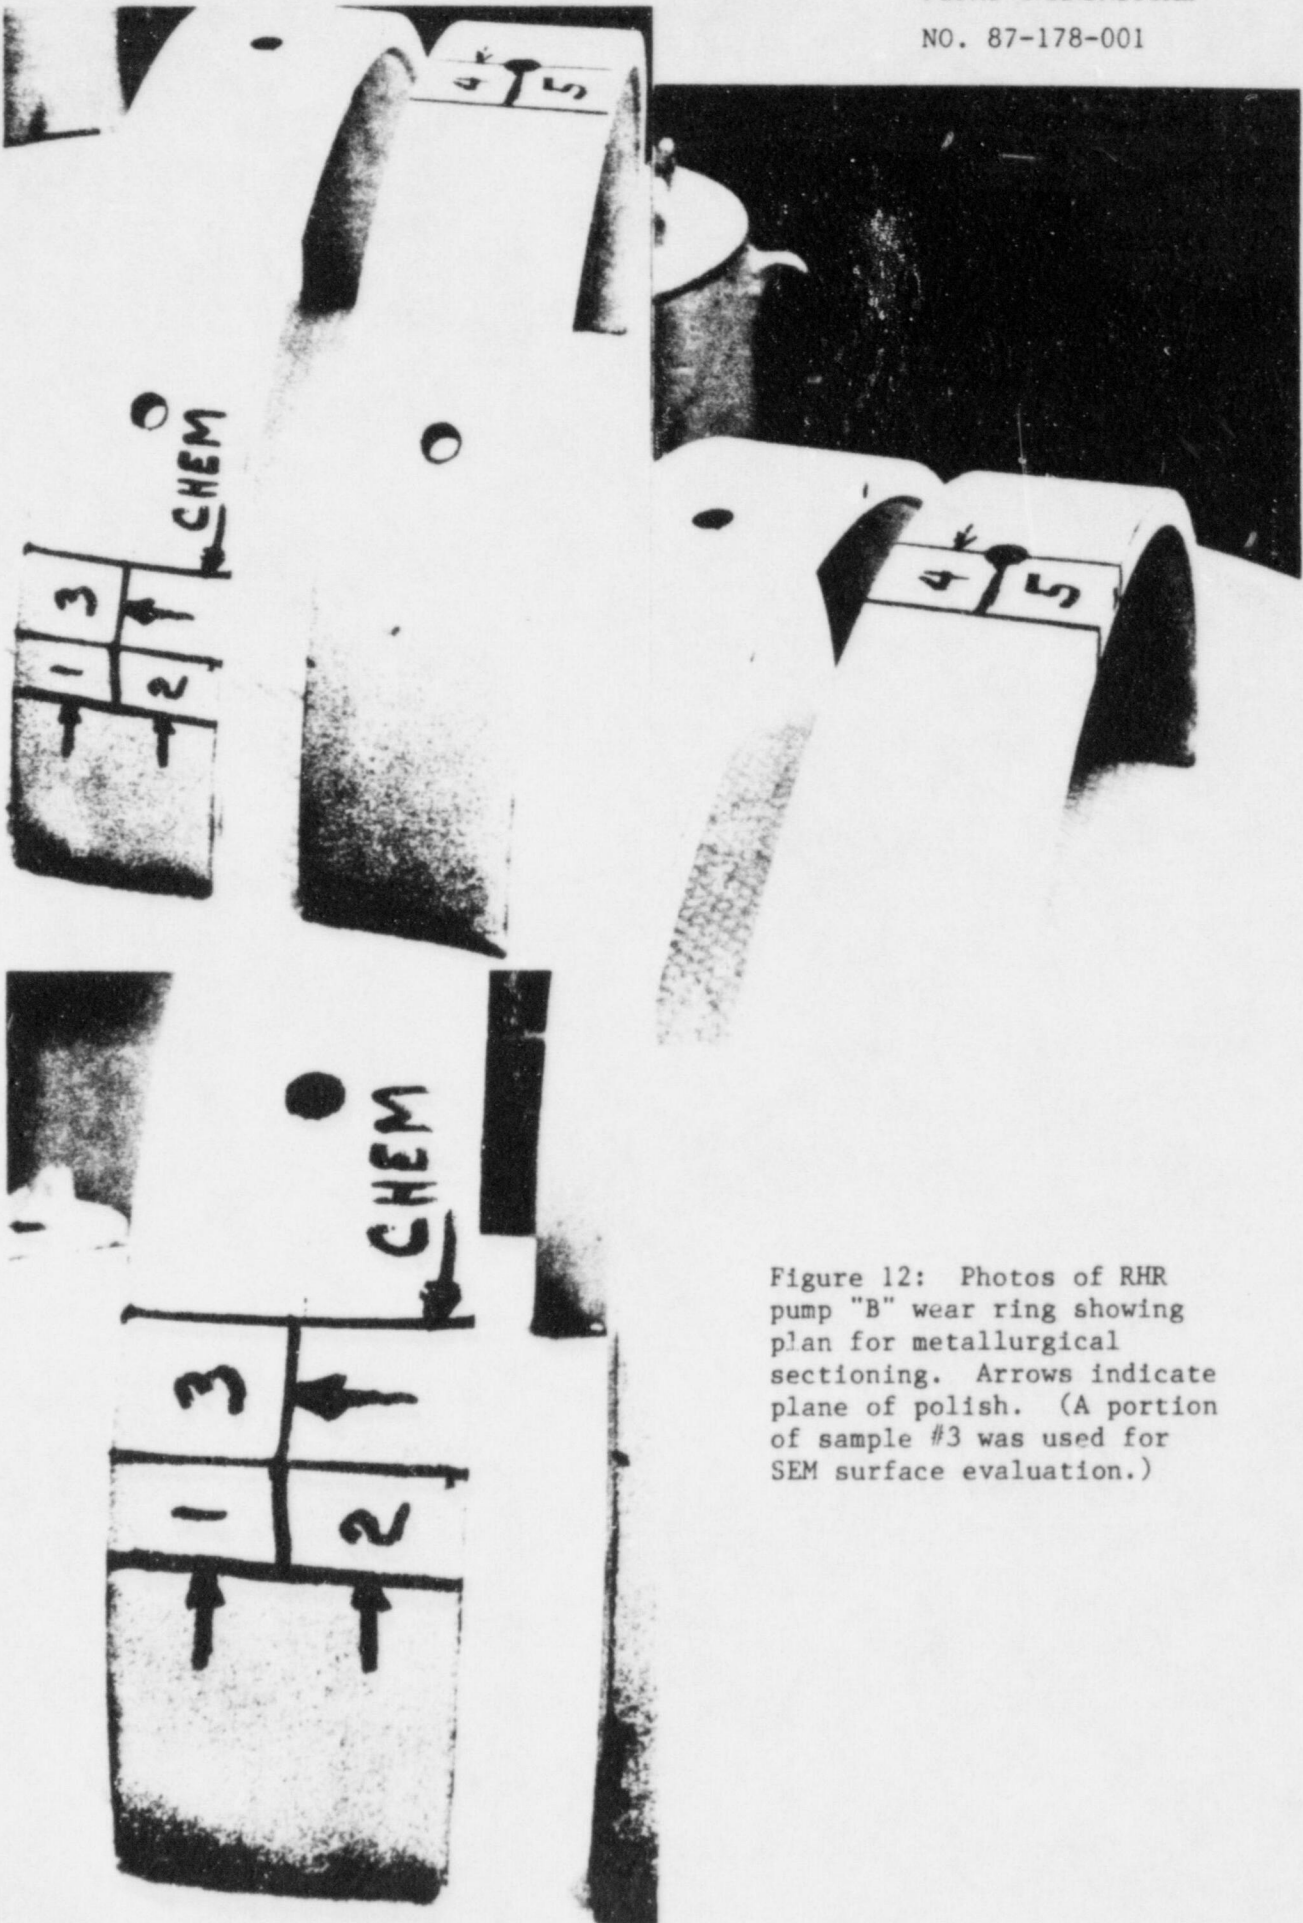
Following visual examination, samples of RHR Pump "B" wear ring were removed for metallurgical evaluation. Figure 12 is a set of photos showing the RHR Pump "B" metallurgical sectioning plan. The arrows in the photos indicate the plane of polish. Since no relevant indications were found by penetrant examination on this wear ring, typical random areas were selected for sampling. As indicated in Figure 12, a total of 7 samples were selected for metallurgical characterization. (A portion of sample #3 was used for SEM evaluation). Five samples were used for optical microscopy, one for SEM and one for chemical analysis.

Figure 12: Photos of RHR pump "B" wear ring showing plan for metallurgical sectioning. Arrows indicate plane of polish. (A portion of sample #3 was used for SEM surface evaluation.)

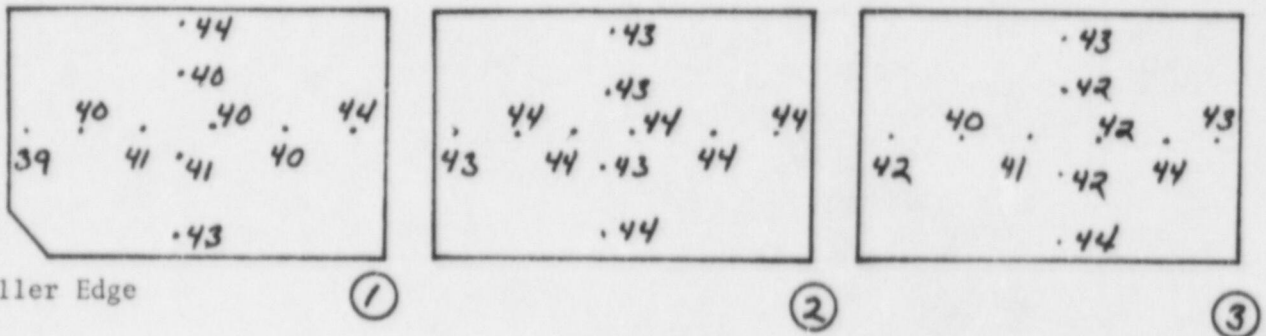
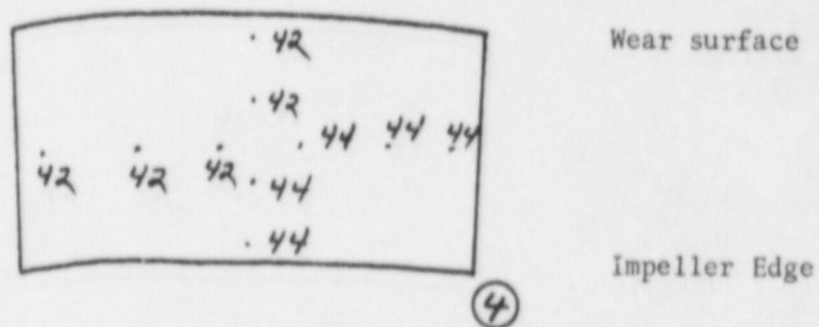
average hardness.....	42.4 Rc
average near wear surface.....	42.8 Rc
average near impeller surface...	42.8 Rc

Note that in the case of each ring, the average hardness level exceeds the specified maximum hardness level of 39 Rockwell C. At this level of hardness Type 410 Stainless Steel is known to have a susceptibility to stress corrosion crack initiation and growth under suitable conditions of stress and environment.

Avg. overall hardness.....42.4

Avg. near wear surface.....42.8

Avg. near impeller surface...42.8

Figure 19: Hardness measurement for RHR pump "A" wear ring.

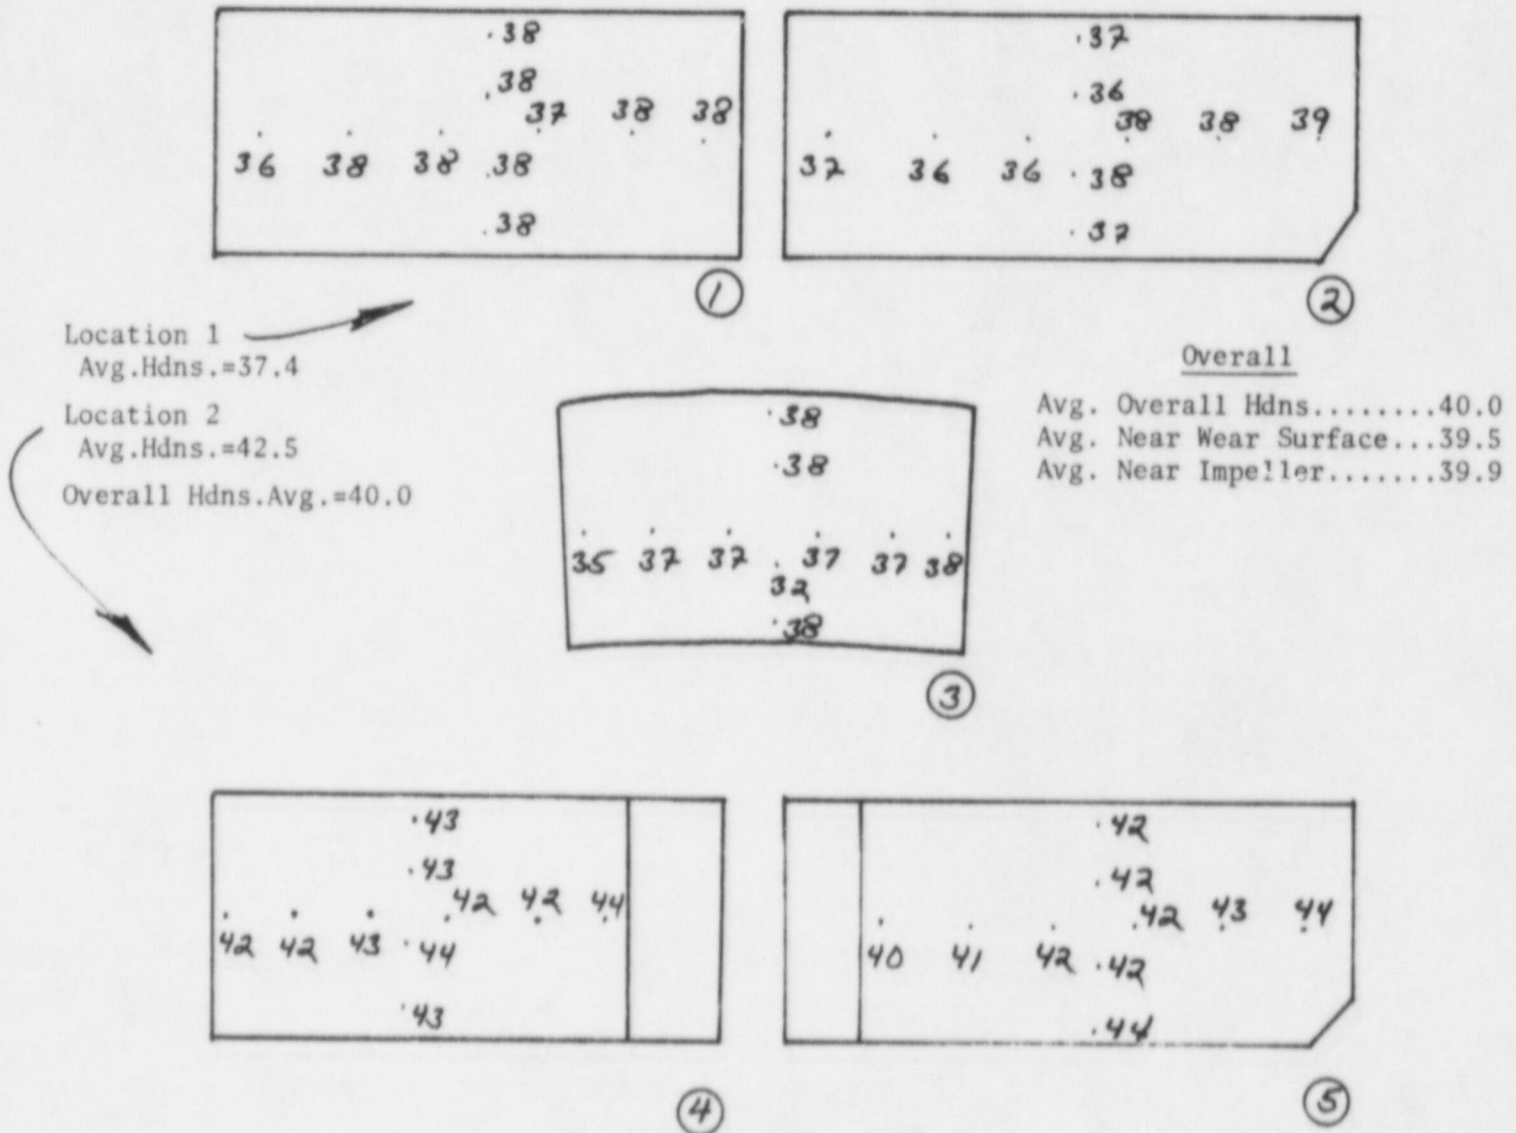
average hardness.....	40.0 Rc
average near wear surface.....	39.5 Rc
average near impeller surface...	39.9 Rc

Figure 20. Hardness measurements for RHR pump "B" wear ring.
