Long-Term Surveillance and Monitoring Program

**Annual Site Inspection and Monitoring Report
for
Uranium Mill Tailings Radiation Control Act
Slick Rock, Colorado, Site**

1998 Annual Report

February 1999

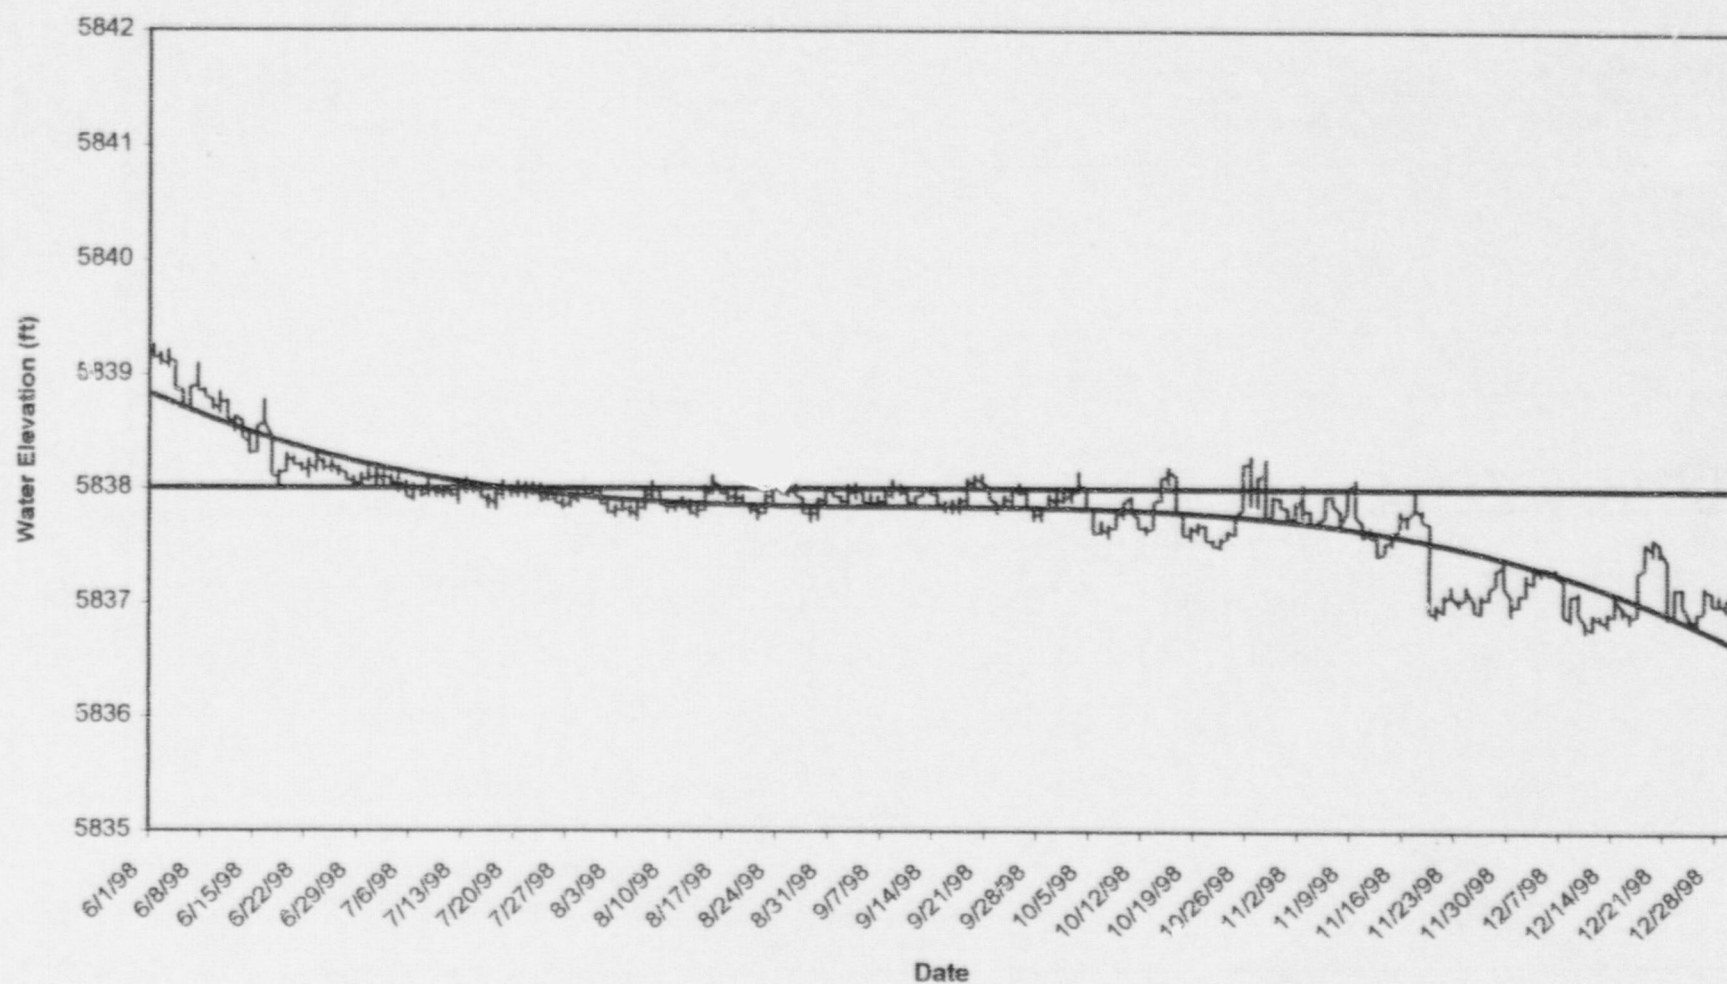
Figure SRK-2. Slick Rock, Colorado Standpipe No. 3

The most recent downloading of data loggers, December 1998, shows water levels at 5,837.1 ft in SP-3 (Figure SRK-2) and 5,837.6 ft in SP-4 (Figure SRK-3). Both are below the 5,838 ft datum for Kd-1, the lowermost sandstone unit. The data in Figures SRK-2 and SRK-3 show a gradually decreasing elevation for ground water in the two standpipes over the last 6 months of 1998. (Noise or "bounce" in the data is attributed to changes in barometric pressure.) DOE regards the regression line superimposed on the data in both figures to represent mean water level. Data loggers are down-loaded quarterly.

DOE will continue to monitor water levels in the two standpipes until a downward trend is consistently observed for three consecutive quarters *and* the water level in both standpipes is at or below the base of the Kd-1 sandstone bed (5,838 ft). At that time, DOE will decommission the remaining standpipes.

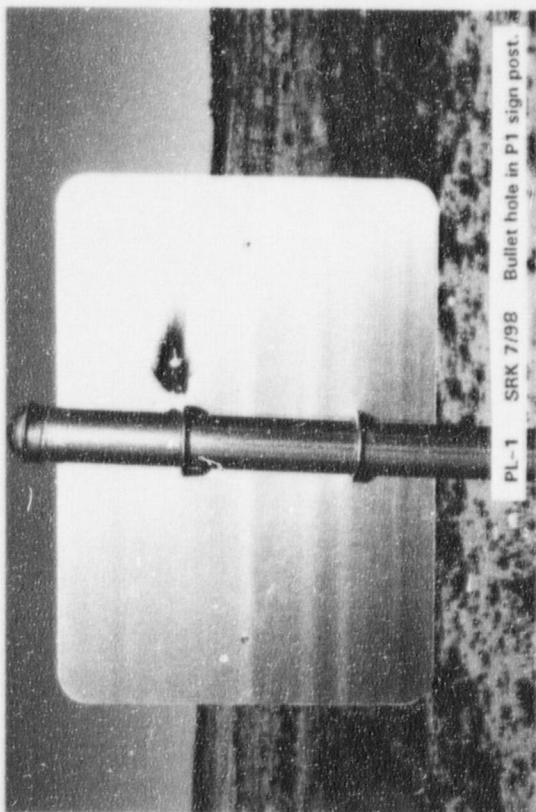
The entrance sign is inside the stock fence immediately east of the entrance gate. Thirty-two perimeter signs, designated P1 through P32, are spaced at approximately 200-foot (ft) intervals around the site. All signs are attached to steel posts set in concrete about 5 ft inside the site boundary. The sign post at P1 has a bullet hole (SRK PL-1) and the sign at P32 has a bullet hole and is bent (SRK PL-2). All other signs are in excellent condition.

PL-1 SRK 7/98 Bullet hole in P1 sign post.

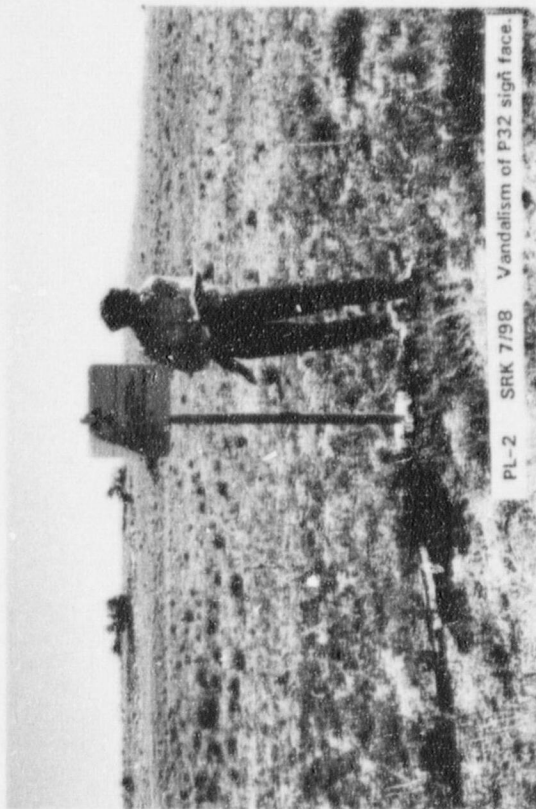
PL-2 SRK 7/98 Vandalism of P32 sign face.

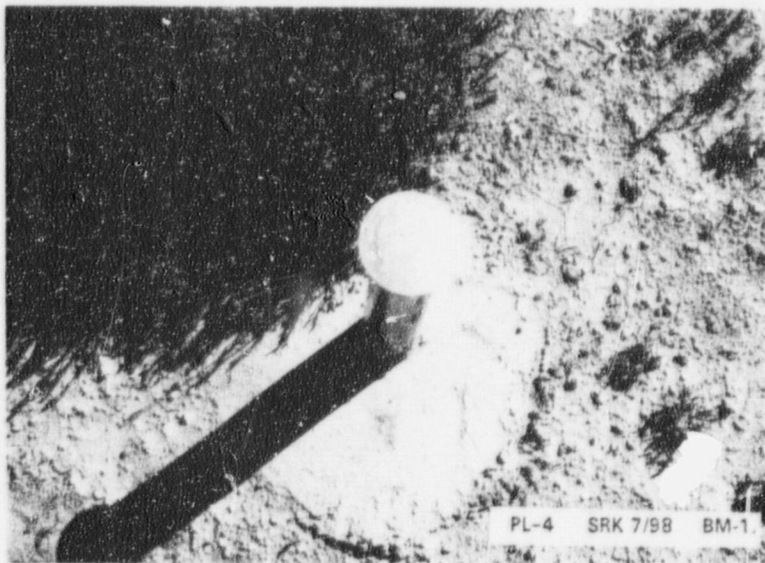
Six boundary monuments define the site boundary. Two boundary monuments, BM-1 and BM-5, were not found during the 1997 inspection but were found during this year's inspection (SRK PL-4 and SRK PL-5). The cap on each monument is stamped with the monument number, e.g., BM-1. All six boundary monuments are in excellent condition.

PL-4 SRK 7/98 BM-1.

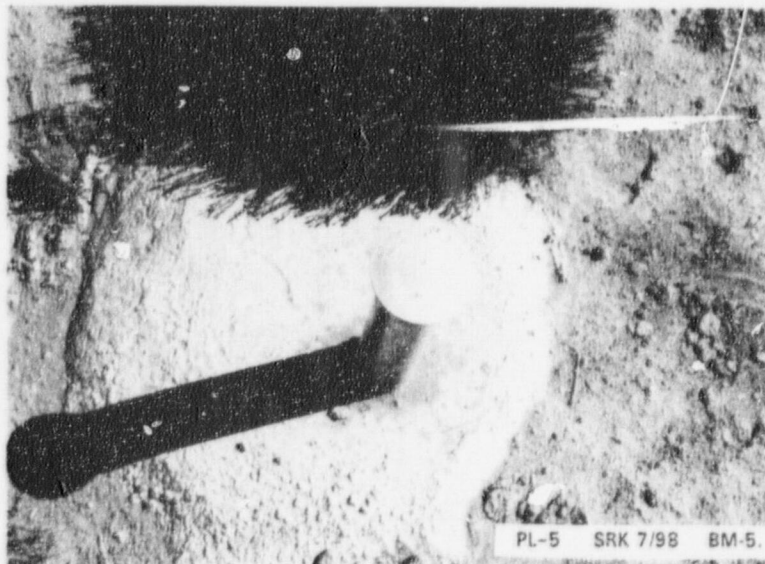
PL-5 SRK 7/98 BM-5.

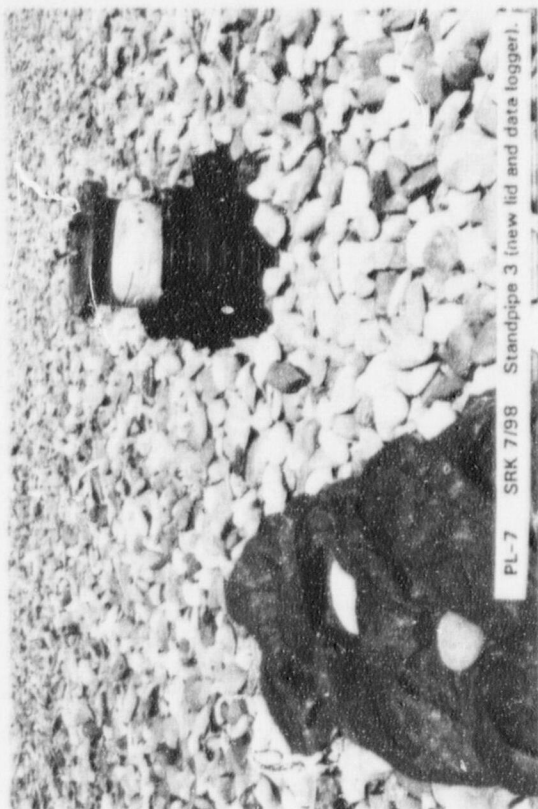
Standpipes SP-3 and SP-4 were reinstalled in August 1998. Data loggers installed in the new standpipes are shown in SRK PL-7 and SRK PL-8.

PL-7 SRK 7/98 Standpipe 3 (new lid and data logger).

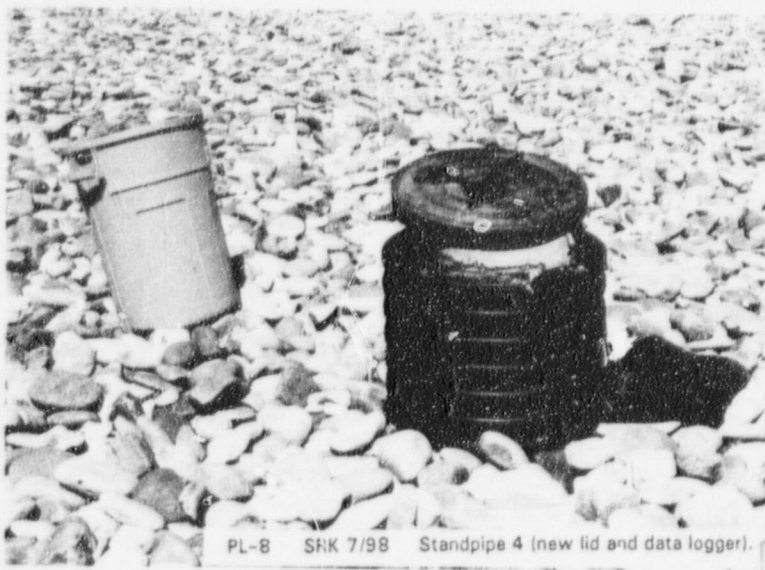
PL-8 SRK 7/98 Standpipe 4 (new lid and data logger).

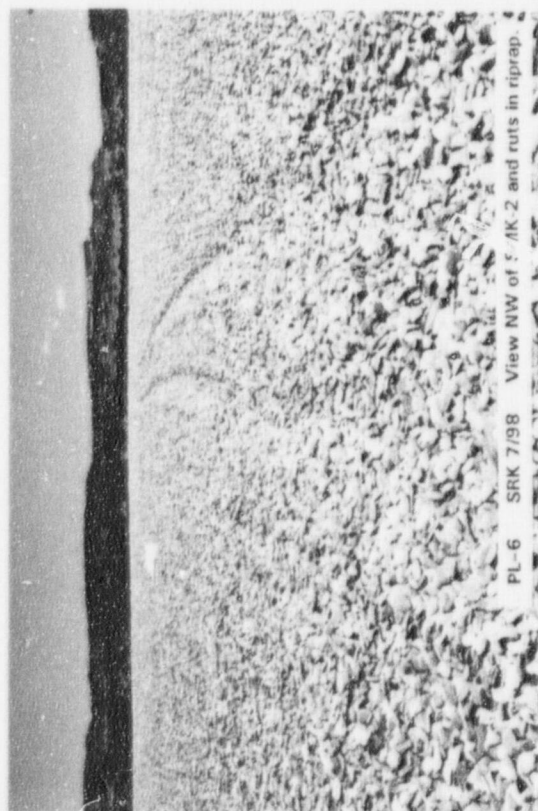
There are tire tracks in the riprap north and east of site marker SMK-2 between standpipes SP-3 and SP-4 (SRK PL-6). The tracks were made by heavy equipment when two standpipes in the disposal cell were decommissioned and two were reinstalled. To maintain the appearance of the site, these tracks will be filled or smoothed. (See Standpipes below.)

PL-6 SRK 7/98 View NW of SRK 2 and ruts in riprap.

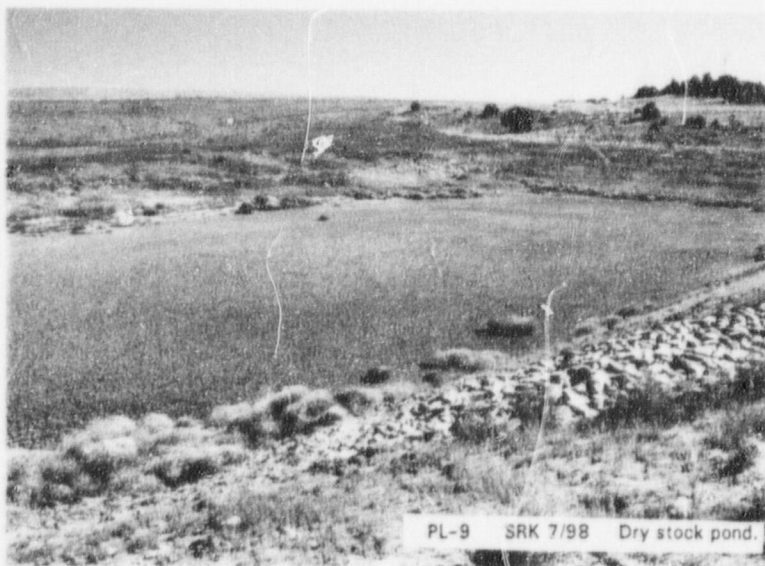
Runoff from the disposal cell flows southward into the stock pond that lies at the southern tip of the site. The stock pond was originally constructed as a retention pond during site construction. The pond was dry at the time of this year's inspection (SRK PL-9). The outflow channel below the pond is armored for a short distance with cobbles. The channel continues to the east where it becomes a tributary to Joe Davis Canyon. A silt fence, remaining from site construction, crosses the channel downstream from the armored portion of the channel. The silt fence is no longer needed or functional. It will be removed to improve the appearance of the site.

PL-9 SRK 7/98 Dry stock pond.

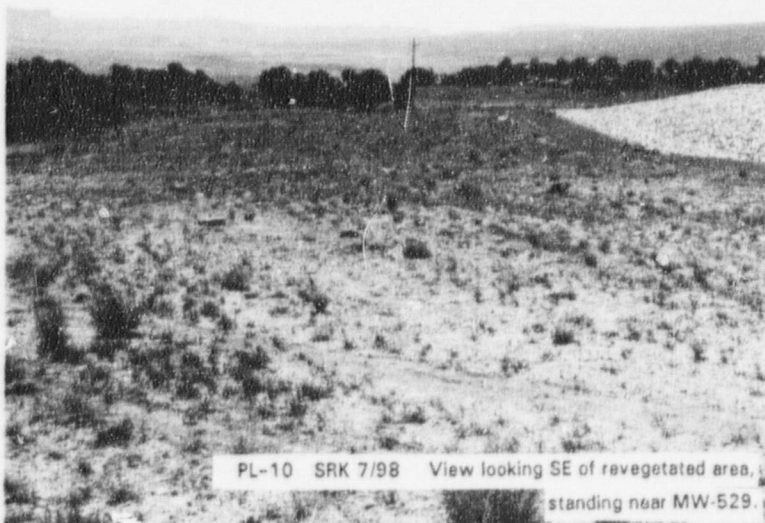
Typical vegetative cover in the northeastern part of the site is pictured in SRK PL-10 and in the southeast part of the site in SRK PL-11. It is too soon to evaluate the long-term success of the seeding because the vegetation is only in its second growing season. With time, it is hoped that native perennial vegetation will replace Russian thistle and prevent erosion from occurring. In several places, planting furrows from the reseeded process run parallel to the slope instead of across the slope. This situation has caused or worsened erosion at some places. Progress of revegetation will continue to be monitored.

PL-10 SRK 7/98 View looking SE of revegetated area, standing near MW-529.

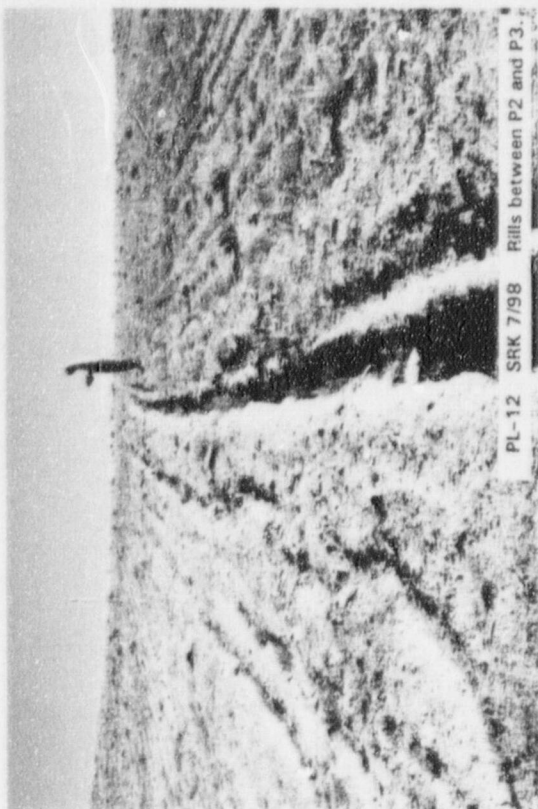
The rills along the west edge of the site, in the area between perimeter signs P2 and P4, appeared to have lengthened since 1997 (SRK PL-12). Whereas they were primarily restricted to the area between P4 and P3 in 1997, they extended to P2 in 1998, and appeared to have deepened. Rills as deep as 9 in. were measured. The progress of erosion in all recontoured areas will continue to be monitored.

PL-12 SRK 7/98 Rills between P2 and P3.

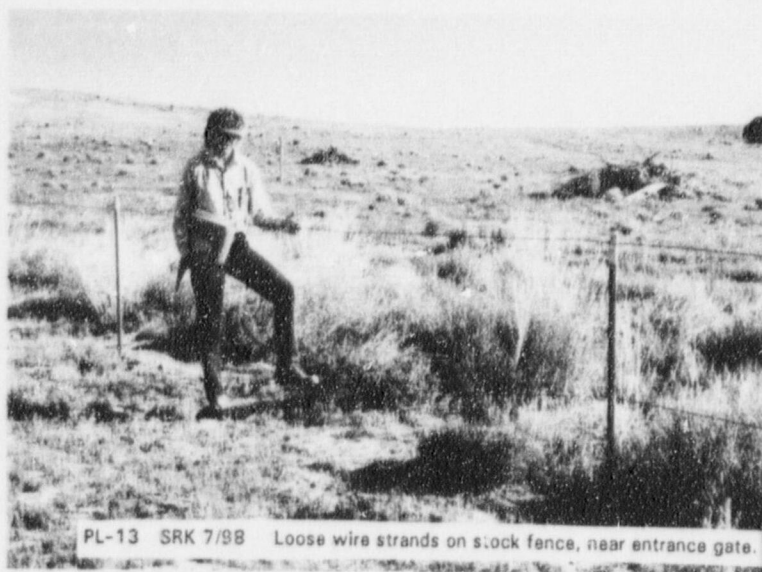
A stock fence of sorts surrounds the disposal cell, most of the reseeded areas, and the spoils pile west of the disposal cell. The approximate location of the fence is shown on Figure SRK-1. The fence, such as it is, is in excellent condition except between perimeter signs P31 and P32 where a strand of wire is broken, and west of the entrance gate, where several wires are slack (SRK PL-13).

PL-13 SRK 7/98 Loose wire strands on stock fence, near entrance gate.

When cattle graze on young plants, the entire plant is often pulled out of the ground or damaged to the extent that it does not recover. To prevent this situation, and to give desirable young plants an opportunity to fully establish, it is essential that the fence be reinforced to keep cattle

out for the next several years. Adding additional strands of wire to the fence is recommended. It is understood that a smooth wire fence was requested by the U.S. Bureau of Land Management (BLM) to allow antelope to pass without injury. Consideration will be given to adding barbed wire to the fence. Barbed wire at the top of the fence will still permit antelope to crawl under the fence as they are usually wont to do.

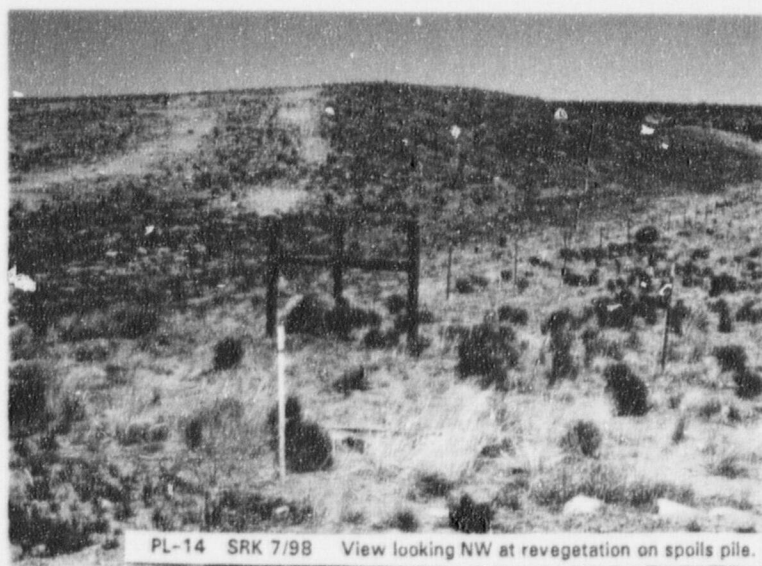
A spoils pile, composed of material excavated during site construction, forms a mound about 50-ft high west of the site boundary. Reseeding on the spoils pile has produced a cover primarily of Russian thistle with very few desirable perennial plants (SRK PL-14, SRK PL-15A, and SRK PL-15B). On the northeast-facing slope of the spoils pile, growing conditions are apparently a little better and the vegetative cover can be described as moderate. Establishment of vegetation across the entire spoils pile is a goal in order to stabilize the pile and prevent erosion. A series of small rills occurs along the southwest slope of the spoils pile where the drill-seeding furrows run parallel to the slope. The progress of revegetation and erosion control on the spoils pile will continue to be monitored.

PL-14 SRK 7/98 View looking NW at revegetation on spoils pile.

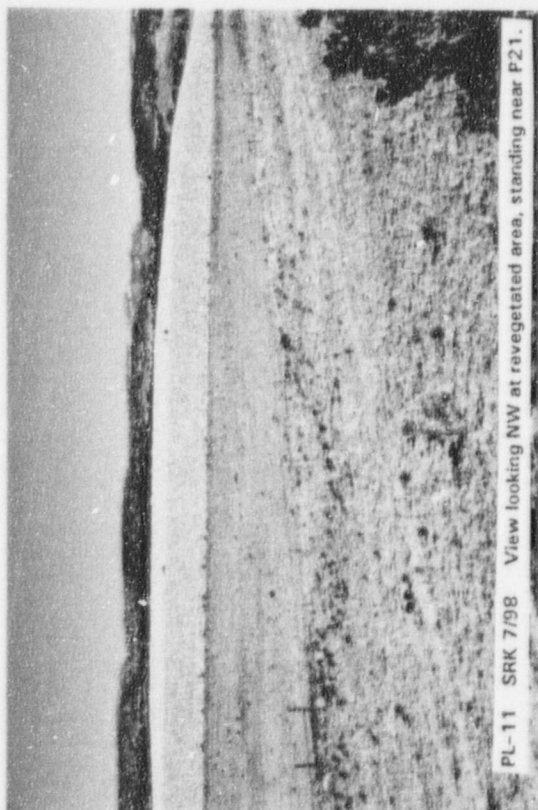
PL-11 SRK 7/98 View looking NW at revegetated area, standing near P21.

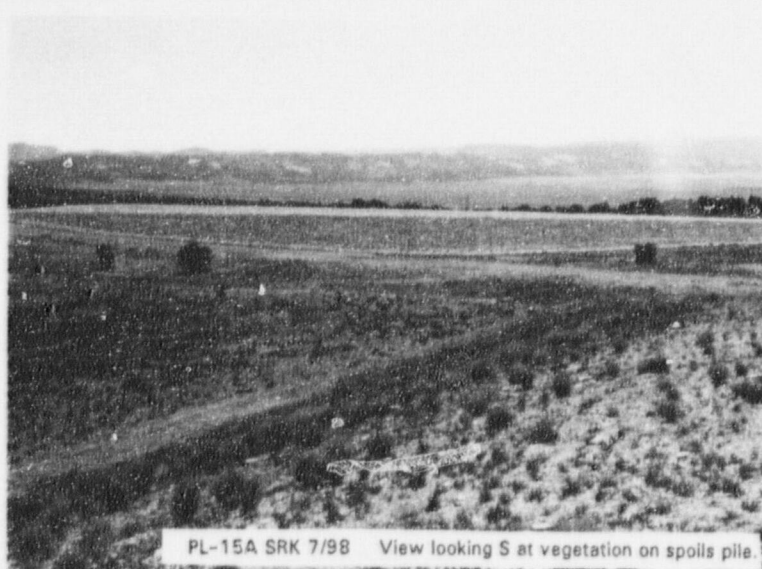
PL-15A SRK 7/98 View looking S at vegetation on spoils pile.

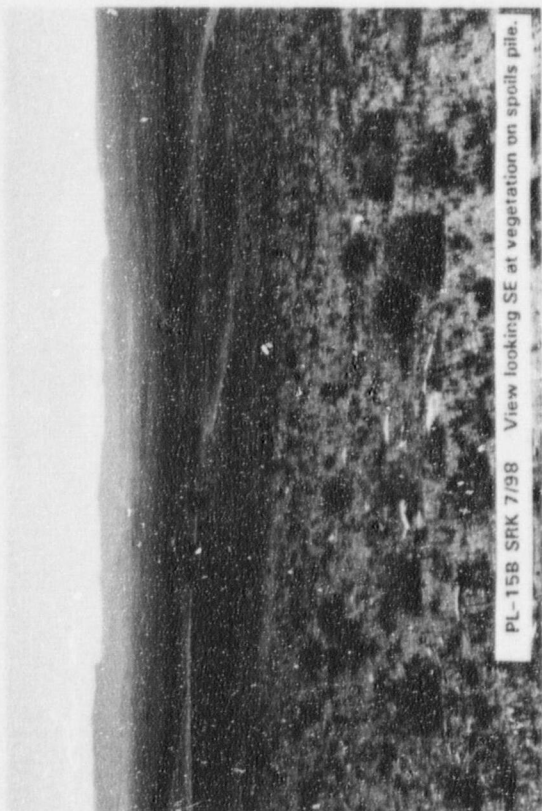
PL-158 SRK 7/98 View looking SE at vegetation on spoils pile.
