Long-Term Surveillance and Monitoring Program

Annual Site Inspection and Monitoring Report
for
Uranium Mill Tailings Radiation Control Act
Spook, Wyoming, Site

1998 Annual Report

February 1999

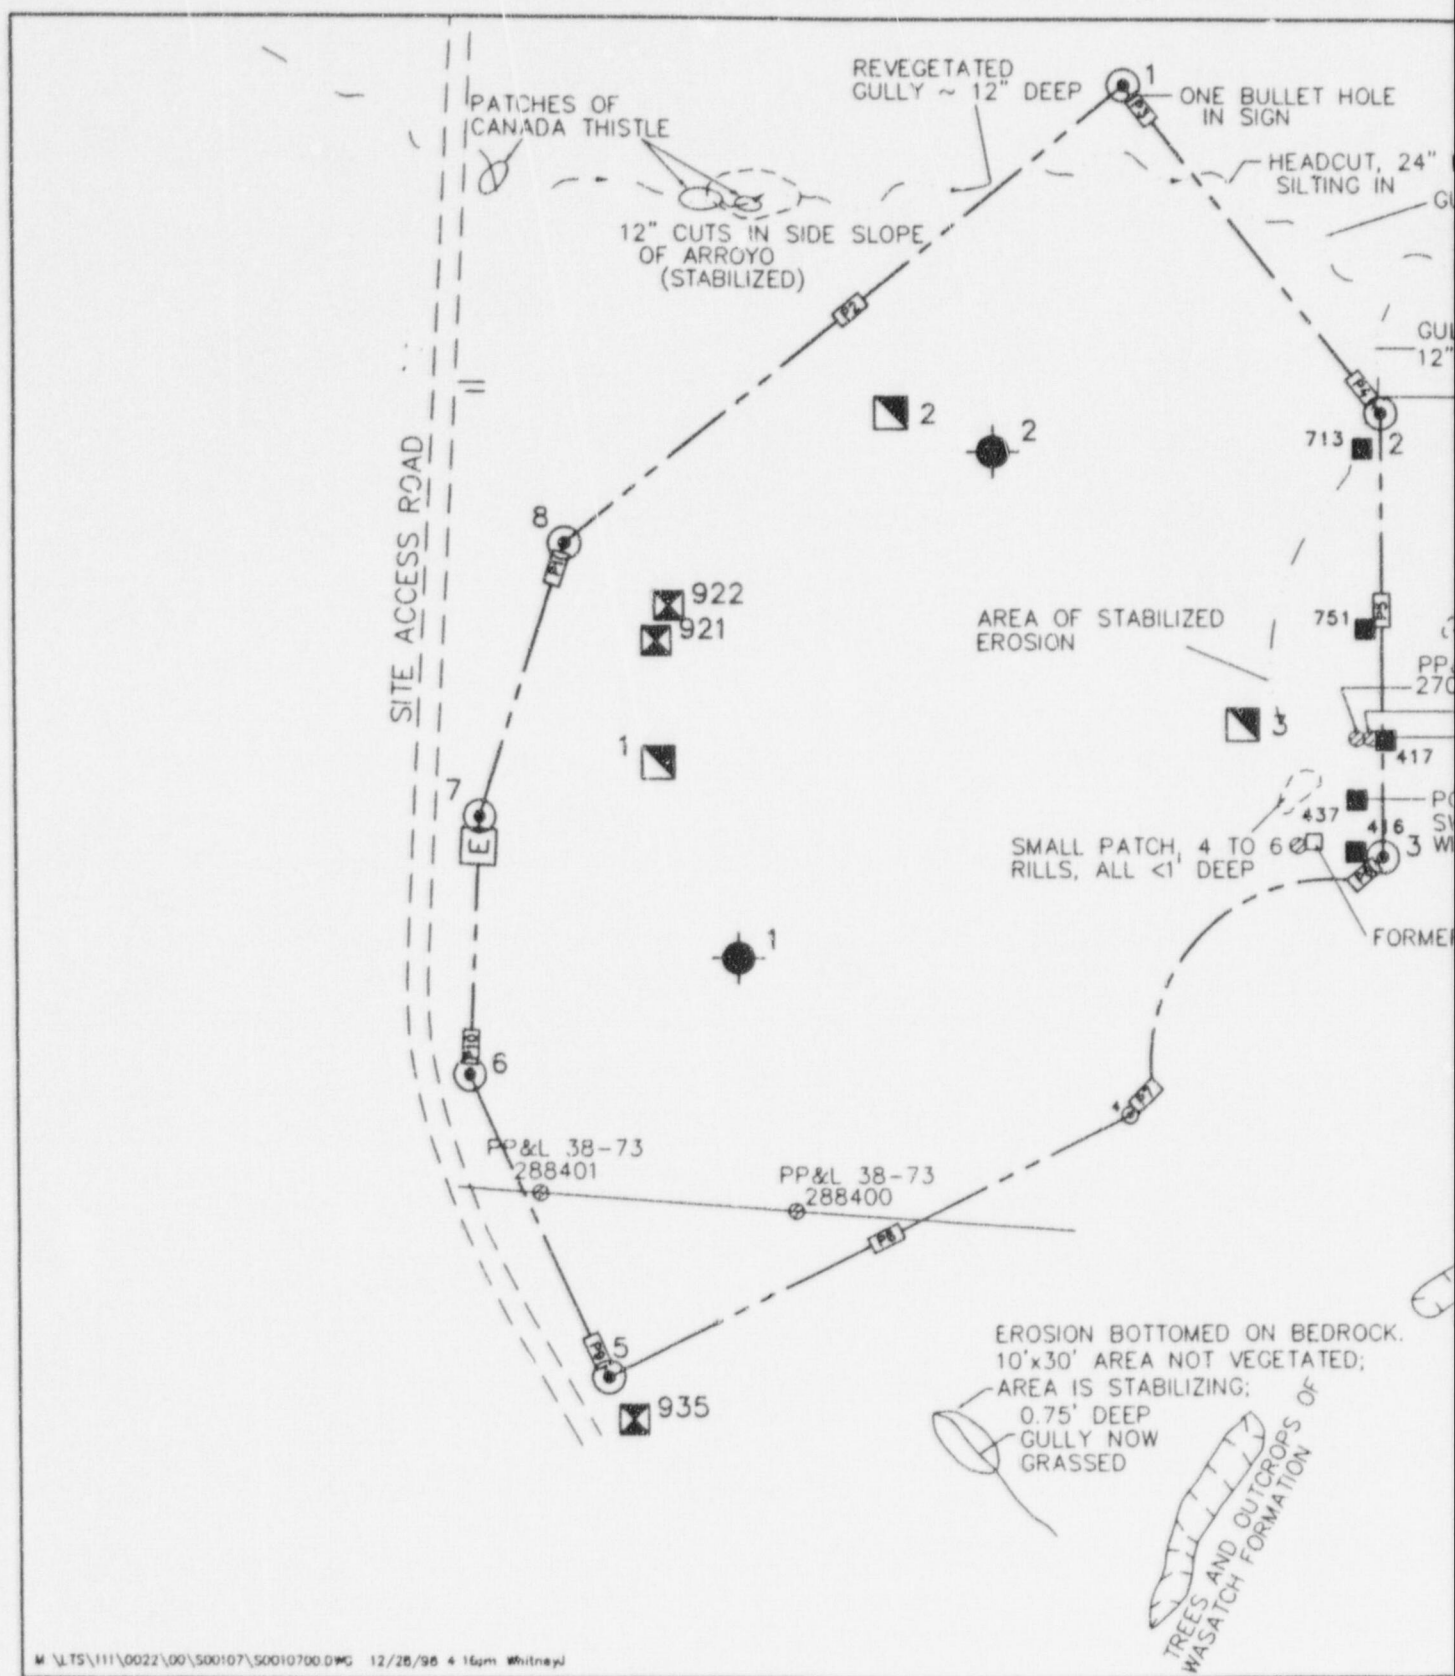
SPOOK, WYOMING,
1998 INSPECTION DRAWING

The most noticeable erosion on site is confined to two areas, both part of the same small drainage system. One branch of this drainage system flows across the northern tip of the site from west to east; the other branch starts near the transformer platform, drains the east side of the site, and flows northward to join the first branch. Each branch contains one noticeable knickpoint noted

DEEP
GULLY ~ 12" DEEP

HEADCUT,
12" DEEP

EROSION 12" DEEP
18" WIDE, 20' LONG

EROSION NOT ACTIVELY
EXPANDING

APPROXIMATE LOCATION OF FORMER
EROSION-CONTROL STRUCTURE
12-18" DEEP GULLY (NO LONGER
ACTIVE; GRASS AND SEDIMENT
FILLING IN)

during 1996 and 1997 inspections. Neither knickpoint has increased in height or migrated upstream from its 1997 position. The gullies appear to be filling with sediment, coming to grade, and revegetating naturally.

Southeast of the site, approximately 900 ft south-southeast of boundary monument BM-3, a formerly active area of erosion appears to be filling in with sediment and revegetating naturally. Immediately upstream of this old headcut, the gradient flattens and vegetation is well established. Erosion at this location is no longer a concern. The area will continue to be monitored in case erosion should resume.
