South Texas Project
Units 1 & 2
Docket Nos. STN 50-498, STN 50-499
Final Report Concerning
Failure of Limitorque Motor Operated Valve Actuators

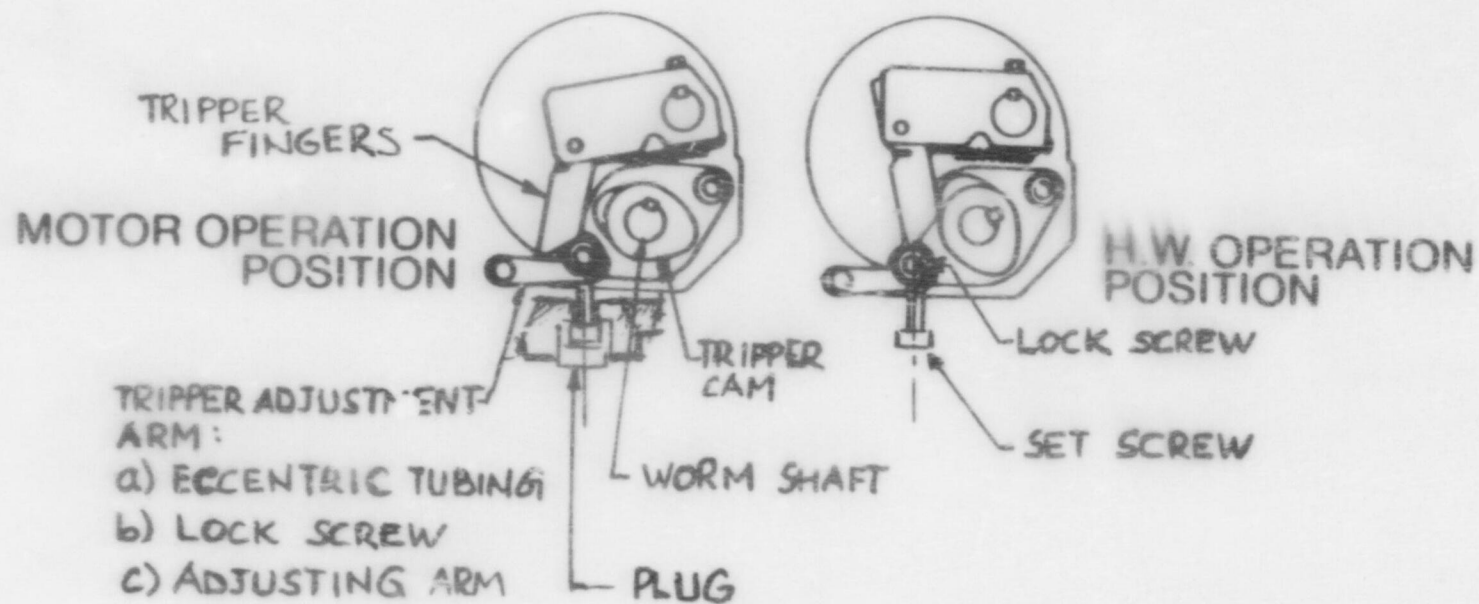
FIGURE 1

In each case upon removal of the motors to inspect the Limitorque operator, one tripper finger was found broken. The second tripper finger and the two tripper cams (Figure 1) were found gouged as well. A small amount of scarring was also noted on the operator housing near the normal location of the broken tripper finger.

During the events in question it is postulated that the tripper fingers did not drop behind the tripper adjustment arm because the tripper fingers had been ground to approximately the same length. All three MOV actuator failures were observed to have ground tripper fingers. Due to

the operator housing design and because the tripper fingers did not drop behind the tripper adjustment arm, the valve-side tripper finger was struck by its cam and in turn struck the housing of the operator as the speed of the motor increased. This condition existed until the valve-side tripper finger broke due to repeated impact with the cam and the operator housing. During this time the motor-side tripper finger and its cam had worn to the extent that the cam would not knock the tripper finger off the tripper adjustment arm keeping the operator in the manual position.

The root cause of this deficiency is the erroneous information and direction provided to the project by the first Limitorque service representative. This caused the grinding of the fingers which led to the failure of the operators.

The tripper finger assembly in each of the three damaged MOV actuators was removed and replaced with a new tripper finger assembly. Tripper cams will be replaced as required.

A rework program of all safety-related type SMB-00 and SMB-000 operators was initiated. This rework program being performed under the site Nonconformance Report procedures will require the inspection and replacement as needed, of installed tripper fingers with new fingers of uneven lengths. Approximately 125 safety-related Unit 1 MOVs will be reworked during this program. The valve rework program will be completed by Unit 1 fuel load. No tripper fingers on Unit 2 MOVs were ground.
