LICENSEE EVENT REPORT (LER)

Facility Name (1) LaSalle County Station Unit 1	Docket Number (2) 0 5 0 0 0 3 7 3	Page (3) 1 of 0 5
--	--	----------------------------

Title (4) Reactor Core Isolation Cooling Isolation Due to Inadvertent Draining of Instrument Line

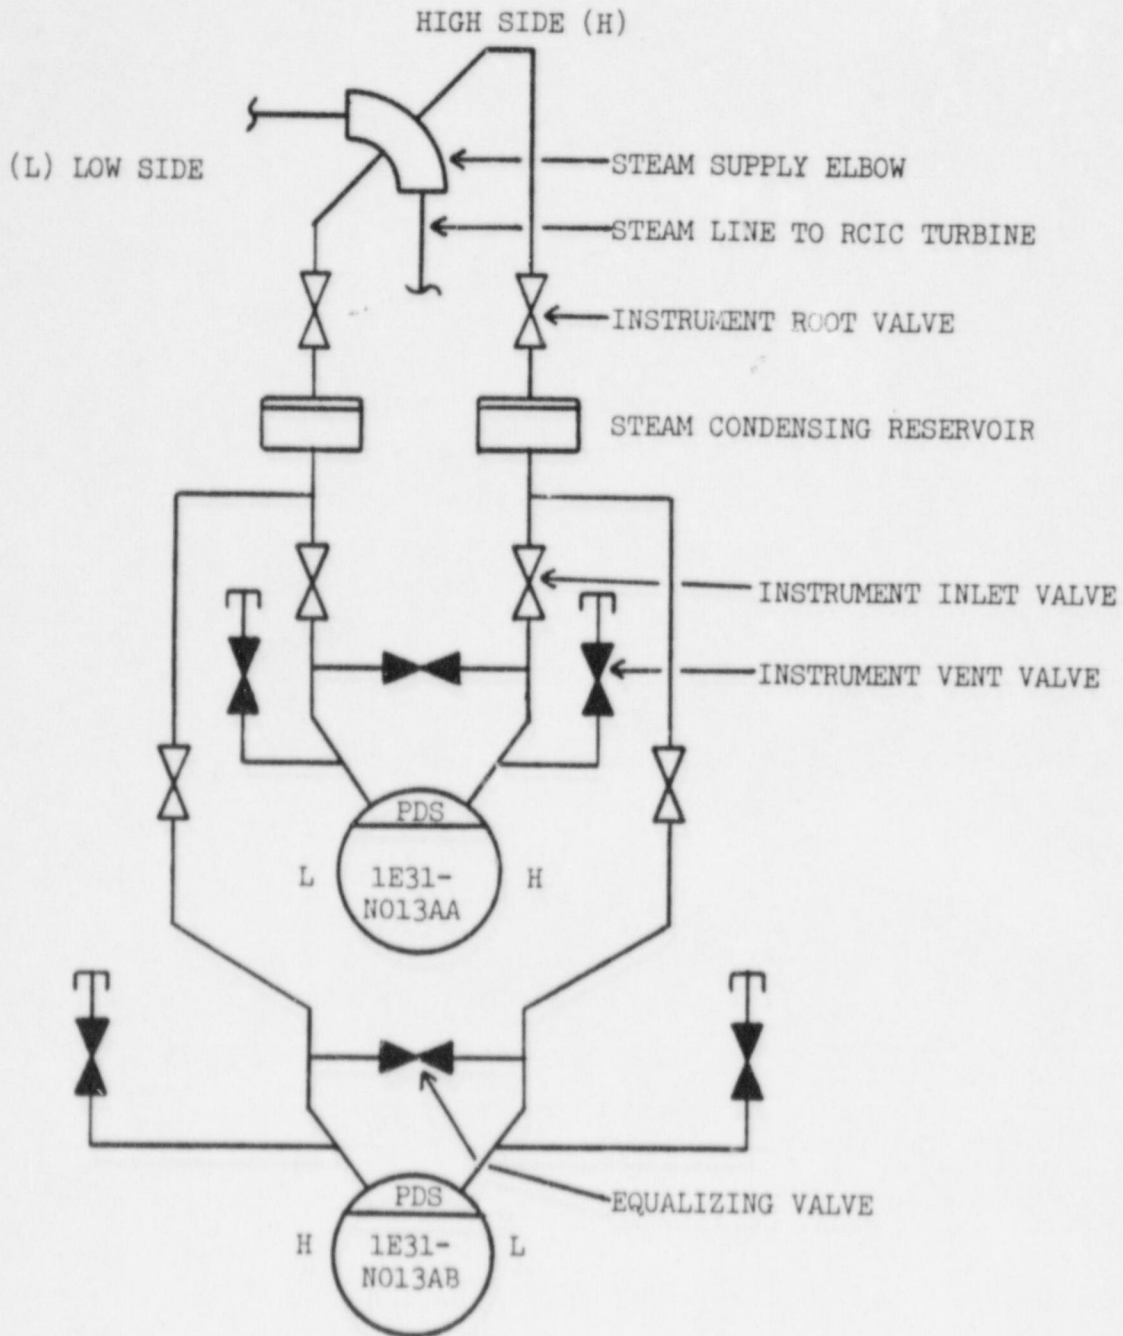
FIGURE 1

Between the hours of 1545 and 2225 on March 31, while testing PDS 1E31-N013AB, the Instrument Maintenance (IM) technician inadvertently partially drained the high side instrument line of the switch, which is also the low side instrument line of PDS 1E31-N013AA. (Note: The high side of 1E31-N013AA is piped to the low side of 1E31-N013AB. See Figure 1.) The amount of water drained from the instrument line was insufficient to cause PDS 1E31-N013AA or PDS 1E31-N013AB to trip on high differential pressure (166.4 inches water column increasing). The surveillance (LIS-RI-110) was completed at 2225 hours, and the IM technician notified Operating (shift) personnel and IM supervision of this fact. However, the IM technician failed to notify anyone that water had been drained from the instrument line. The IM technician thought the line would refill via the condensing chamber.

RCIC STEAM HI-FLOW DIVISION I ISOLATION

INSTRUMENT LINEUP
