WISCONSIN PUBLIC SERVICE CORPORATION

Docket 50-305
Operating License DPR-43
Kewaunee Nuclear Power Plant
Update to IE Bulletin 85-03 Response

- References:
- 1) I.E. Bulletin 85-03 - Motor Operated Valve Common Mode Failures During Plant Transients Due to Improper Switch Setting
 - 2) Letter from Mr. D. C. Hintz to Mr. J. G. Keppler, dated May 14, 1986
 - 3) Letter from Mr. Charles E. Norelius to Mr. D. C. Hintz, dated August 1, 1986

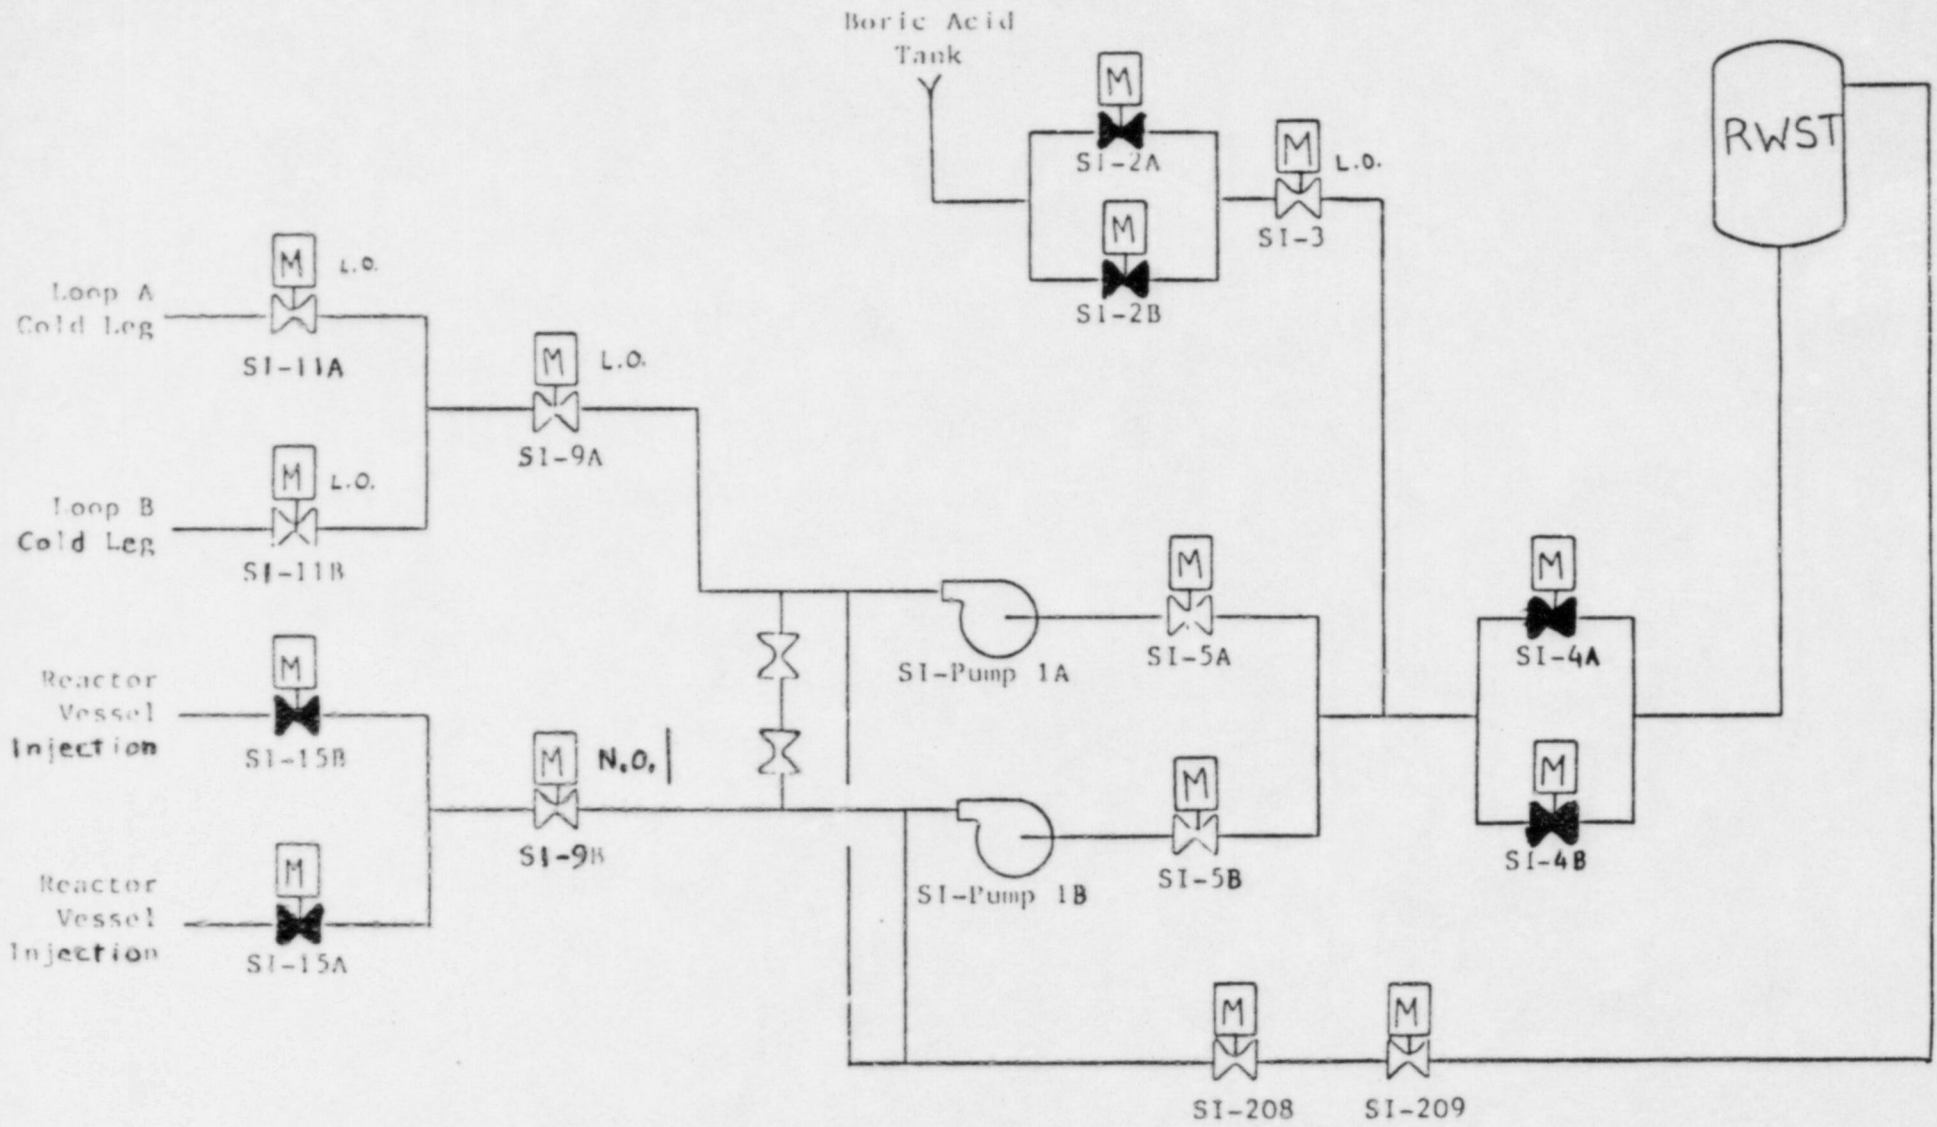
KNPP Safety Injection System
(Rev. 1)

Attachment I to this submittal contains a revised simplified drawing of KNPP's High Head Safety Injection System and should be used in place of the drawing contained in Reference 2. The valve SI-9B is a normally open valve but was inadvertently shown as locked open. This valve is not included in the scope of IEB 85-03. This submittal was delayed as agreed to by Mr. Greenman of NRC Region III staff. The extension was requested in order to allow my staff to perform a more comprehensive review.
