Enclosure 1
VP-86-0025
March 18, 1986
Page 1

REVISION TO DESCRIPTION OF DIESEL GENERATOR
BEARING RELIABILITY DEMONSTRATION
TEST PROGRAM

REVISION TO DESCRIPTION OF DIESEL GENERATOR BEARING
RELIABILITY DEMONSTRATION TEST PROGRAM
Table of Contents

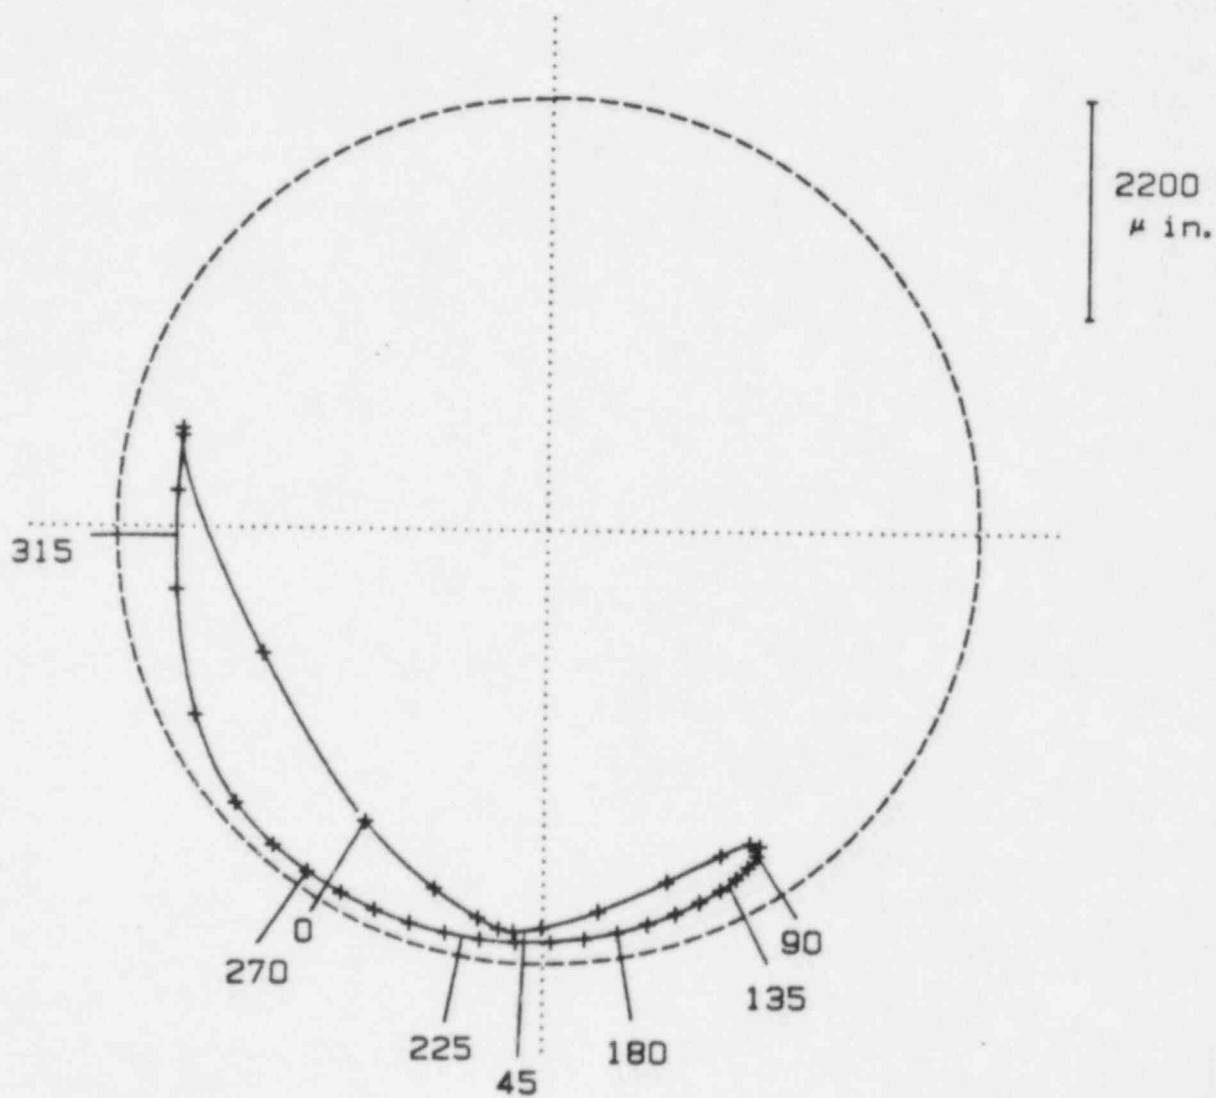
UPPER MAIN 1 (LOADED)
900 rpm/35 psi/170°F

THE MEAN OIL FILM THICKNESS IS .000407 INCHES

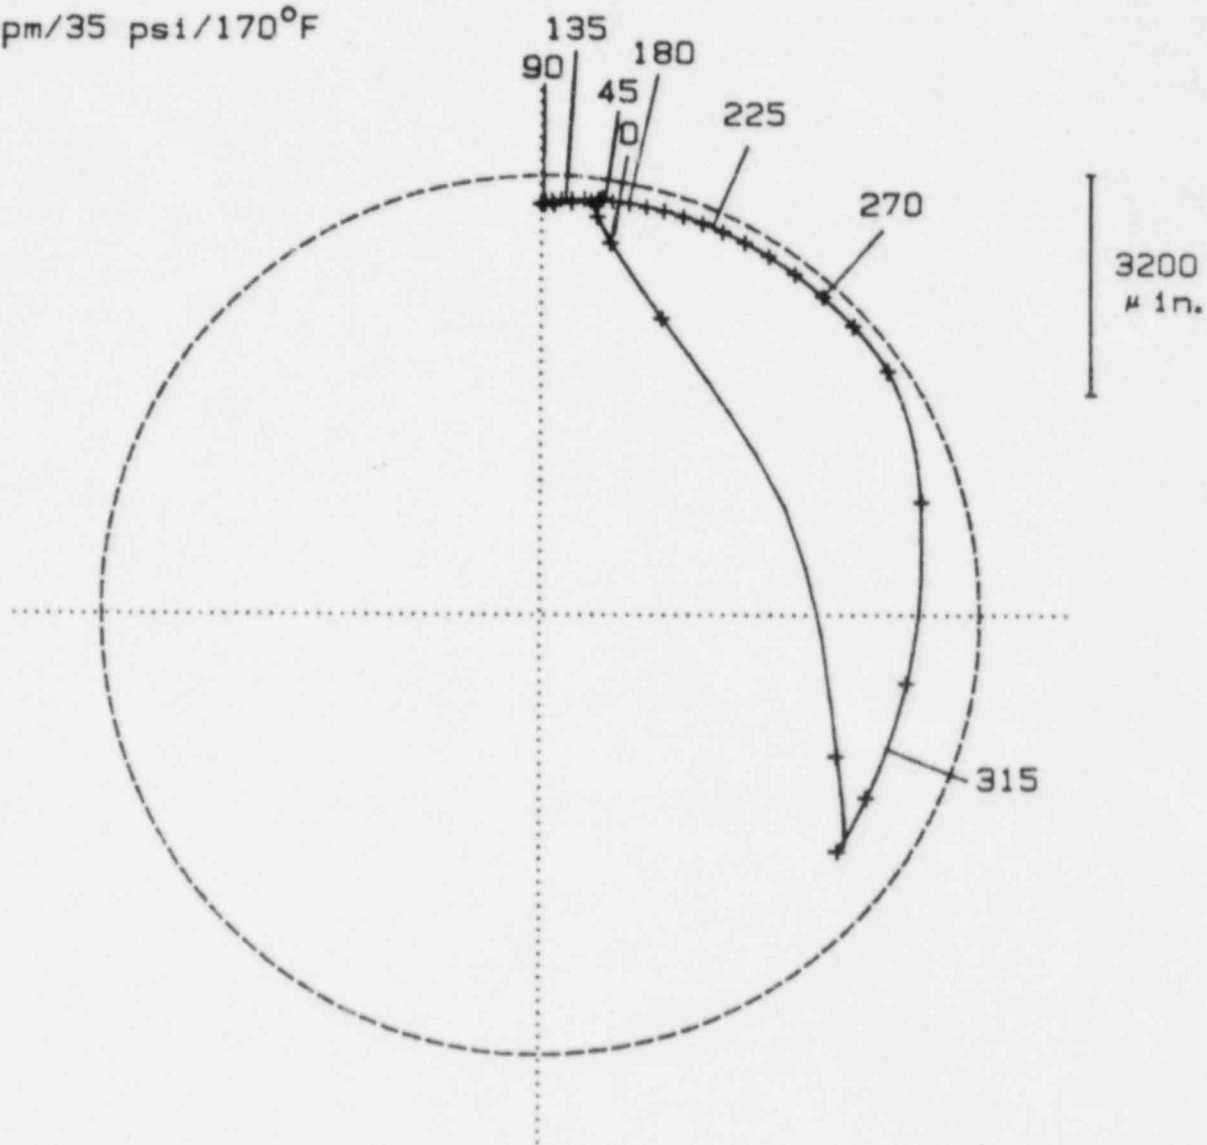
CON ROD (LOADED)
900 rpm/35 psi/170°F

THE MEAN OIL FILM THICKNESS IS .000469 INCHES

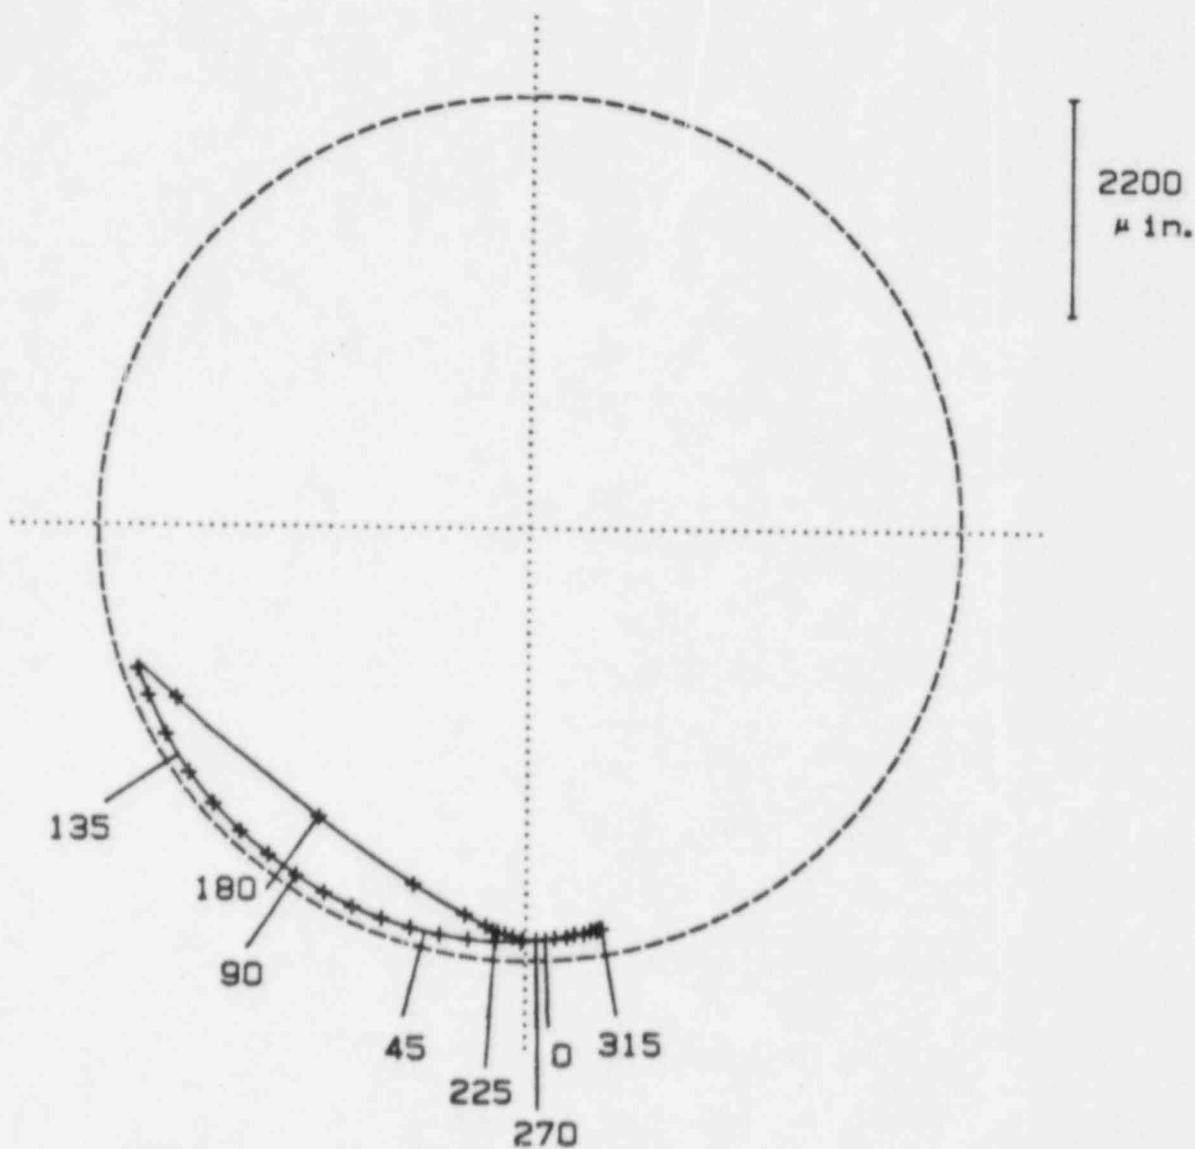
UPPER MAIN 4 (LOADED)
900 rpm/35 psi/170°F

THE MEAN OIL FILM THICKNESS IS .000246 INCHES
