L I C E N S E E E V E N T R E P O R T (L E P)

FACILITY NAME (1) Arkansas Nuclear One, Unit One

TITLE (4) High Pressure Reactor Trip While Troubleshooting the Integrated Control System

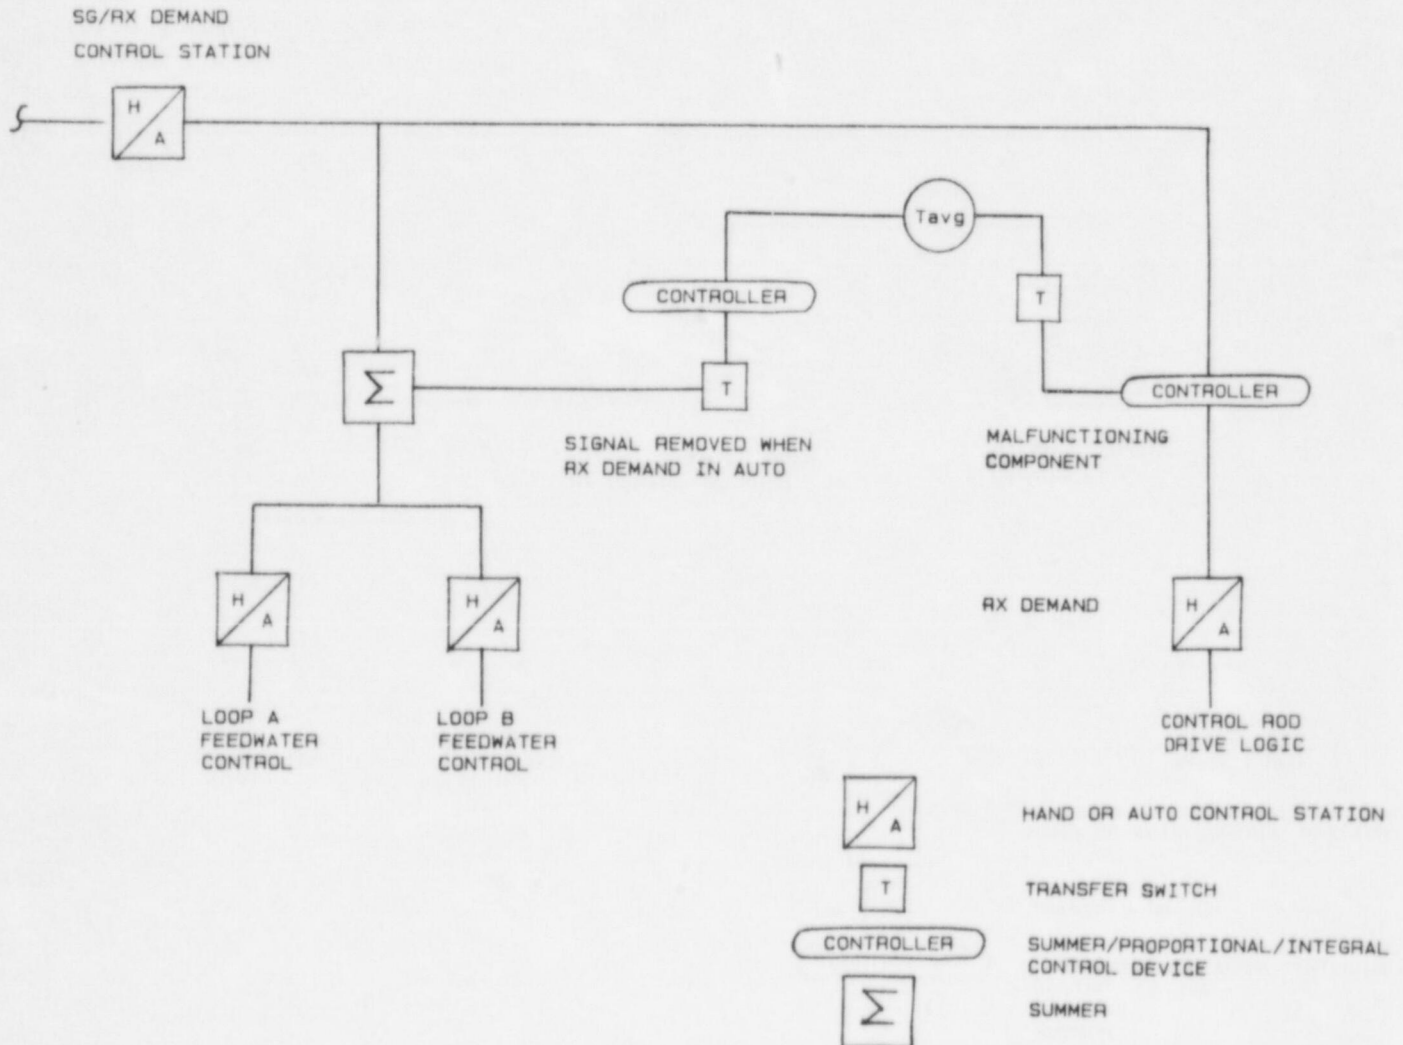
SIMPLIFIED DRAWING OF RELATED ICS CIRCUITRY

Integrated Control System (ICS) module C-46-6-12 which is a summer/proportional/integral unit (model no. 6624151A) in the RCS average temperature (Tavg) correction circuitry of the ICS associated with the reactor demand control station.

0508 hours. As a result of the problem with the reactor demand station, the ICS was operated with the SG/RX control station in manual. As power increased, a mismatch resulted across the FW control station, and a large Tavg to FW correction signal built in. This correction circuit provides for control of Tavg when the RX demand control station is in manual. At 0716 hours, when the RX demand station was placed in AUTO to aid troubleshooting, the Tavg to FW correction signal was removed. The removal of the correction signal caused the FW transient. A contributing cause of the FW transient was the fact that there is no direct reading for the correction signal. Placing the RX station in AUTO also induced a control rod withdrawal as previously experienced.

The failed ICS module was replaced and tested. Other similar modules were checked for proper operation and found to be operating properly. Operations crews were briefed on the problem in the feedwater correction circuit and the pitfalls of prolonged operation with the steam generator/reactor control station in manual.
