Radiological and Engineering Assessment

Vicinity Property No. DUR 028

FINAL
THE RADIOLOGICAL AND ENGINEERING ASSESSMENT
AND FINAL DESIGN

DU-028

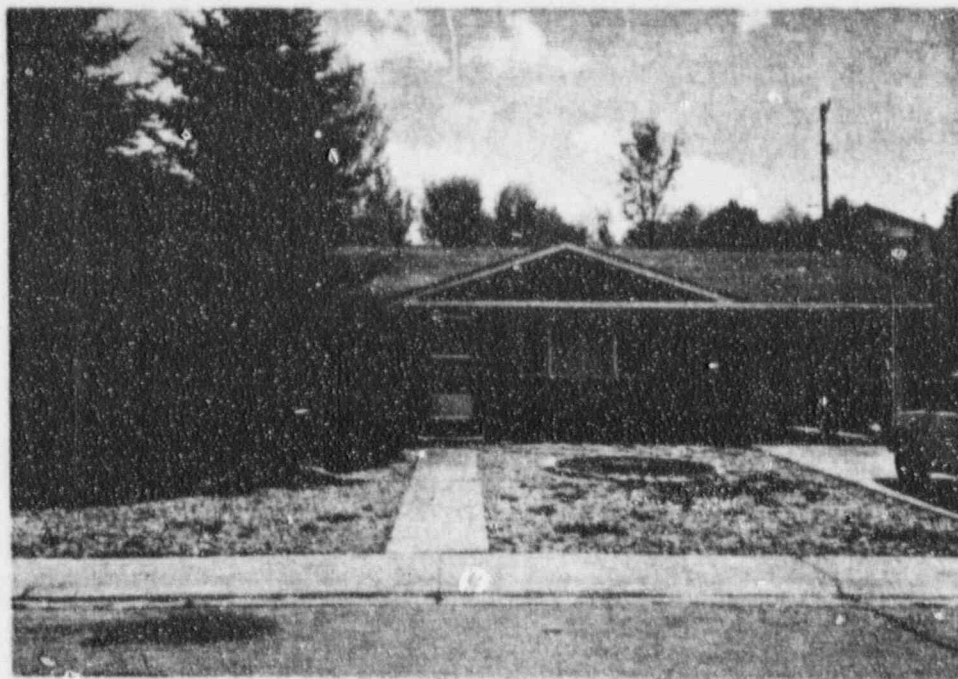
Front of House Looking East

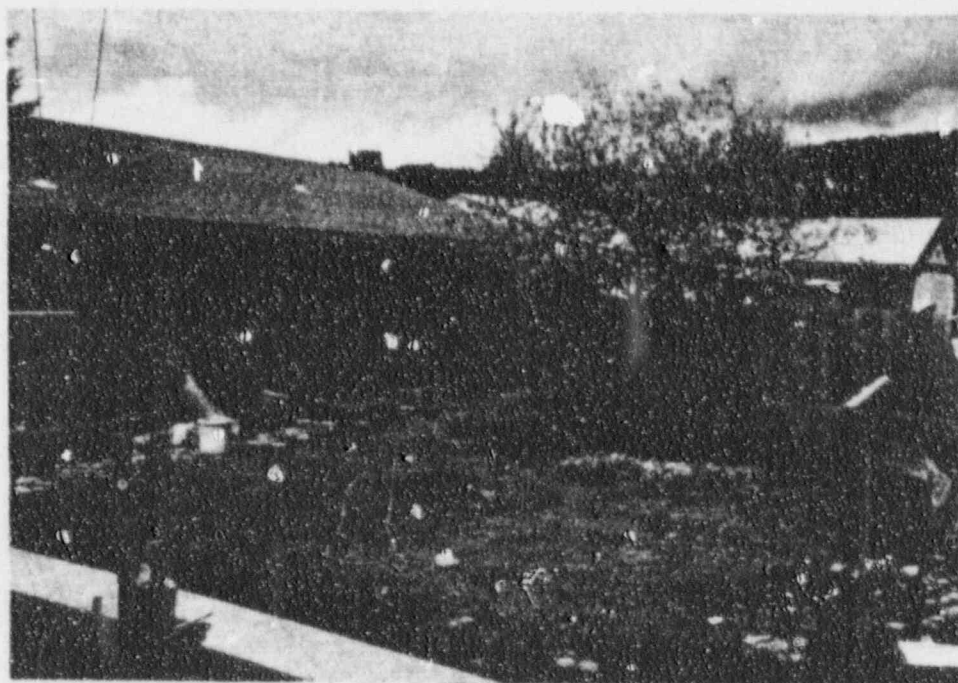
Rear of House Looking Northwest

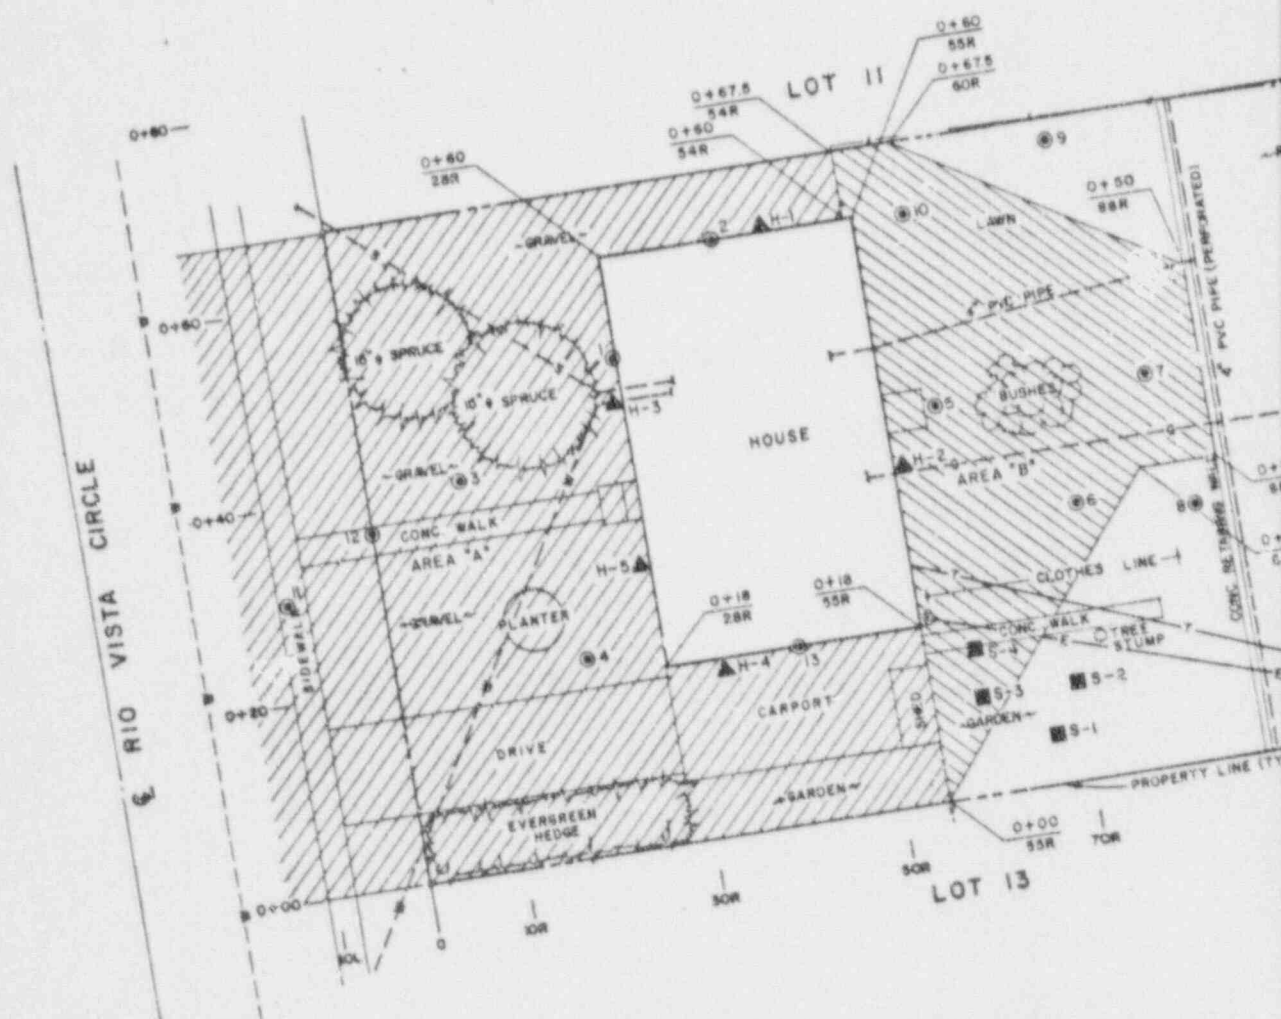
Contamination was found in 11 of the 13 outdoor holes augered. The location and depth of the contamination is described in Table 3.2 and is shown in Figure 3.1.

Two of the four shovel holes showed contamination. The location and depth of these holes are described in Table 3.3 and are shown in Figure 3.1.

Contamination was found in one of the five angled holes. This single contamination point was at the water line, where it enters the home. The other holes, all angled under the house, showed no evidence of contamination. The locations of these holes are described in Table 3.3 and shown in Figure 3.1.

As shown on Figure 3.1, Area A is contaminated to an approximate depth of 24 inches. Pockets of contamination may extend to 30 inches deep. Some excavation may be required in the utility trench under the house; however, this should not affect the foundation. The depth of contamination is difficult to estimate accurately, since the rocky soil makes it impossible to drill below the contamination in most locations.

The approximate depth of contamination in Area B ranges from 30 inches deep near the east (back) wall of the house to 6 inches deep near the concrete retaining wall.
