Draft Radiological and Engineering Assessment

Vicinity Property No. 032

DRAFT
THE RADIOLOGICAL AND ENGINEERING ASSESSMENT
AND FINAL DESIGN
FOR
PROPERTY
DU-032
February 27, 1985

Property DU-032 is a private residence located at 460 San Juan Drive, Durango, CO.

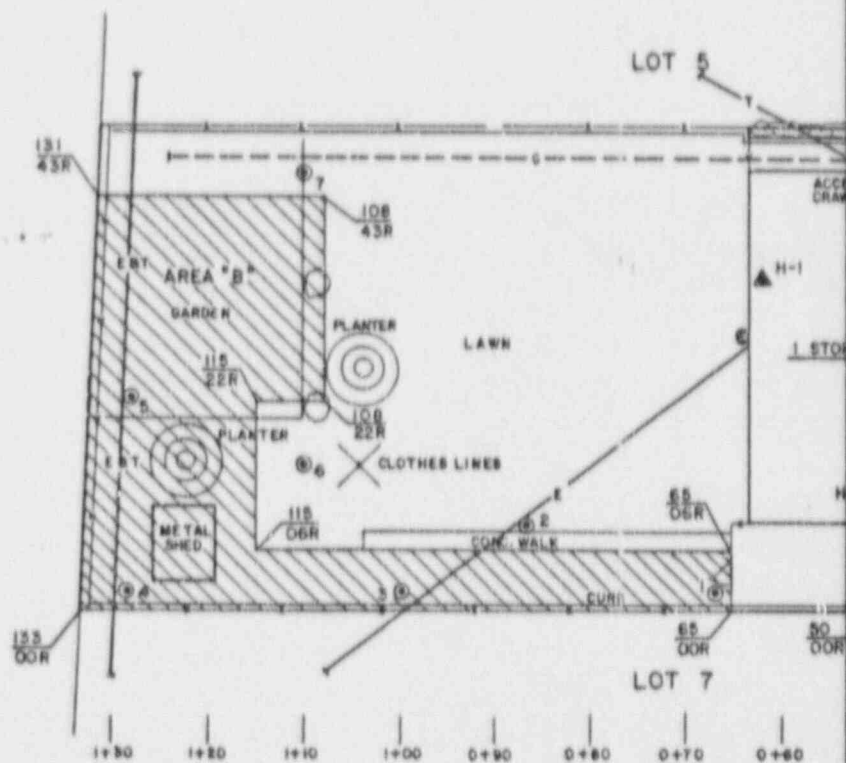
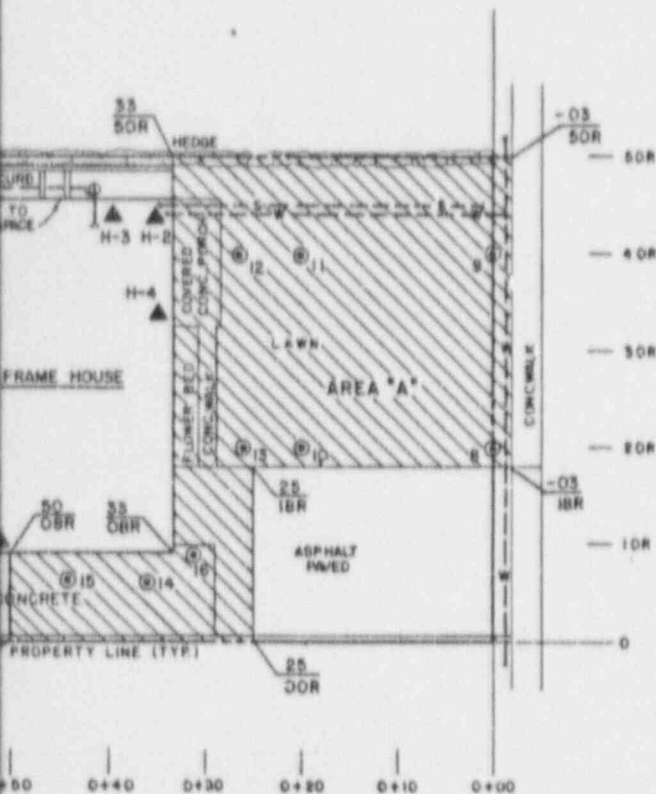
FIGURE 3.1

Contamination was found in 11 of the 16 outdoor holes augered. The location and depth of the contamination is described in Table 3.2 and is shown in Figure 3.1.

Two areas of contamination were identified in the survey.

Area A has an estimated depth of contamination of 18 inches, but could be 24 inches in some locations. Contamination above guidelines could exist underneath the paved driveway, but this has not been determined. When Area A has been excavated, the walls of the driveway should be checked; if contamination is present, the driveway also should be added to Area A.

Area B is in the rear of the property and has an estimated depth of contamination of 18 inches.
