Draft Radiological and Engineering Assessment

Vicinity Property No. DUR 202

THE RADIOLOGICAL AND ENGINEERING ASSESSMENT
AND FINAL DESIGN

DU-202

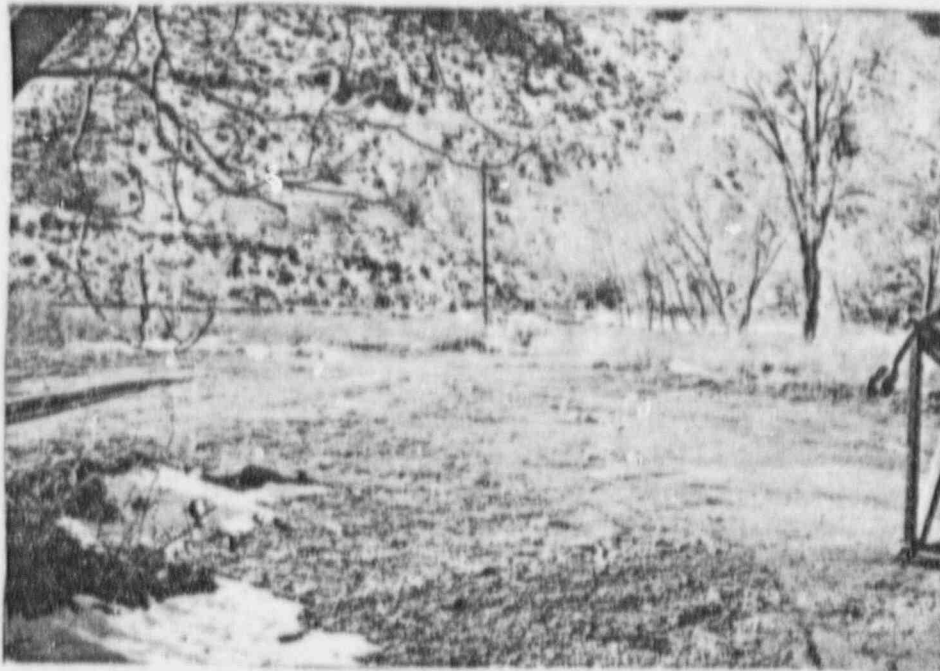
Park Area Looking Northwest

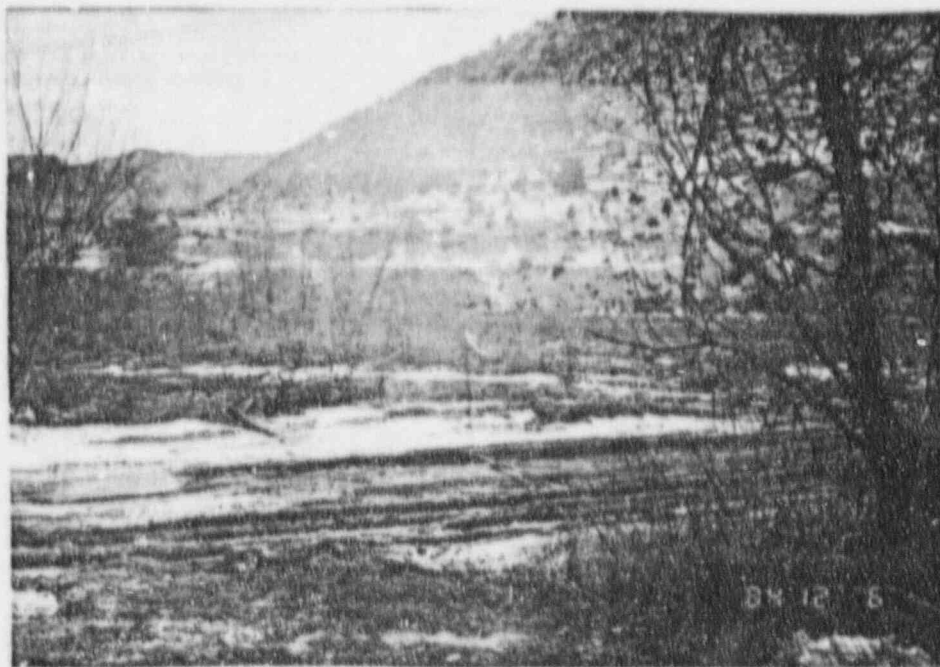
Park Area Looking West

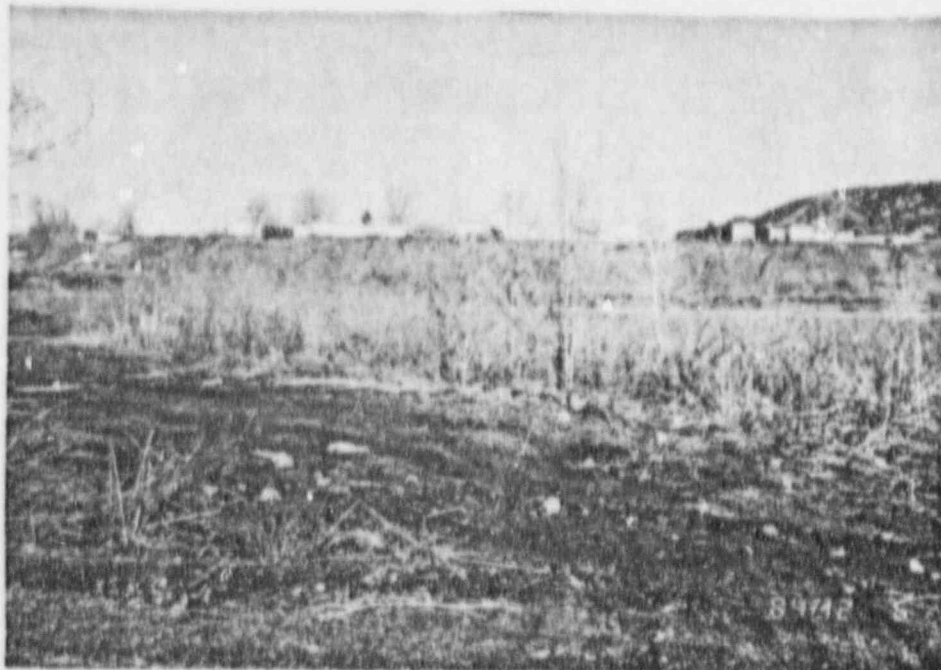
Park Area Looking East

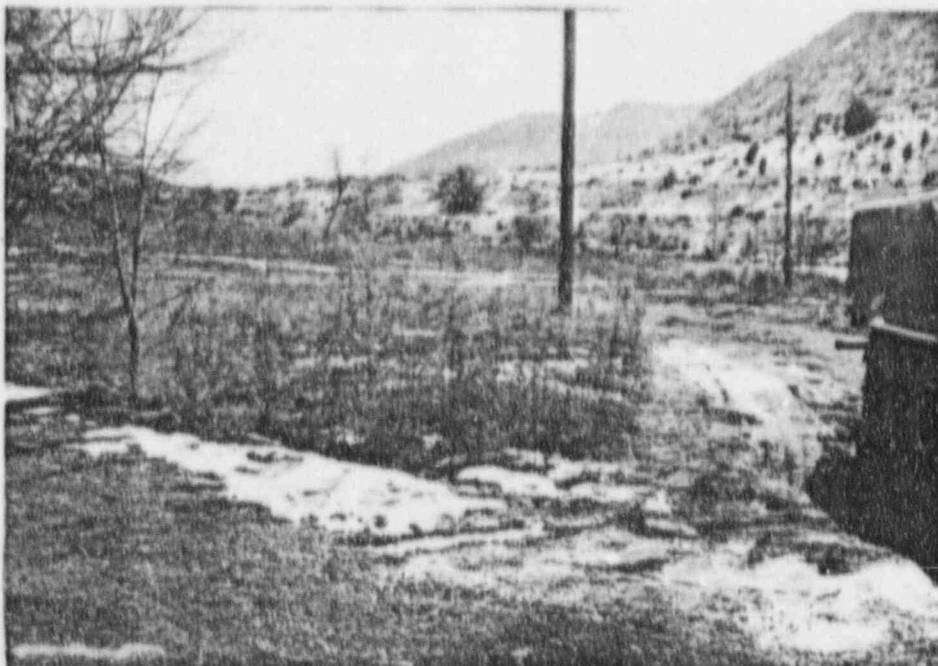
Park Area Looking South West

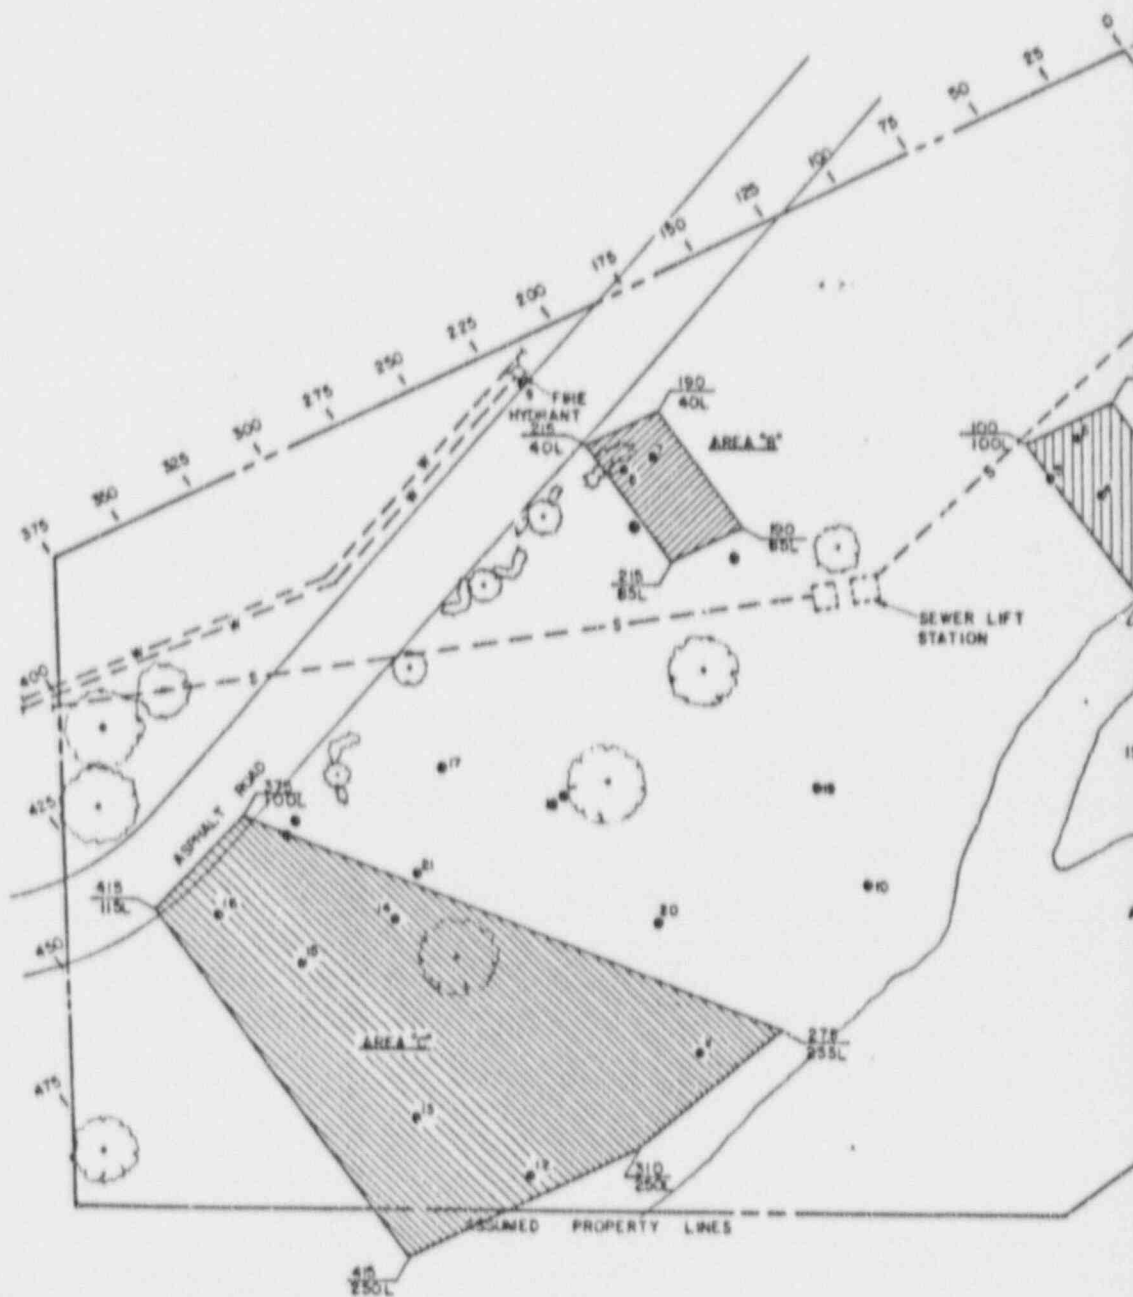
Surface gamma readings on the property, as shown in Figure 3.1, range from 15 to 35 micro R/hr. This may be compared with the background for the Durango site of about 12 micro R/hr.

Contamination was found in 9 of the 21 holes augered. The location and depth of the contamination is described in Table 3.1 and is shown in Figure 3.1.

Three distinct areas of contamination were identified in the survey. Area A has an estimated depth of contamination of 30 inches below the surface but it may be deeper closer to the river.

Area B has an estimated depth of 6 inches.

The largest of the three contaminated areas in the park region is Area C. The estimated depth of contamination in this Area is 12 inches, with possibly some pockets of contamination as deep as 24 inches.

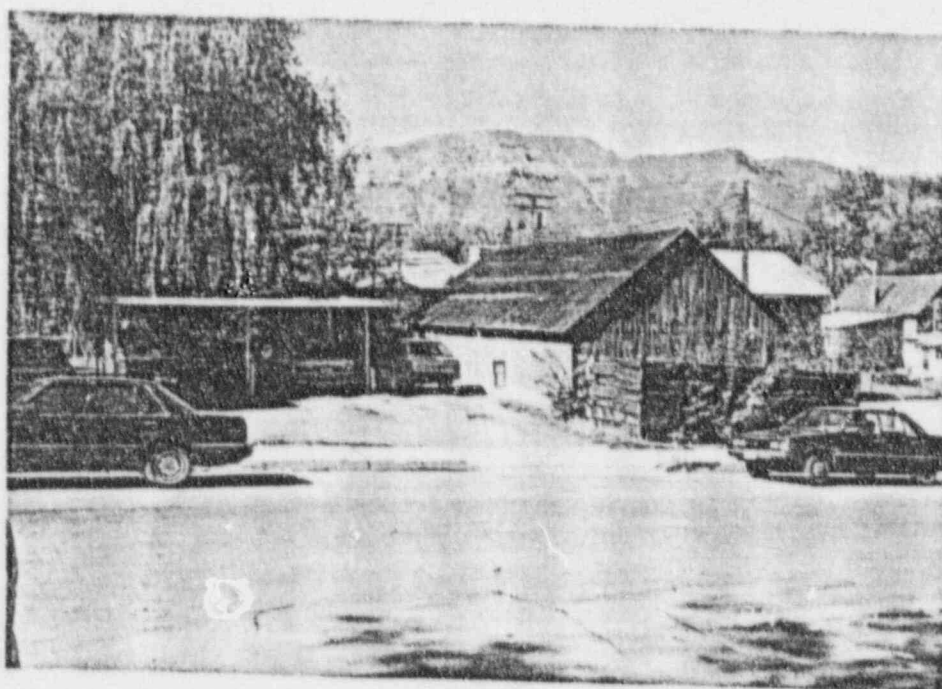
Fenced Storage Area Looking West

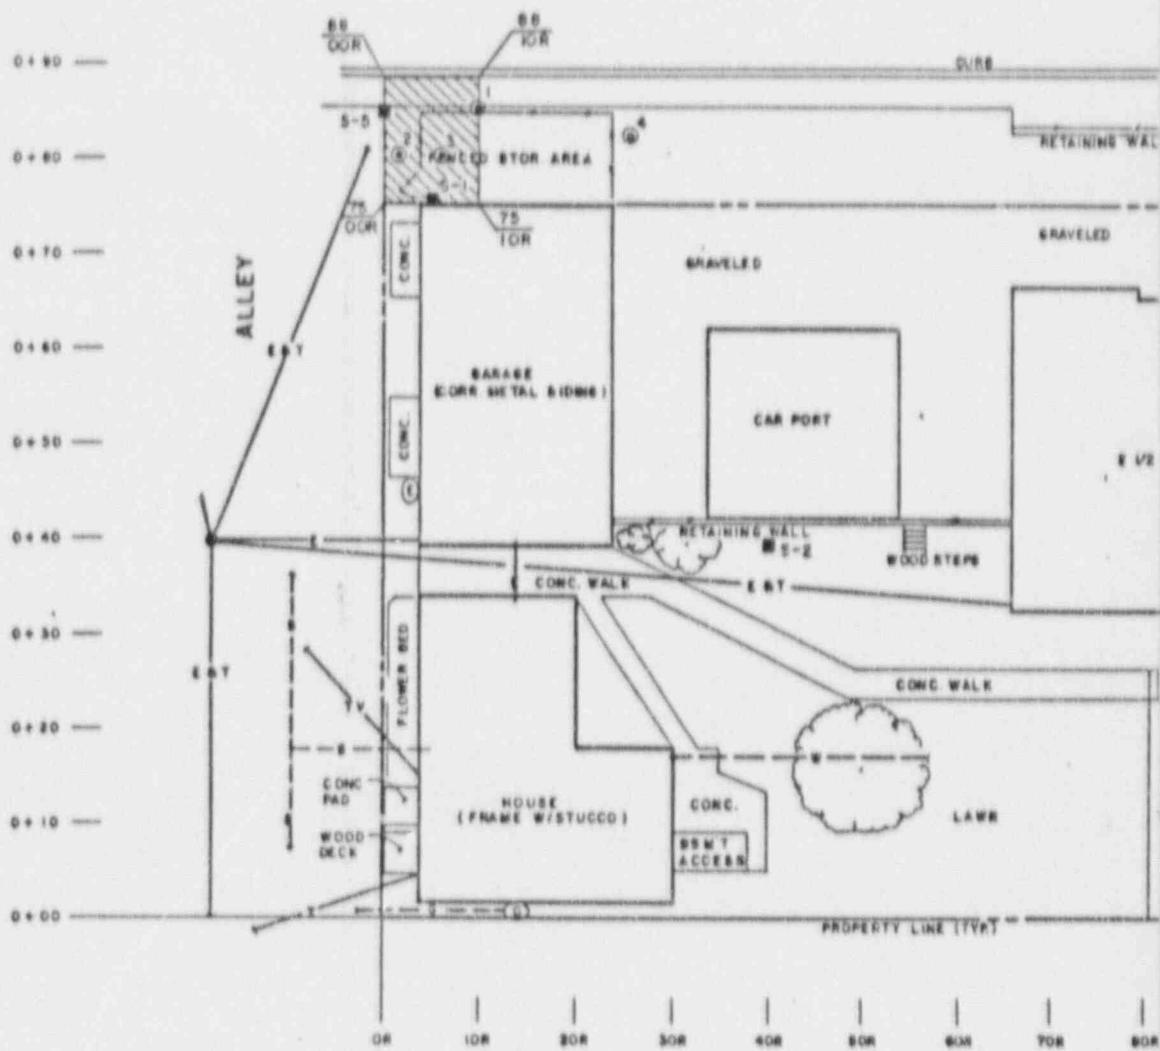
Contamination was found in 2 of the 4 outdoor holes augered. The location and depth of the contamination is described in Table 3.3 and is shown in Figure 3.1. Contamination was also found in one of the 7 shovel holes. Table 4 describes the location and depth of the contamination and of all shovel holes; these holes are shown in Figure 3.1.
