Radiological and Engineering Assessment

THE RADIOLOGICAL AND ENGINEERING ASSESSMENT

DURANGO PROPERTY

May 10, 1985

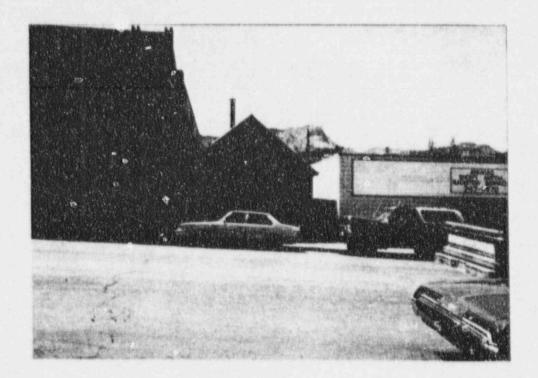
Front of Property Looking West

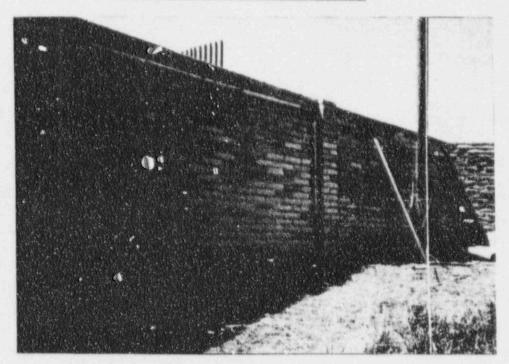
Rear of Property Looking Northwest Figure 2.3 Property Photos

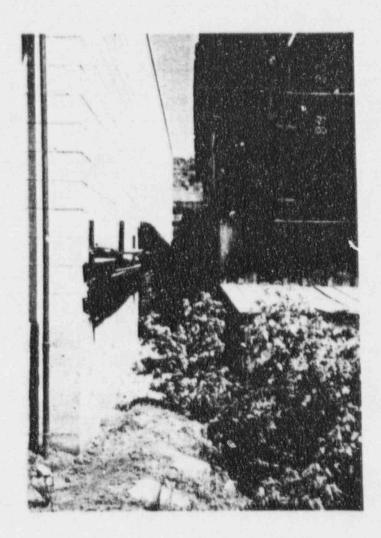
North Side of Building Looking East Figure 2.5 Property Photos

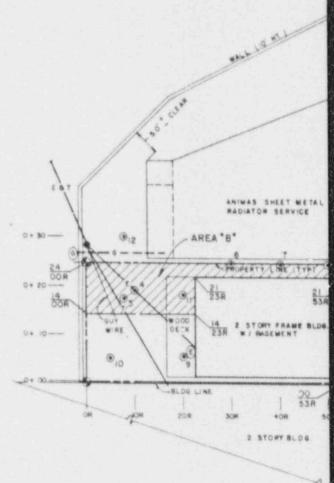
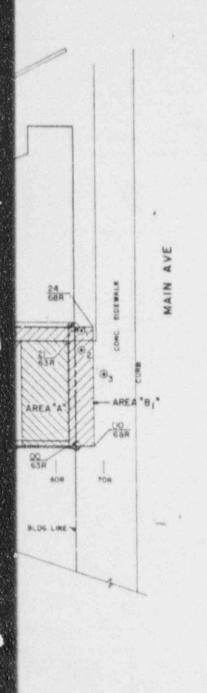
Contamination was found in 7 of the 12 outdoor holes augered. The location and depth of the contamination is described in Table 3.3 and is shown in Figure 3.1. Boreholes were augered on three sides of the building, as shown in Figure 3.1. It was physically impossible to get the auger into the narrow passageway south of the building. However, gamma readings here were 14-17 micro R/hr, and it is not likely that contamination is in this area. Large rocks prevented drilling through the vertical extent of contamination. The maximum depth attainable was 17 inches, and the gamma reading was still increasing. It is likely that contamination extends to a depth of 30 inches or more.

Two contiguous areas of contamination were identified in the survey.

Area A, Figure 3.1, is located in the eastern portion of the building basement. This area consists of tailings from the outside to the east where fill was placed under the street and sidewalk. The tailings have come in through the deteriorating foundation of the building. Contamination is visible in piles 6-12 inches in depth. While it is likely that none of the contamination is below the original floor level, the engineering estimate should allow for approximately 6 inches of excavation.

Area B is the outdoor contaminated area. The depth of contamination east of the building is at least 18 inches and could be 30 inches or more. Along the side of the building and in back the estimated depth of contamination is 18 inches. (For quantity estimates, a depth of approximately 30 inches should be used in Area B).
