Re: License No. 37-17860-01

PermaGrain Products is pleased to report that we returned to full production operation at 6:00 a.m. on June 4. There was no release during this period of time of chemical contaminants or radioactive material to the environment. Per the request of your Inspector, Mr. Frank Costello, the following will summarize the incident.

At 8:05 on the evening of May 31, the Quehanna production facilities were subjected to the forces of a wide group of tornadoes. To ease the explanation, I will first refer to Figure 4.1. The group of the tornadoes were flowing from west to east. The swath pattern was approximately 1.5 miles wide. The northern edge of the swath was approximately 300 yards from the lobby entrance on the far side of the home of the resident Vice President of Manufacturing, Mr. Larry Griest. As indicated previously, the tornado direction is west to east. On the west end of the building, the wall near the word "open" was torn off with an area of approximately 8 feet wide, 30 feet high. The roof over this entire process area was damaged so that it was leaking. The wall in the conference room on the west end, and the woodworking shop wall were penetrated.

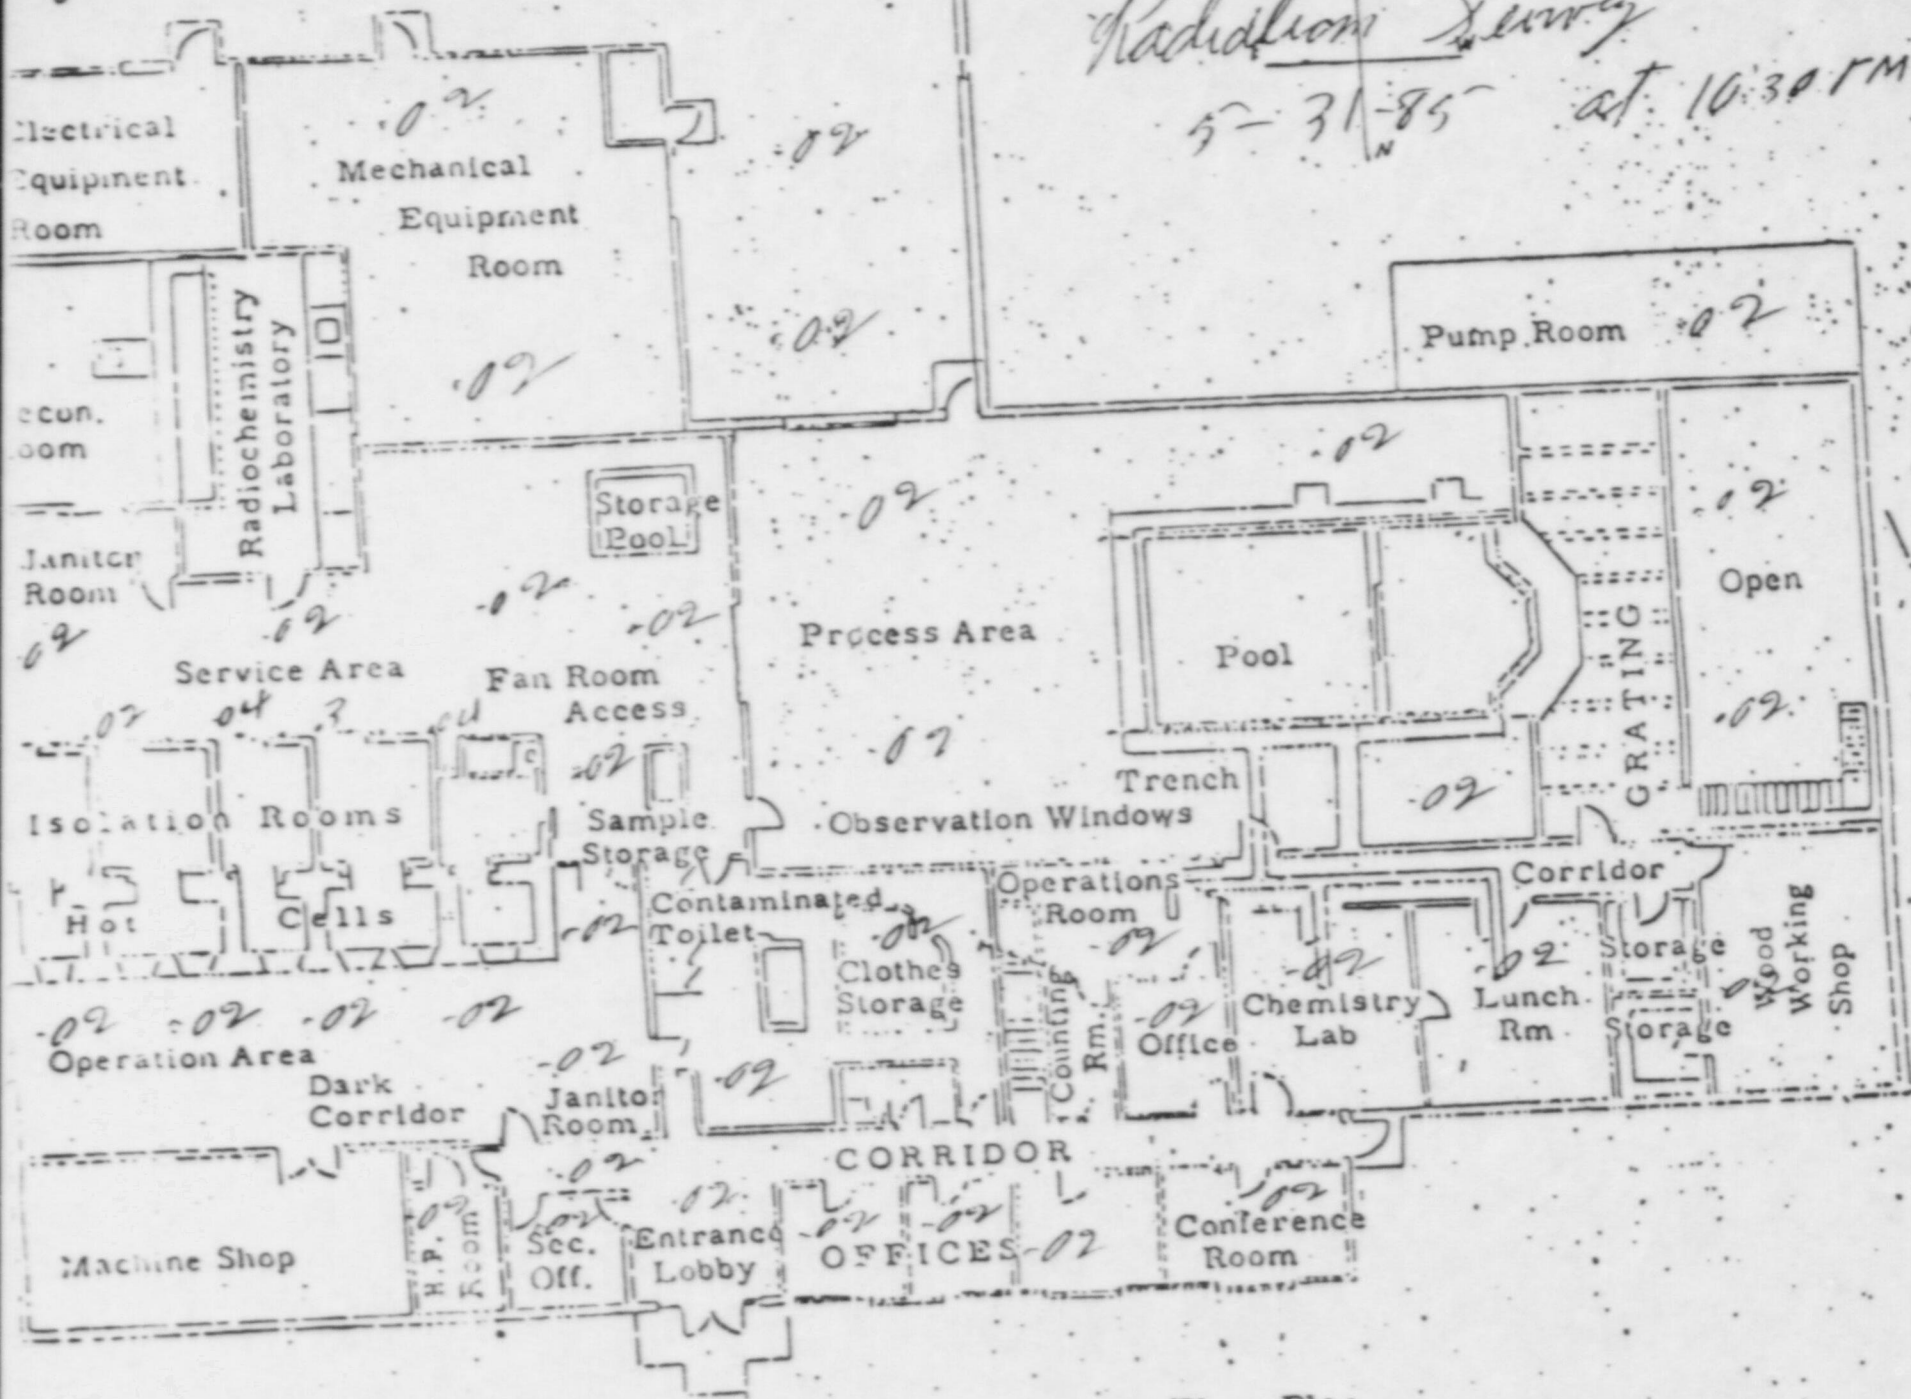
*All readings in Mv/Hr  
Radiation Survey*

*5-31-85 at 10:30 PM*

San Francisco Survey 6-1-85  
GROUND ELEV. 66.0 07:45 AM

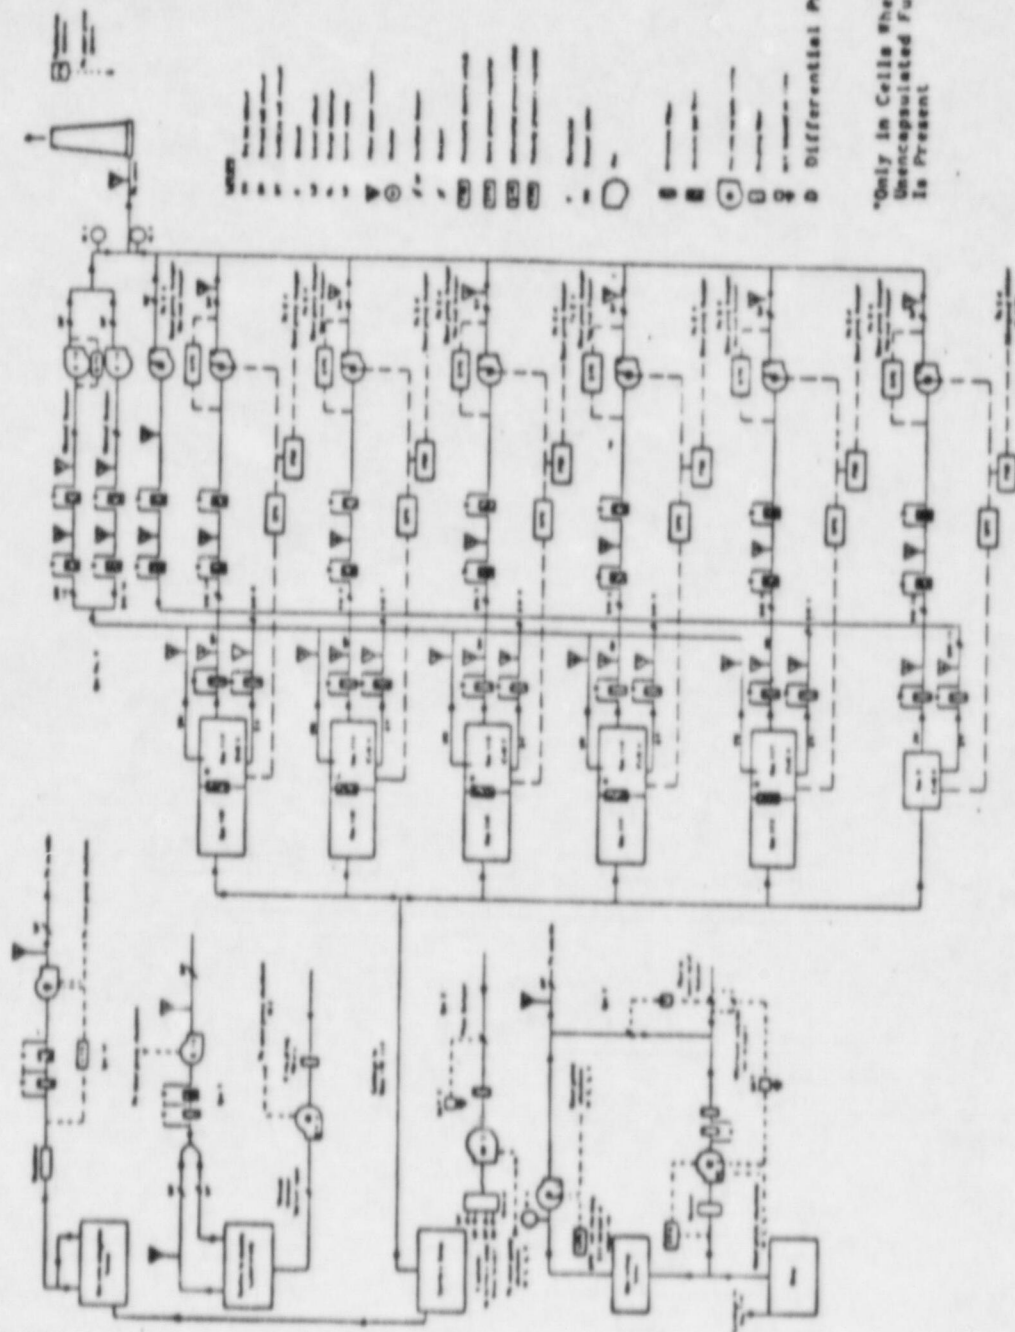
Figure 8.2. Air Ventilation System.

On Saturday, June 1, PermaGrain staff began cleanup operations. We were inspected by Roger Grimm at the request of D.E.R. At approximately 1:30., Mr. Frank Costello of the N.R.C. inspected the facilities. During this inspection, Mr. Costello discussed our overall response plan and activities in some detail. He did express some questions relative to our ventilation system. Figure 8.2 from our license is attached. This attachment shows the location of the cell 3 final filter, as well as the flow throughout the system. Mr. Costello was concerned over the fact that there was a negative pressure reading across this filter. Thus, we agreed to pull this filter as soon as possible and check for damage. Based on our other radiation instruments, as well as the radiation surveys, we were confident that this filter had not been breached, but due to the fact there is very little particulate in

this cell, this filter effectively has no film buildup, and thus, the readings of the pressure drop across it are extremely low and basically unreadable. Attachment 3 is the summary from the Health and Safety Supervisor. This filter was removed on June 4 and replaced. It was visually inspected and found to be intact. There was no radiation level on the face of the filter. This filter is being stored for examination by the N.R.C. if desired.

Radiation Work Permit was received June 4, 1985 at 11:00 A.M. to replace Cell #3 Final Filter. No radiation level recorded using Eberline Geiger Counter E-400 on face of filter. Filter was double bagged when removed from housing and placed in Decon. Room for inspection. Filter is in good condition.
