Entergy Operations, Inc.  
1448 S.R. 333  
Russellville, AR 72801  
Tel 501 858-5000

Subject: Arkansas Nuclear One - Unit 2  
Docket No. 50-368  
License No. NPF-6  
2P99 Steam Generator Tube Inspection

## **2P99 STEAM GENERATOR TUBE INSPECTION**

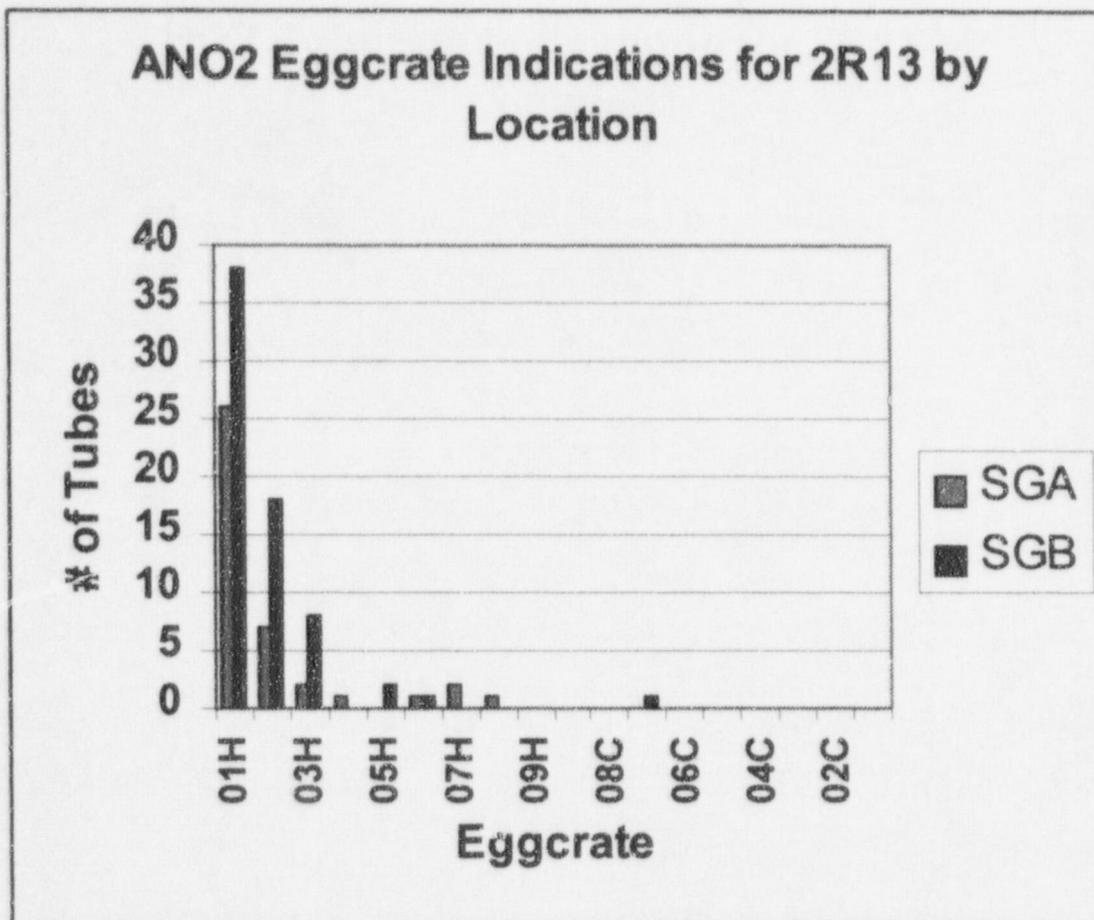
Figure 1

A review was performed to identify the locations of the indications detected in the previous inspection (2R13). As shown in Figure 1, the majority of the indications at the TSPs have been found in the lower sections of the hot leg side of the SG. This is due to the higher temperature effect on the flaw initiation and growth rate. The 2R13 inspection results are consistent with those of previous inspections. Because the lower hot leg tube sections have had the majority of axial indications, as well as the largest indications, these areas are of primary interest for the mid-cycle inspection. The inspection scope was conservatively modified to include inspection of the tubes to just above the seventh TSP.

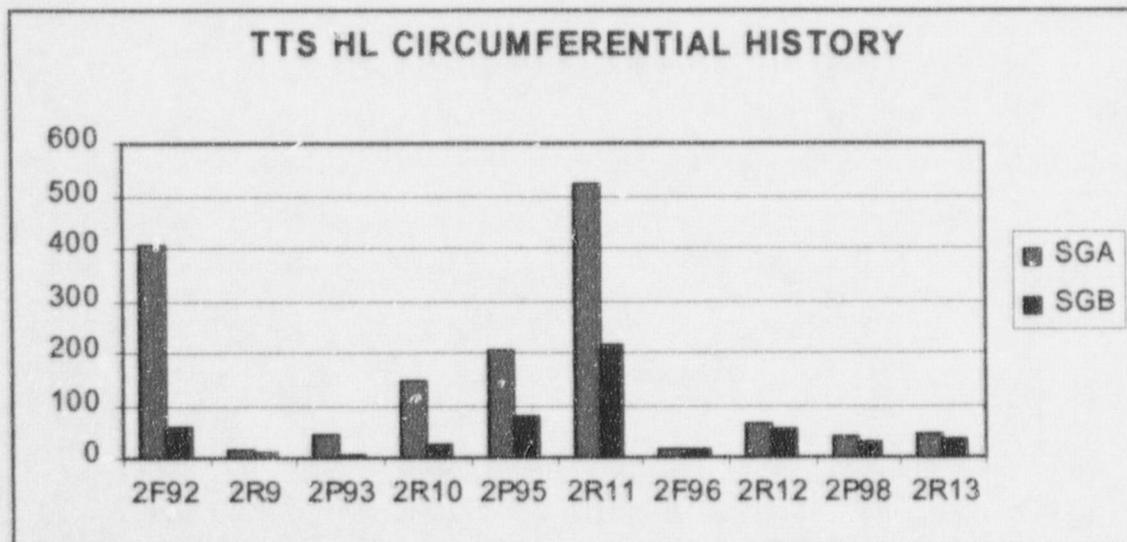
The ten TTS inspections performed over a seven-year period have yielded an extensive database. Circumferential cracking generally has shown a decreasing trend and has stabilized to a minimal value as noted in Figure 2 below. The cracking, as mentioned earlier, is associated with the kidney shaped sludge pile (see attached tubesheet map). The circumferential indications found to date have been primarily located at the edge of the sludge pile region concentrated around the stay cylinder. The sludge pile is actually two separate piles that form the lobes of the kidney. A large number of indications have been found at the edges of the two lobes. However, the indications at the edges of the lobes have been smaller than the flaws identified in the two areas on the right and left side of the stay cylinder (sample plan). Based on using PDA and evaluating the flaw morphology, the area between the lobes, as well as the center of the lobes (deep sludge pile), have a lower probability of developing a large flaw than the sample plan areas. The sludge pile has been monitored based on eddy current techniques and visually by sludge lancing equipment. Historically, the indications have developed at the edge of the kidney and moved only slightly toward the divider plate and stay cylinder. Since 1994, there have been no circumferential indications identified and in-situ tested that have leaked or burst. The last ANO-2 inspection included 100% of the inservice tubes. The operational assessment performed following this inspection determined that full cycle operation would not result in an unacceptable risk to the public health and safety as a result of circumferential flaws.

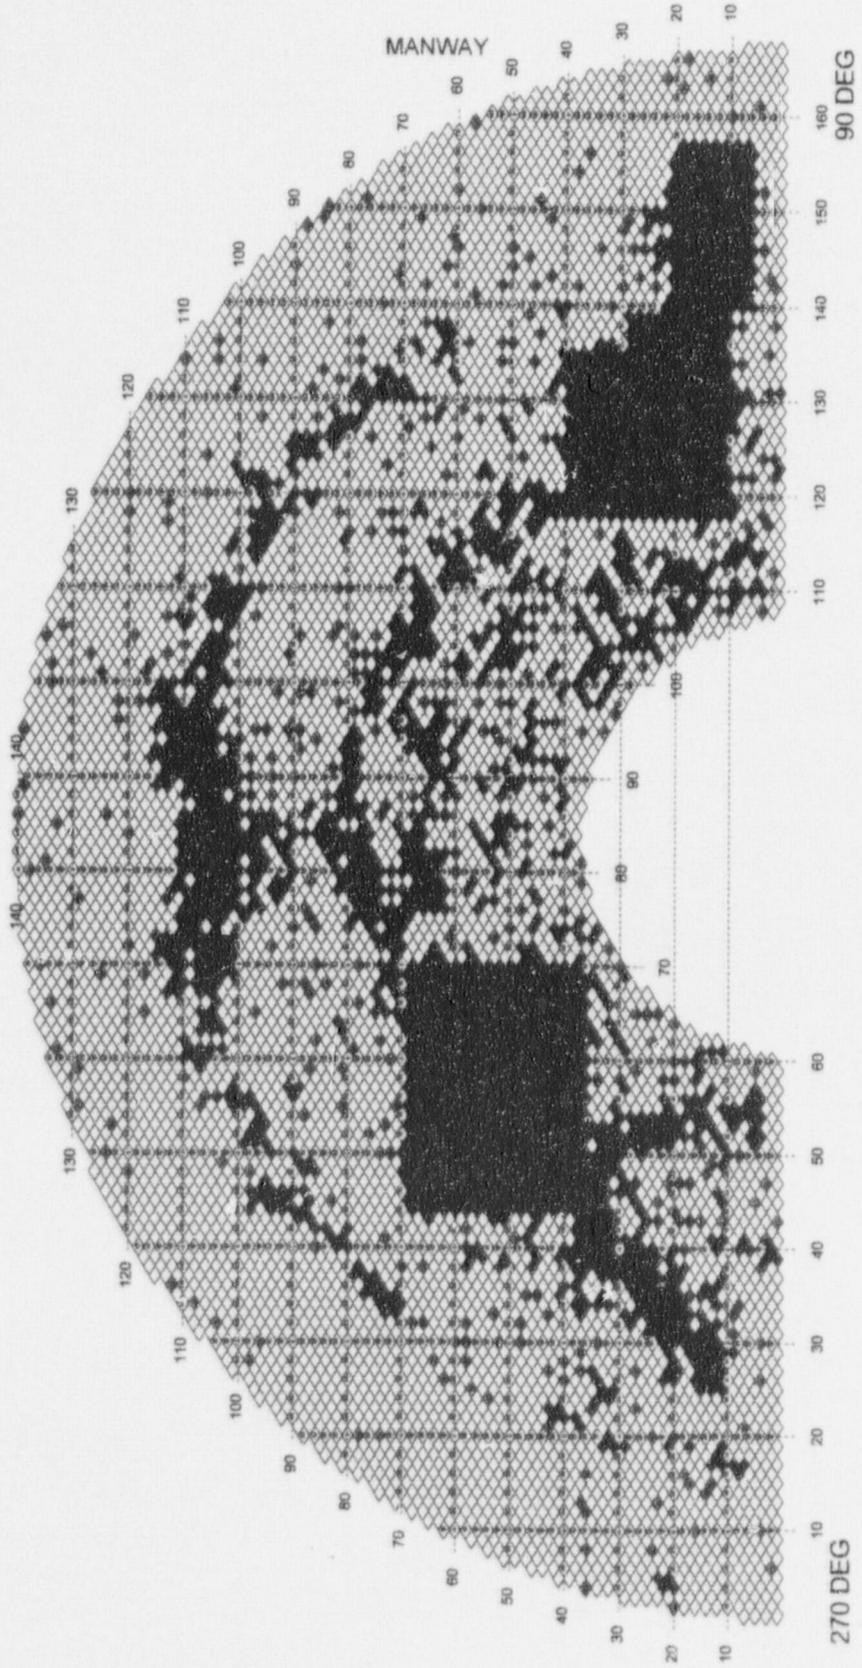
S/G A  
INLET  
PRIMARY FACE

Within the sludge pile region, two areas in the "A" SG have produced the largest circumferential cracks. An inspection plan was developed that includes these areas. Each area was chosen based on a bounding inspection of the region containing the large flaws. Taking the largest cracks (structural challenges and those that leaked at main steam line break conditions) from the 1992 and 1994 inspections and bounding them by 4 tubes would result in all the flaws  $\geq$  50 PDA since the 1992 inspection being contained. Additionally, the largest flaws identified in the most recent inspection (2R13), which were between 40 and 50 PDA, would also be bounded by this area. For the 2P99 inspection, the boxes were expanded to provide a buffer zone of at least two tubes around the previous large flaws. The area toward the divider plate and stay cylinder have been expanded also to accommodate the potential movement of the indications.

The attached tubesheet map of the inspection plan shows the planned inspection locations. The blue areas show the tubes to be inspected. Red areas show the location of tubes which have been previously in-situ tested due to the largest identified circumferential flaws. Green areas represent tubes either sleeved or no longer in service.
