U. S. NUCLEAR REGULATORY COMMISSION

Report No. 50-311/86-26  
Docket No. 50-311  
License No. DPR-75  
Licensee: Public Service Electric and Gas Company  
80 Park Plaza  
Newark, New Jersey 07101  
Facility Name: Salem Nuclear Generating Station - Unit 2  
Inspection At: Hancocks Bridge, New Jersey  
Inspection Conducted: August 26, 1986 - August 30, 1986

Areas Inspected: This special inspection was conducted to evaluate a reactor trip with safety injection compounded by a false loss of offsite power (blackout) signal. The inspection team members reviewed licensee actions during and subsequent to the event.

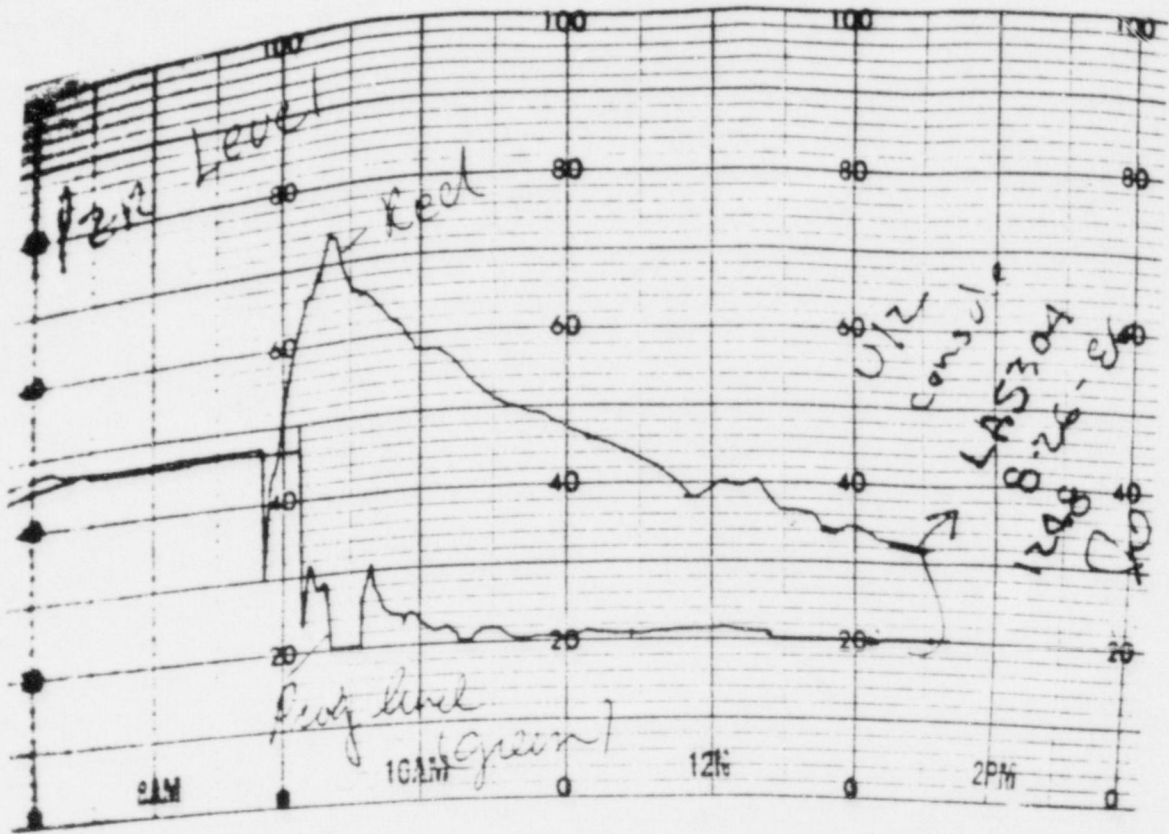
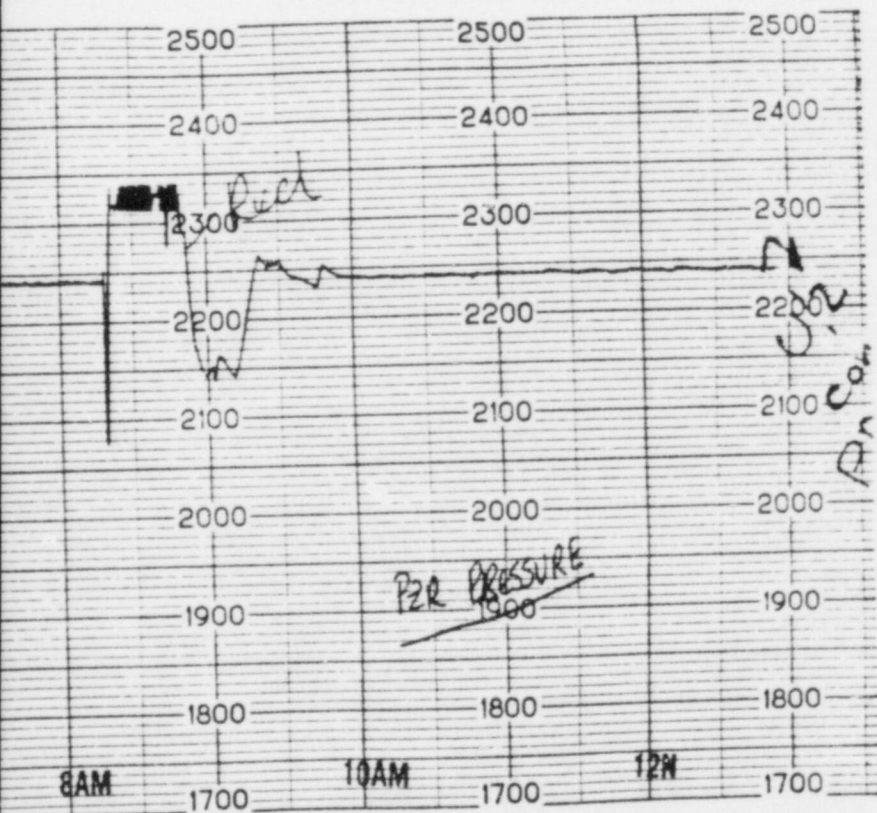
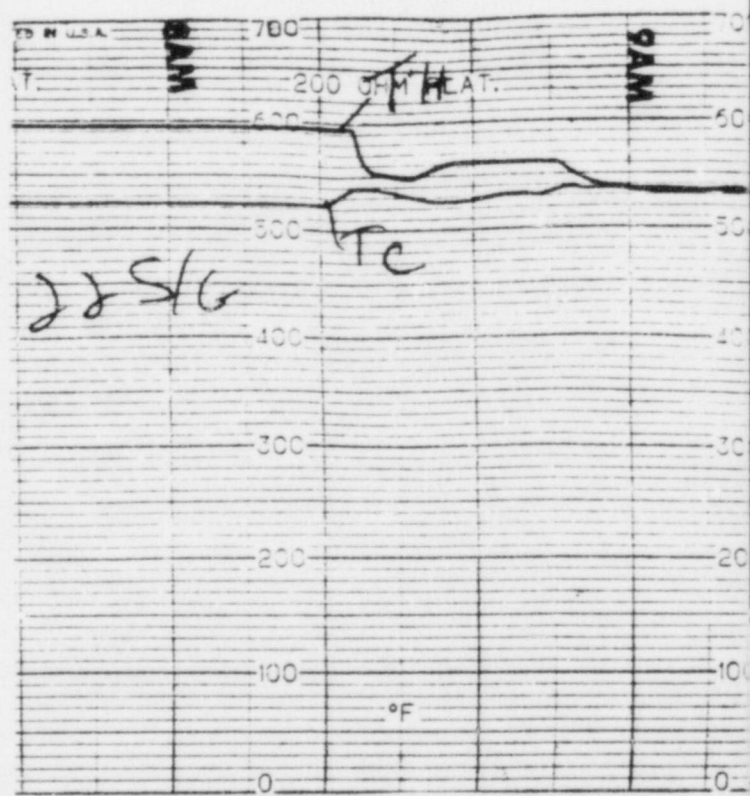
# FIGURE 1 REACTOR COOLANT SYSTEM PARAMETERS

Figure 1 is the Control Room recorder traces for a) Pressurizer Pressure, b) Pressurizer Level and c) typical Reactor Coolant System loop temperatures. The pressure trace shows the initial safety injection, a lift of the pressurizer Power Operated Relief Valve (PORV), a period of stable pressure, then pressure control by means of numerous actuations and resets of the PORV. Termination of SI about 21 minutes after event initiation appears as a downward pressure spike with recovery to the PORV control band. The turning off of the RCPs and the establishment of natural circulation can be clearly seen from the RCS loop temperatures; the hot and cold leg temperatures converge as forced circulation ceases, then diverge to about 30 F difference for natural circulation, then converge again when 21 RCP is returned to service about 25 minutes into the event. The pressurizer pressure also quickly returns to normal as pressurizer spray becomes available and normal pressure control can be resumed. By 9:45 a.m. a second RCP was returned to operation and two of the vital buses had been returned to offsite power. By 12:30 p.m., the unit was stable in hot standby (Mode 3).

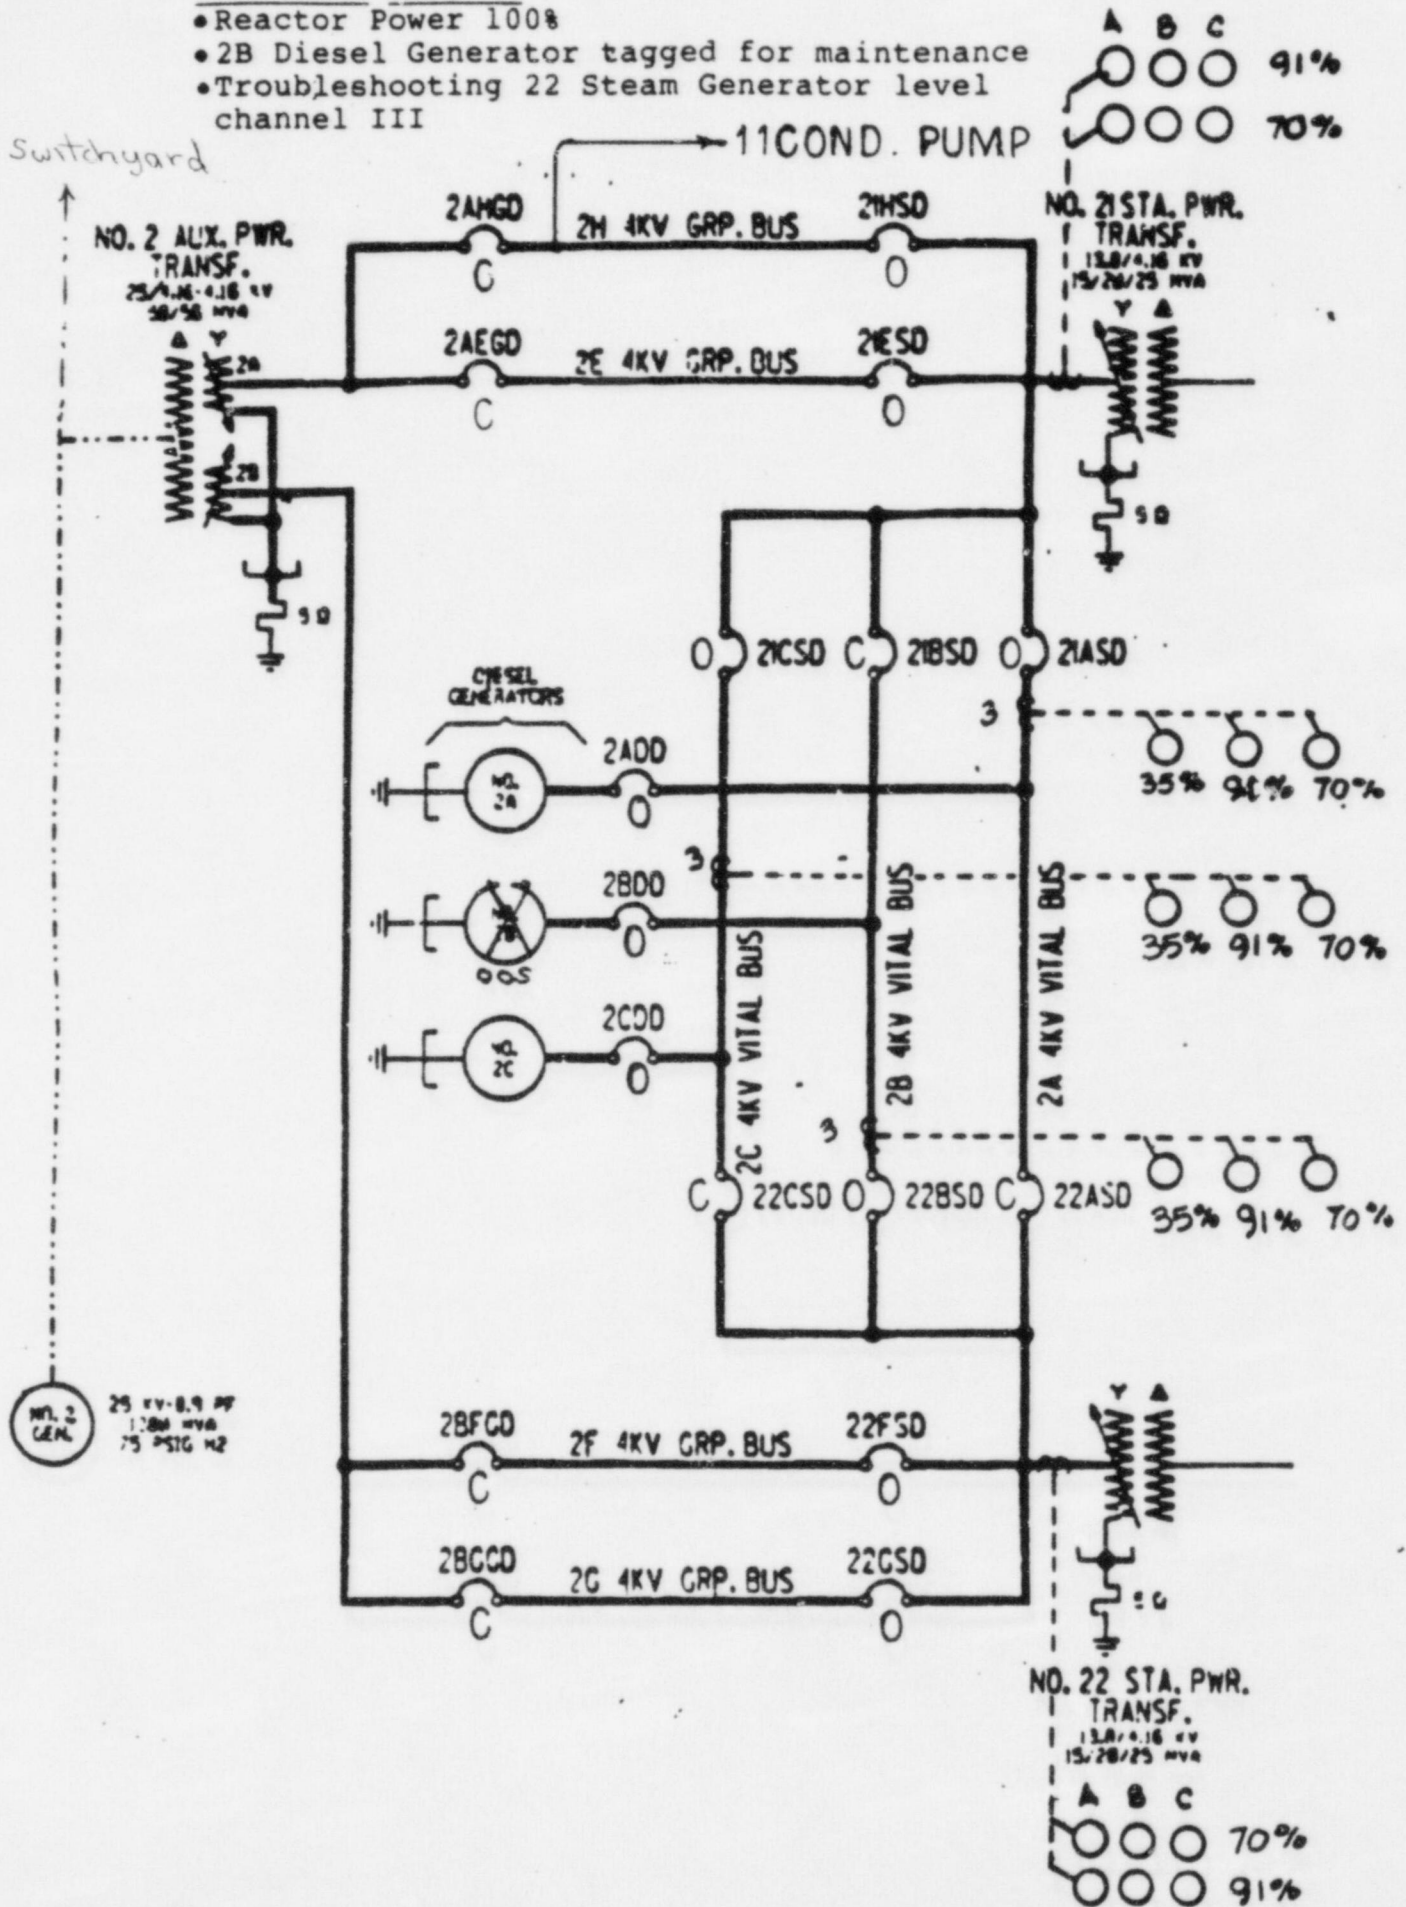
# FIGURE 2

The Vital Buses (VB) have protective relaying, denoted by the groups of circles on Figure 2, to maintain the quality (voltage, power availability) of their source of supply. The undervoltage protection levels shown on Fig. 2 are 91% for degraded grid protection, 70% for equipment protection and 35% for reclosure permissive logic. The combination of load on SPT 22, the relay setting and an appropriate (10.5 sec.) time delay resulted in a signal from only the A 91% protective relay on SPT 22 for VBA to affect a transfer from SPT 22 to SPT 21; this is shown in the upper left portion of Fig. 3. VBC should also have transferred, but did not. No relay trip flag was observed for VBC. The licensee's explanation for this is slight differences in relay settings. The transfer of VBA now increased the electrical load on SPT 21.

Figure 2 shows a simplified electrical one line diagram of Salem Unit 2. During startup and shutdown, 4KV group buses 2E, 2F, 2G, and 2H and the vital buses 2A, 2B, and 2C are supplied from Station Power Transformers (SPTs) 21 and 22. After unit startup, the group buses are manually transferred to No. 2 Auxiliary Power Transformer (APT), which is the normal power supply for the group buses. On a unit trip, the group buses will automatically transfer to the SPTs (offsite source). When the unit is running, the vital buses continue to be supplied by SPTs 21 and 22. Normally two vital buses

Prior to the event on August 26, 1986, the Unit 2 group buses were being supplied from the APT in the normal lineup, except that Unit 1 condensate pump 11 was temporarily powered from Unit 2 group bus 2H because of a problem with Unit 1 APT. When Unit 2 tripped, the group buses transferred to SPTs 21 and 22 as designed. The vital buses also transferred back and forth between SPT 21 and SPT 22. However, approximately 56 seconds after the initiation of the event, (reactor trip and safety injection signal) an undervoltage condition was sensed on two of the vital buses indicating an unsuccessful transfer of the vital buses between SPTs 21 and 22. Diesel generators 2A and 2C had automatically started (diesel generator 2B had been previously tagged out for preventive maintenance). All vital buses automatically shed their connected loads and the safeguard loads were automatically sequenced on diesel generators 2A and 2C through Safeguard Equipment Control (SEC) system as designed. As the plant was restored to normal conditions, the vital buses were returned to their normal sources, i.e., SPTs 21 and 22 (offsite power), with "B" Vital bus returned at 8:56, "A" at 9:42 and "C" at 10:11.
