LICENSEE EVENT REPORT (LER)

FACILITY NAME (1) SAN ONOFRE NUCLEAR GENERATING STATION, UNIT 3										DOCKET NUMBER (2) 0 5 0 0 0 3 6 2				PAGE (3) 1 OF 0 4		
TITLE (4) PRESSURIZER INSTRUMENT NOZZLE PRESSURE BOUNDARY LEAK																
EVENT DATE (5)			LER NUMBER (6)			REPORT DATE (7)			OTHER FACILITIES INVOLVED (8)							
MONTH	DAY	YEAR	YEAR	SEQ. NUMBER	REV. NUMBER	MONTH	DAY	YEAR	FACILITY NAMES				DOCKET NUMBER(S)			
									SAN ONOFRE, UNIT 2				0 5 0 0 0 3 6 1			
0 2	2 7	8 6	8 6	0 0 3	0 2	0 1	2 9	8 7					0 5 0 0 0 1 1			
OPERATING MODE (9)		THIS REPORT IS SUBMITTED PURSUANT TO THE REQUIREMENTS OF 10 CFR §: (Check one or more of the following) (11)														
3		20.402(b)				20.405(c)				50.73(a)(2)(iv)				73.71(b)		
POWER LEVEL (10)		0 0 0				20.405(a)(1)(i)				50.73(a)(2)(v)				73.71(c)

Subject: Docket No 50-362
Licensee Event Report No. 86-003, Rev. 2
San Onofre Nuclear Generating Station, Unit 3

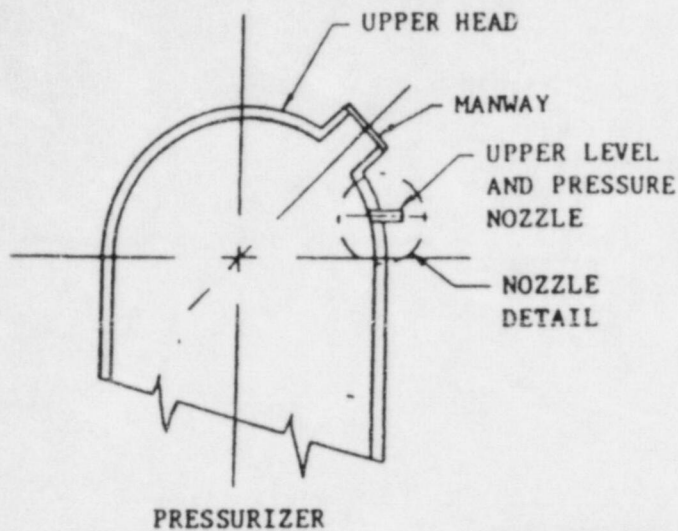
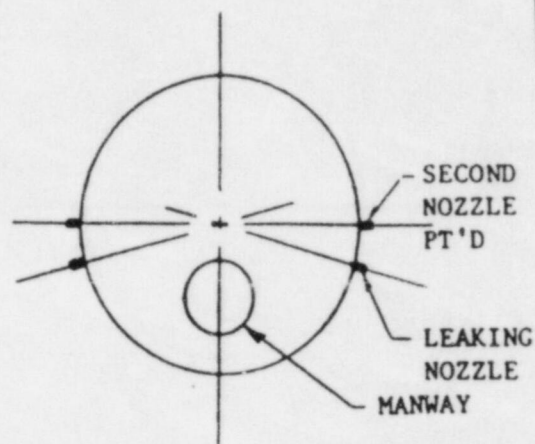
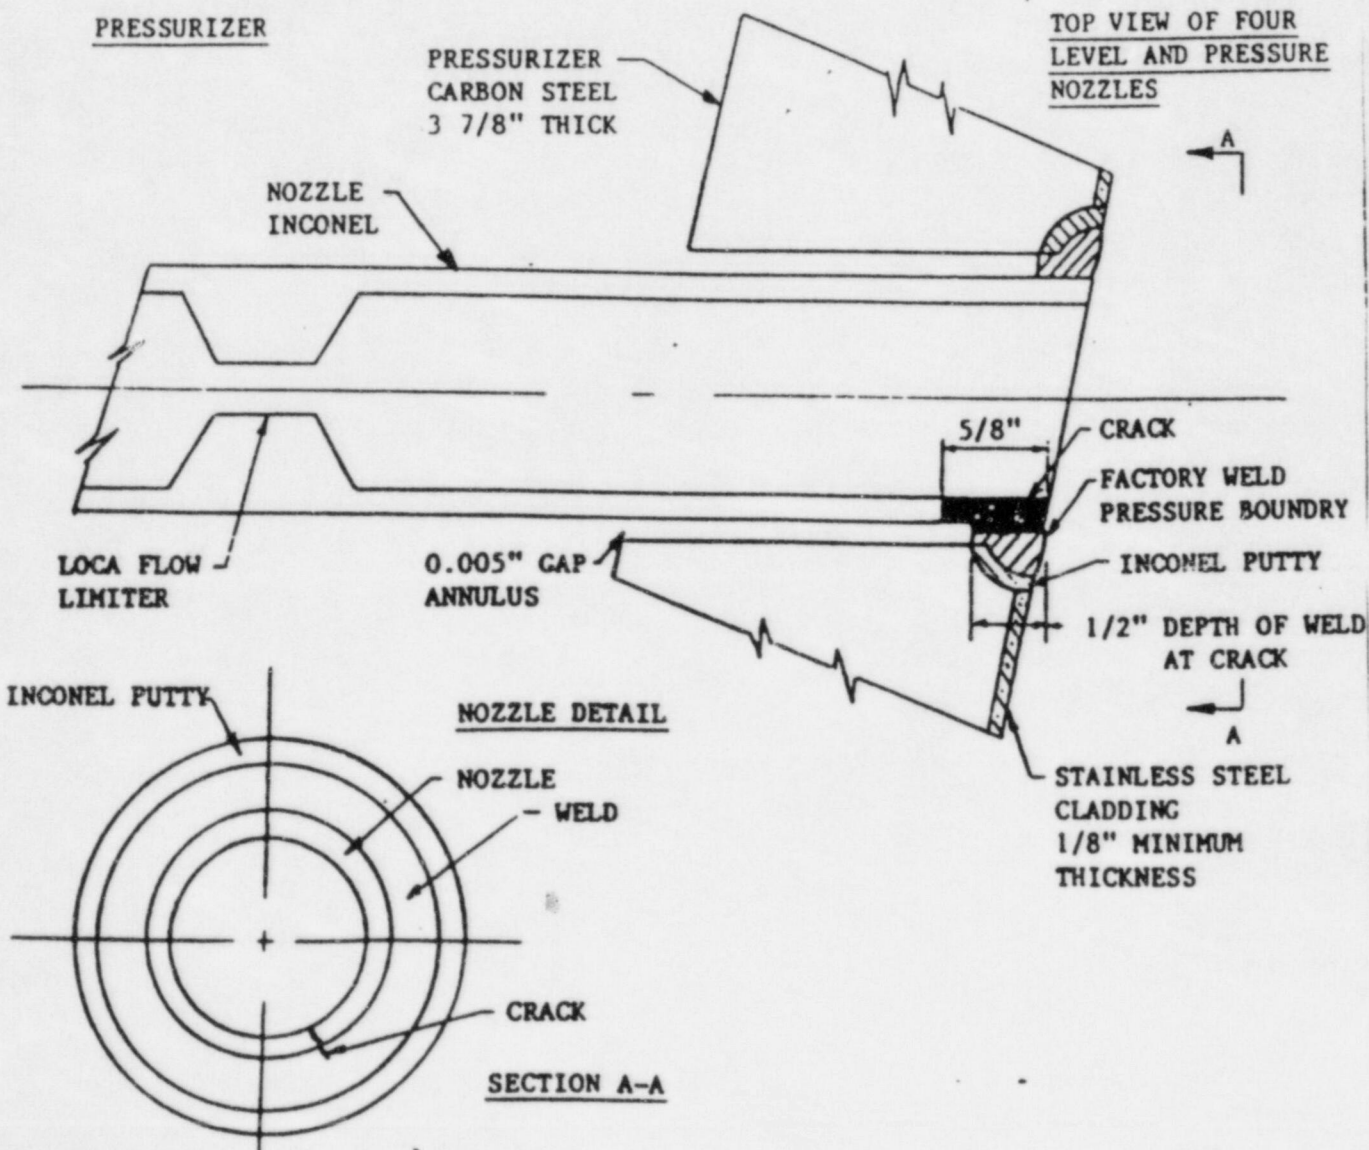
On March 6, 1986, with Unit 3 in Cold Shutdown, dye penetrant tests (PT) were performed on the instrument nozzle. As a result, a crack was identified in the nozzle, extending into the pressure boundary weld. The crack was axial to the nozzle starting from the end of the nozzle inside the pressurizer, extending outward approximately 5/8 inch (see attached sketch). At the point of the crack the weld is approximately 1/2 inch in depth. The crack extended beyond the weld approximately 1/8 inch into the annulus area of the nozzle assembly.

Subsequent metallurgical examination of the affected nozzle and weld joint material in the area of the crack by Combustion Engineering (CE) determined that intergranular stress corrosion cracking (IGSCC) of the nozzle material had occurred. Since the cracking has occurred only in the subject nozzle and not in any of the nine other nozzles fabricated from the same heat of Inconel-600 raw material (which includes five in another CE plant), CE concluded that the San Onofre Unit 3 cracking was the result of an isolated case involving a unique set of conditions.

Subsequent to the CE analysis and findings, SCE confirmed by independent analysis, that the weld joint cracking was due to Pure Water IGSCC. SCE analysis, however, concluded that two other nozzles from the same heat of material, which are located in the vapor space of the Unit 3 pressurizer, could be susceptible to similar cracking. Therefore, SCE decided to replace these nozzles during the January 1987 refueling outage.

The affected nozzle was completely cut out including the entire weld. The new nozzle was installed by the NSSS vendor (Combustion Engineering) in accordance with the vendor's fabrication specifications. The installation of the new nozzle was completed on March 10, 1986.
