LICENSEE EVENT REPORT (LER)

FACILITY NAME (1): **DIABLO CANYON UNIT 1** DOCKET NUMBER (2): **05000275** PAGE (3): **1 OF 4**

TITLE (4): **REACTOR TRIP DURING TESTING OF THE REACTOR TRIP SWITCHGEAR**

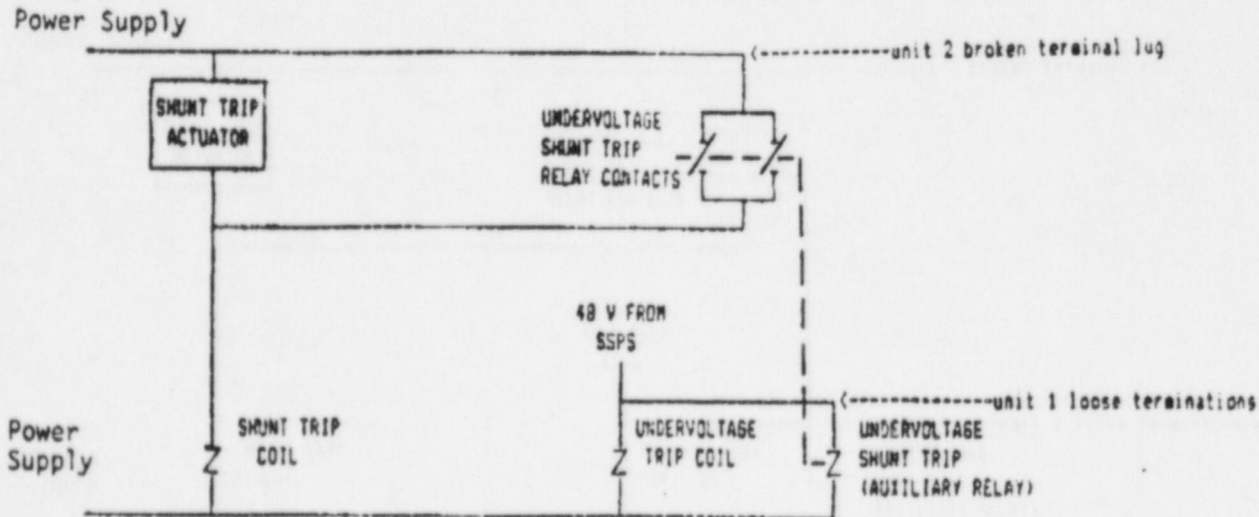
C. Reactor Trip Breaker UV and shunt trip circuitry simplified schematic.

A loose termination on the coil of the undervoltage shunt trip auxiliary relay momentarily broke contact, allowing the reactor trip breaker to open.
