LICENSEE EVENT REPORT (LER)

Facility Name (1) **San Onofre Nuclear Generating Station (SONGS) Unit 2** Docket Number (2) **0 5 0 0 0 3 6 1 1** Page (3) **1 of 0 4**
 Title (4) **Design Inadequacy In Backup Nitrogen Supply To Component Cooling Water Surge Tanks**

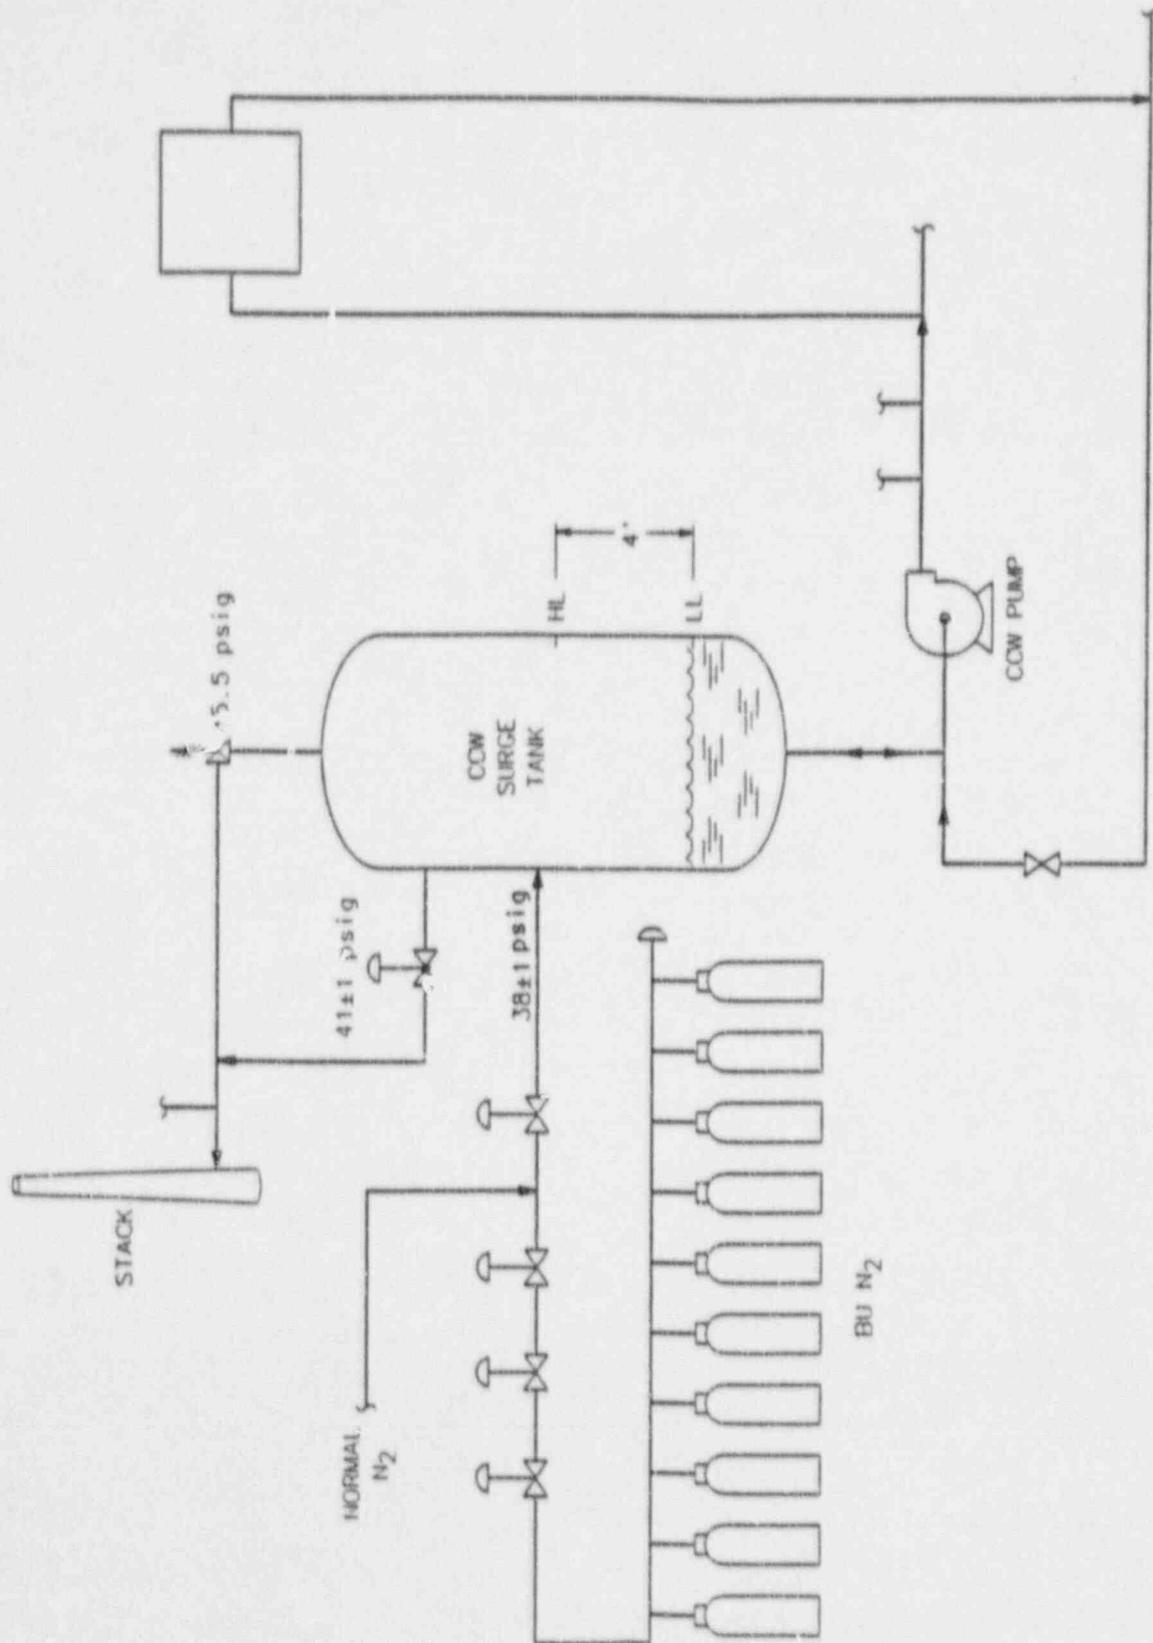
Figure 1

The component cooling water (CCW) [CC] system for each of the SONGS 2 and 3 Units consists of two independent trains, each train equipped with a 6,658 gallon (approximate) surge tank [TK]. See Figure 1. Each surge tank is pressurized to approximately 38 psig with nitrogen gas to prevent void formation at high points in the system and to minimize the potential for water hammer in the event of a rapid drawdown in surge tank level together with a CCW pump trip and restart transient. Each surge tank is equipped with a back pressure control valve designed to vent the tank if pressure increases above the control valve set point of approximately 41 psig.

When CCW system leakage causes surge tank level to decrease, backup nitrogen gas expands into the tank to maintain system pressure. During the ensuing makeup, the nitrogen gas is compressed by the rising water level, and is vented by the back pressure control valve.
