Arizona Nuclear Power Project

Subject: Final Report - DER 86-14
A 50.55(e) and 10CFR21 Reportable Condition Relating to
Weld Failure on Pipe Support Structure
File: 86-006-216; D.4.33.2

DER 86-14 - Final Report

FINAL REPORT - DER 86-14
DEFICIENCY EVALUATION 50.55(e)
ARIZONA NUCLEAR POWER PROJECT (ANPP)
PVNGS UNITS 1, 2, 3

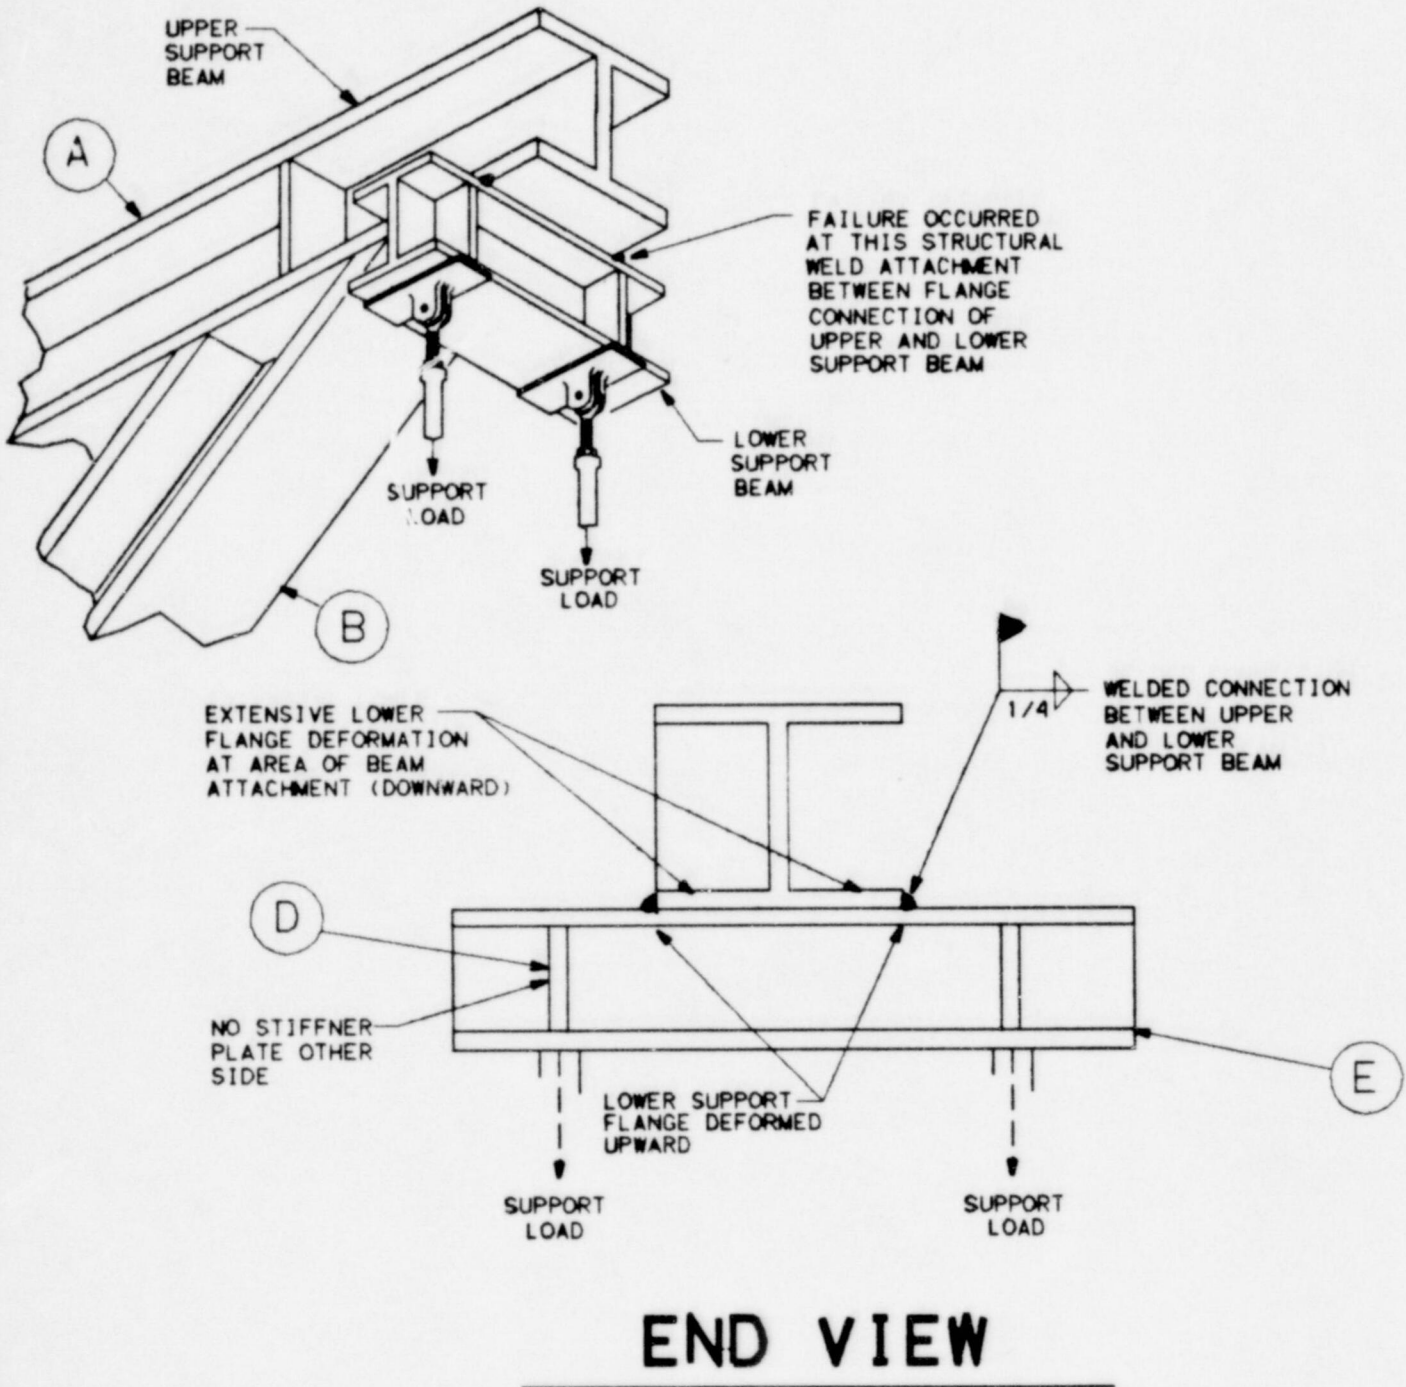
FAILURE LOCATION

A surveillance inspection of Unit 1 on March 13, 1986, identified a failed pipe support (Support No. 1-SG-005-H008). The failed support was located inside the Containment Building and was a strut type support for the 24 inch main feedwater line to Steam Generator No. 2. The failure occurred in the weld between the flange connection of the upper and lower support beams. The lower portion of the support separated completely from the upper support beam (see Attachment A). The axes of the two beams were oriented 90°, and it was discovered that the two 4 inch long, 1/4 inch leg fillet welds between member A (upper beam) and E (lower beam) fractured. Attachment A shows the location of the failure. A distortion of the beam flanges at the weld location occurred.

The failed support was visually inspected. The upper beam's bottom flange edge showed substantial bending. Similarly, the lower beam's upper flange showed some bending. Part of the fractured weld remained on the upper beam with the remainder on the lower beam.

Based on the above observations, it was concluded that the weld fractured due to overloading. Deformation of the flanges indicate that the weld transferred the loads until it could no longer accommodate strains imposed by deformation of the flange, causing the weld to fracture.

The root cause of the failure of Unit 1 support 1-SG-005-H008 was not adjusting the direction of the applied loads to accommodate the normal thermal motion of the pipe and not considering the effect of localized flange bending.

The combination of a relatively large thermal motion and short sway strut length resulted in a large angle which generated a horizontal force not accounted for in the original design. The effect of this horizontal force on the failed weld was amplified by its acting not only through the pin to back plate height of the rear bracket but also through the six-inch height of the W6 x 12 lower beam.

Additionally, the failed weld joined two open section members connected flange to flange at right angles (see Attachment A). It is believed that the welds parallel to the web of the upper member are subject to a prying action resulting from the bending of the lower flanges of that upper beam (localized flange bending). Finite element analysis of the failed structure has indicated that this action does reduce weld capability.

- A. The following work documents have been issued to strengthen pipe supports to accommodate eccentric loading and/or preclude flange bending:
