U. S. NUCLEAR REGULATORY COMMISSION
REGION I

Report Nos. 50-311/87-03

Facility Name: Salem Nuclear Generating Station - Unit 2

Inspection Conducted: January 12, 1987 - January 23, 1987

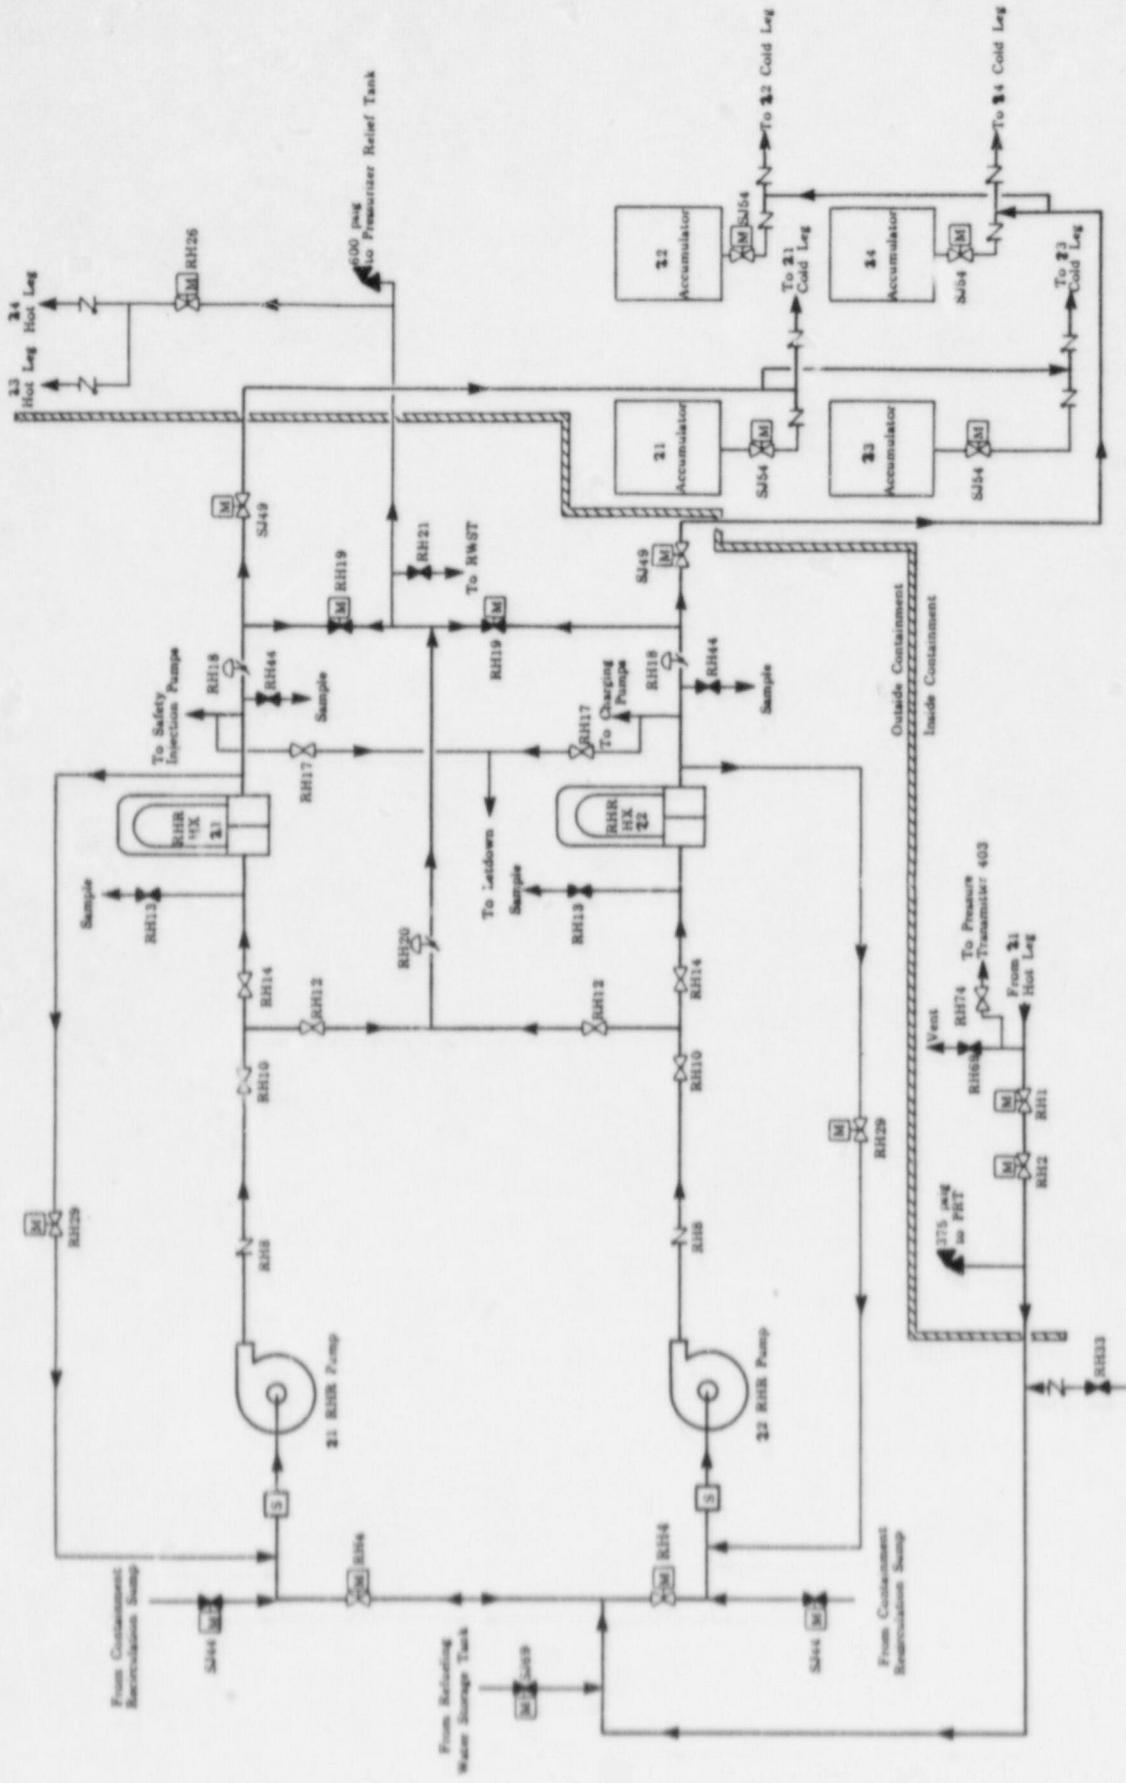
ATTACHMENT 2

On January 12 and 13, 1987 while in Mode 1, for twenty hours and fifty eight minutes, portions of two ECCS subsystems (the RHR system) were inoperable when valve 22SJ49 was closed. With valve 22SJ49 closed, the flow path for RHR cold leg injection is to only two of the four reactor coolant system cold legs.

Note: The valves shown on Attachment 2 RHR System Diagram are main line isolation valves. Vents, drains, and instrument line isolation valves that are listed above are not shown on the diagram.

In order to return the RHR system to a configuration which would provide flow to all four RCS cold legs (with one RHR pump tagged out), the licensee determined that valves 22SJ49 and 22RH19 and their associated breakers needed to be put back to their normal alignment. Valve 22RH14 was chosen as an alternate blocking point to 22SJ49 which needed to be realigned (opened). At this point, 20 of the 28 valves had been unpacked, six of which had to be repacked to return the valves and the RHR flowpath to operability. The maintenance crews (3 crews/2 people each) were redirected to install the Chesterton packing into these six valves in as timely a manner as possible.

At approximately 7:29 p.m., the repacking of the six valves was completed and Temporary/Partial Tagging Release No. 41273-T0 was approved by the Unit 2 Shift Supervisor to return valves 22SJ49, 22RH19, their associated breakers, and drain valve 22RH70 to their normal position returning the RHR flowpath to operable status.
