LICENSEE EVENT REPORT (LER)

Facility Name (1) QUAD-CITIES, NUCLEAR POWER STATION, UNIT One										Docket Number (2) 0   5   0   0   0   2   5   4					Page (3) 1   of   0   4		
Title (4) U-1 RCIC Inoperable Due To Spurious Overspeed Trips																	
Event Date (5)			LER Number (6)					Report Date (7)			Other Facilities Involved (8)						
Month	Day	Year	Year	Sequential Number	Revision Number	Month	Day	Year	Facility Names				Docket Number(s)				
0   5	0   5	8   6	8   6	0   2   3	0   0	0   5	3   0	8   6					0   5   0   0   0				
OPERATING MODE (9)			THIS REPORT IS SUBMITTED PURSUANT TO THE REQUIREMENTS OF 10CFR (Check one or more of the following) (11)														
POWER LEVEL (10) 0   9   6			20.402(b)			20.405(c)			50.73(a)(2)(iv)			73.71(b)

FACILITY NAME (1)	DOCKET NUMBER (2)	LER NUMBER (6)						Page (3)		
		Year	///	Sequential Number	///	Revision Number				
Quad Cities Unit One	0   5   0   0   0   2   5   4	8   6	-	0   2   3	-	0   0	0   2	QF	0   4	
TEXT

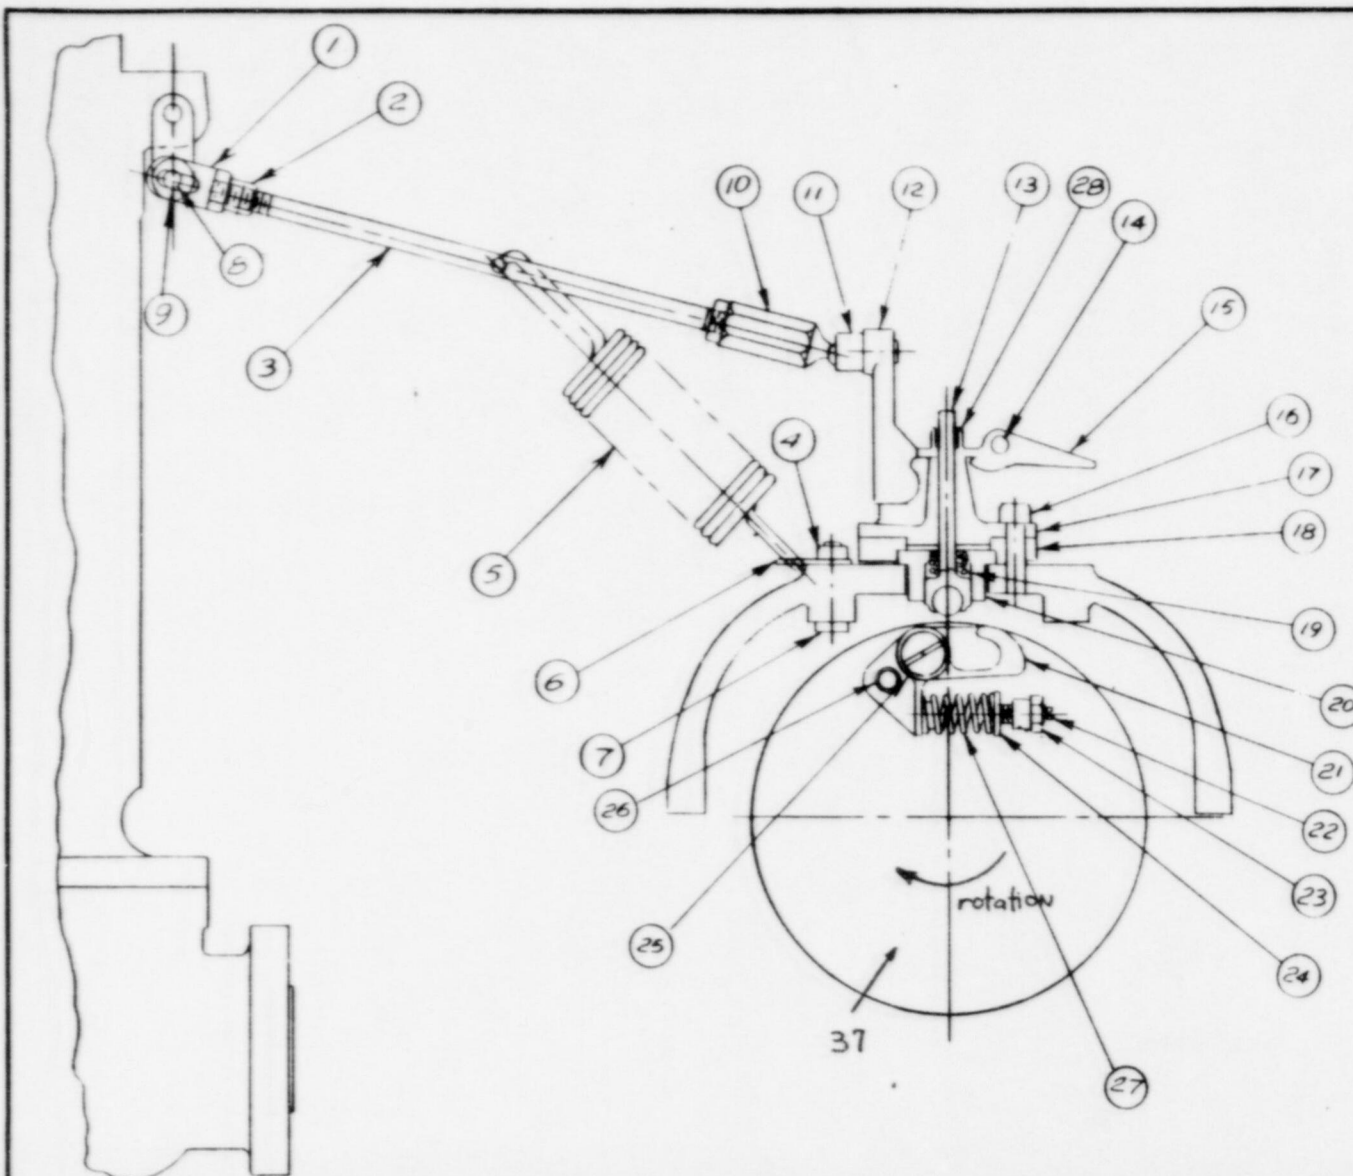
B-12555

This Terry Steam Turbine, type GS, is provided with a mechanical overspeed trip mechanism (drawing B-12555) which consists of a disc (37-B12555) fitted with a lever type emergency weight (21-B12555) and associated parts. This disc is balanced on the turbine shaft after all parts are assembled. The weight is secured to the disc by means of the weight screw (25-B12555) which is also the pivot point of the weight. A needle bearing is fitted to the weight so that it is supported on the weight screw by the bearing to reduce friction when the weight moves. The weight is heavy at the free end and the unbalanced force of the weight is opposed by the emergency weight spring (27-B12555). The compression force on the spring is adjusted by means of the adjusting screw (22-B12555) so that the centrifugal force at the free end of the weight overcomes the opposing forces of the spring when the desired trip speed is attained. The weight then pivots about the adjusting screw and the free end of the weight moves outward and strikes the ball tappet (13-B12555). This blow lifts the tappet breaking the contact between the tappet nut (28-B12555) and head lever (12-B12555). This permits the spring (5-B12555) to actuate the mechanical trip latch to close the trip and throttle valve.

Close investigation showed several components in the above mechanical circuit to be out of tolerance. The emergency weight (21-B12555) striking the tappet and ball (13-B12555) would not engage the trip and throttle valve with good repeatability. This mechanical linkage being out of adjustment was the root cause of the incident.

Several of the mechanical overspeed trip components were adjusted to yield a repeatable trip setting. The emergency weight was adjusted using the Terry Steam Turbine Instruction Manual as a guide by adjusting the emergency weight spring adjusting screw (22-B12555). The emergency head lever was machined to yield a better engagement/disengagement surface for the tappet and ball. The final adjustment was made to the emergency connecting rod spring (5-B12555). The adjustment assured that when the tappet and ball became disengaged there was enough force to disengage the trip and throttle valve thus tripping the turbine. The RCIC system was tested satisfactorily and declared operable at 05:10 hours on May 10, 1986. The system was inoperable from May 5 to May 10.
