LICENSEE EVENT REPORT (LER)

FACILITY NAME (1) RIVER BEND STATION	DOCKET NUMBER (2) 0 5 0 0 0 4 5 8	PAGE(S) 1 OF 0 4
--	---	----------------------------

TITLE (4)
PENETRATIONS WITH INADEQUATE FIRE BARRIERS

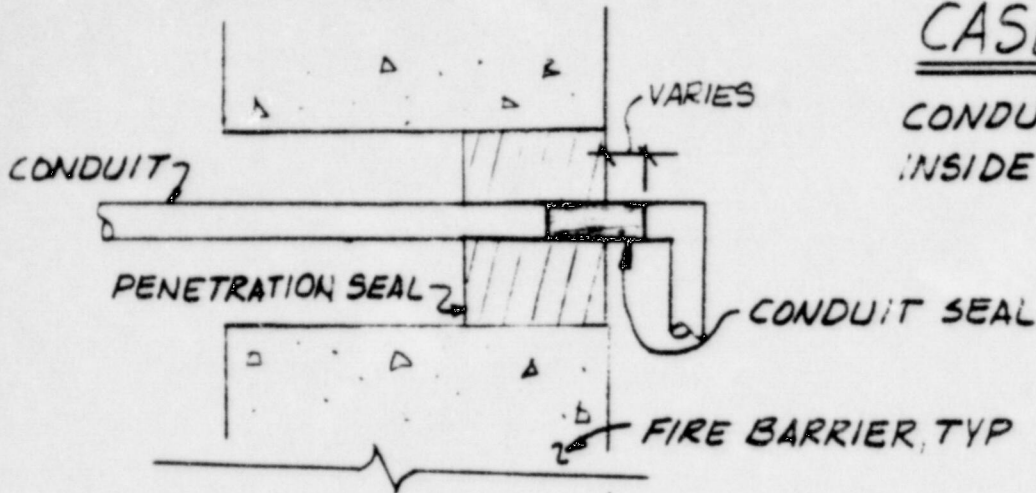
CASE I

These conduit seals were discovered during a site walkdown of fire penetration seals. The seals were not installed per the configurations fire tested by the installation contractor B&B/Promatec (B&B). These seals were installed such that the conduit seal was not completely contained within the penetration seals (see attached sketch). The three types of conditions shown on the sketch were found in varying proportions. All conduit seals were installed as "one shot" - i.e. one internal seal.

CONDUIT SEAL PARTIALLY
INSIDE PENETRATION SEAL

In order to determine the problem scope, a walkdown was initiated of all "one-shot" conduit seals on 5/9/86. This effort is continuing. To date, over 200 non complying seals have been identified. All conduit seals found to be not in accordance with existing fire test are being repaired by installing a second seal on the opposite side of the penetration. This activity is expected to be completed by the end of June 1986.

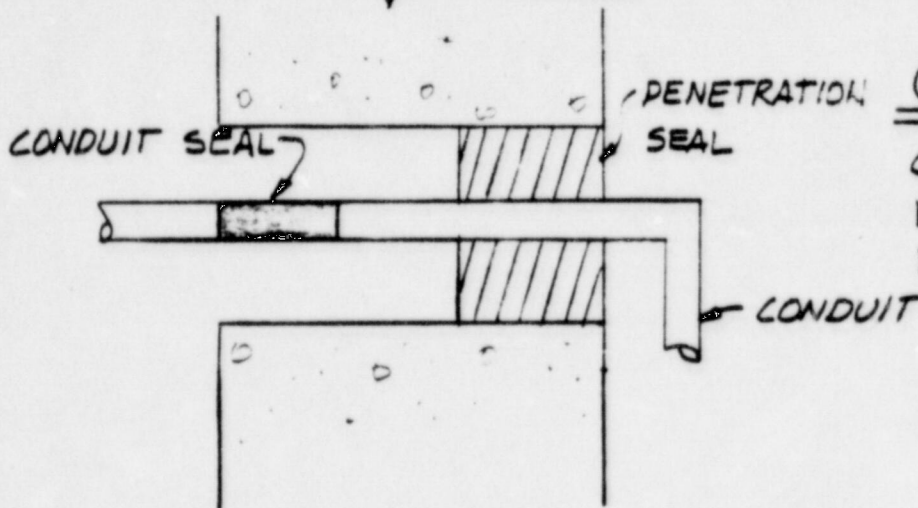
CASE II

CONDUIT SEAL INSIDE
WALL, NOT INSIDE
PENETRATION SEAL

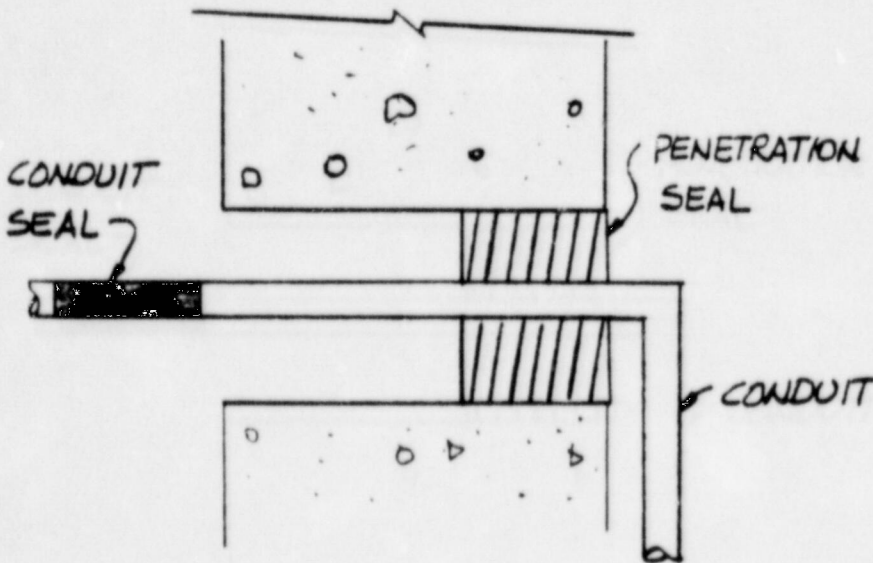
CASE III

CONDUIT SEAL OUTSIDE
WALL AND PENETRATION
SEAL
