LICENSEE EVENT REPORT (LER)

Sequoyah Nuclear Plant (SQN) Unit 1

05000327

Operation of Vital Battery Board #4 Without a Battery Source.

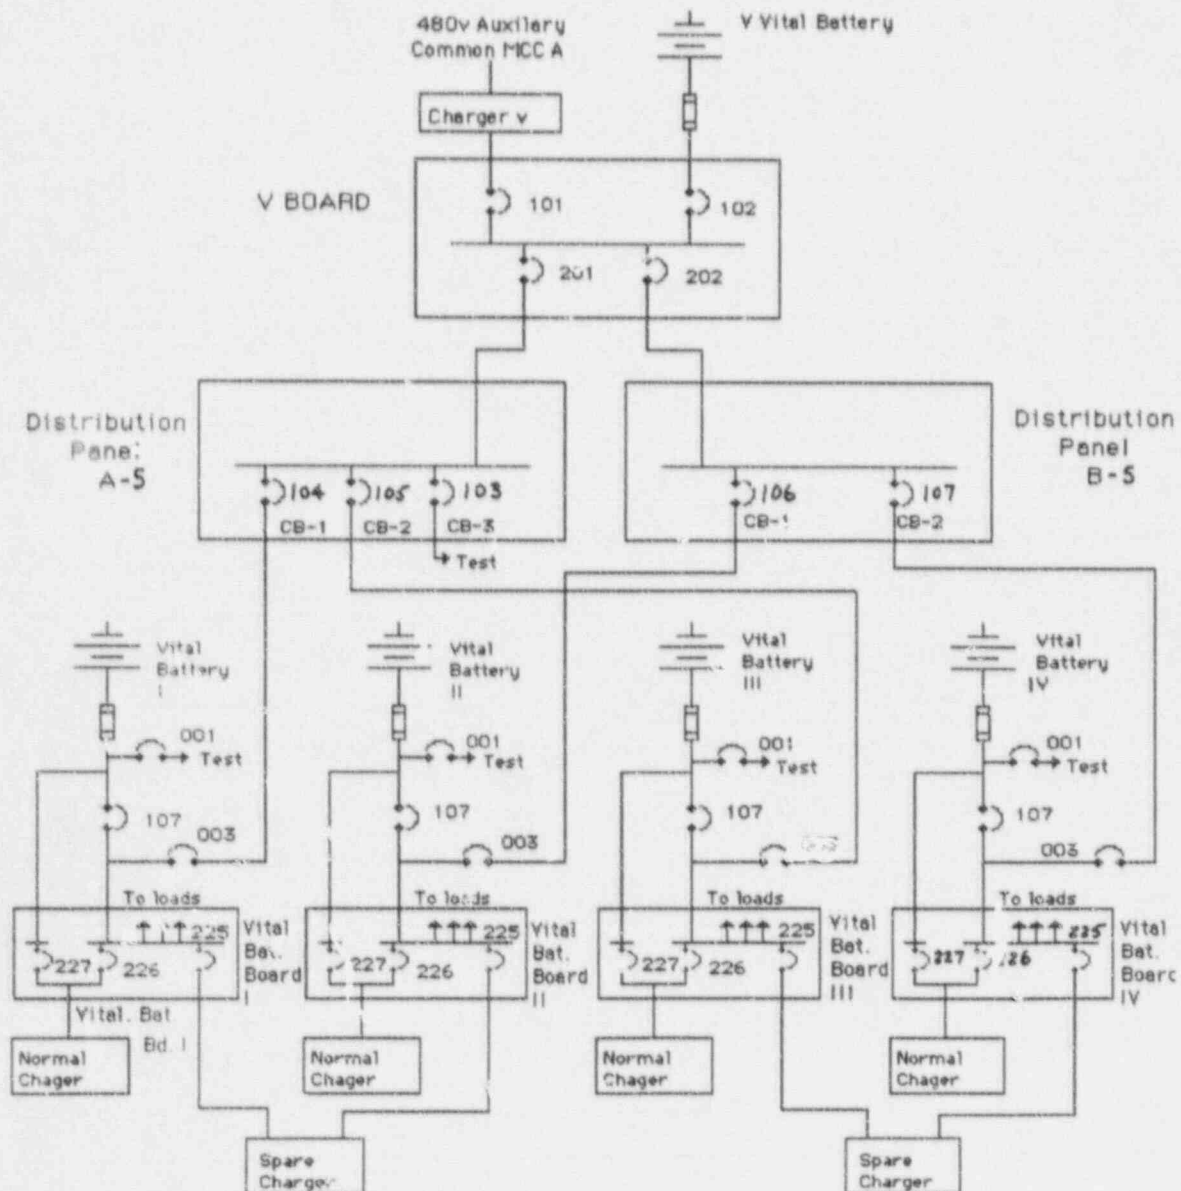
ATTACHMENT

At approximately 0556 Eastern Daylight Time (EDT) on July 24, 1997, the Unit 2 Unit Supervisor/Senior Reactor Operator (US/SRO) approved the activity of sparing out the 125 Vdc vital battery #4 [EIIS Code BTRY] with the 125 Vdc vital battery #5 for performance of a battery discharge test (See attached diagram).

Standing inside the 125 Vdc vital battery board #4 [EIIS Code BYBD] room, the two operators misread a step and performed the step on the wrong 107 breaker which was on panel 1 of the 125 Vdc vital battery board #4. The correct breaker, also numbered 107, was located outside the 125 Vdc battery board room on a panel identified as "B-S." The Floor SRO realized the 107 breaker on 125 Vdc vital battery board #4 panel was already in the procedurally required position, and discussed the actual and procedural differences with the AUO. The Floor SRO, feeling unsure about the breaker already being in the required position, went inside another 125 Vdc vital battery board room to verify the position by using the location and position of a similar breaker also numbered 107 on another 125 Vdc vital battery board. The Floor SRO assumed, by the breaker being closed on another 125 Vdc vital battery board, that the position of the 107 breaker on the 125 Vdc vital board #4 was correct and proceeded with the sparing out of the 125 Vdc vital battery #4.

(Battery board #s are Roman Numeral: see drawing)
