SOUTHERN CALIFORNIA EDISON COMPANY

SAN ONOFRE UNIT 2

STEAM GENERATOR RUN TIME ANALYSIS
CYCLE 9

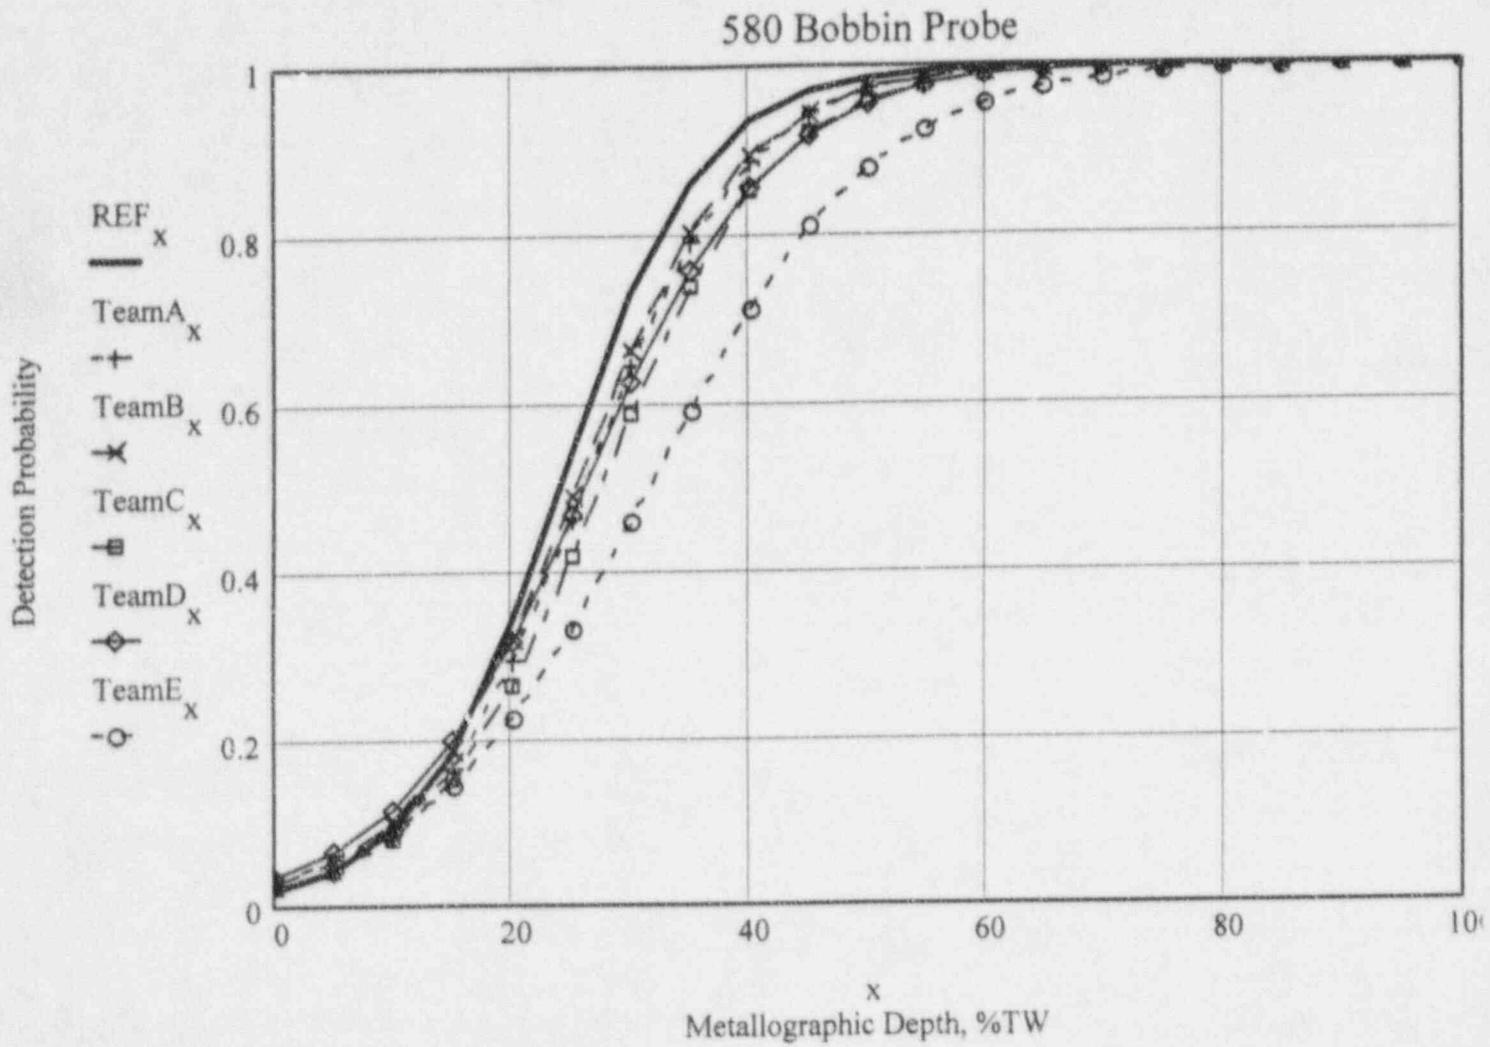
Figure 1, Probability of Detection (POD) Curve - Freespan Axial Cracking

A "supplemental performance demonstration," described in draft RG X.XX, was performed to demonstrate the eddy current bobbin probe detection capabilities for this freespan axial cracking. This demonstration used eddy current indications (nondestructive examination data) with corresponding metallurgical laboratory data (destructive examination data) in sections of pulled tubes. The most significant result of this demonstration, a Probability of Detection (POD) Curve, is illustrated in Figure 1. This figure shows a reference POD which is the technique limit and individual team performances which reflect human factors considerations. More detail is provided in Appendix 2, which is a summary of the purposes and protocol of this demonstration. POD results are considered in the Probabilistic Operational Assessment.

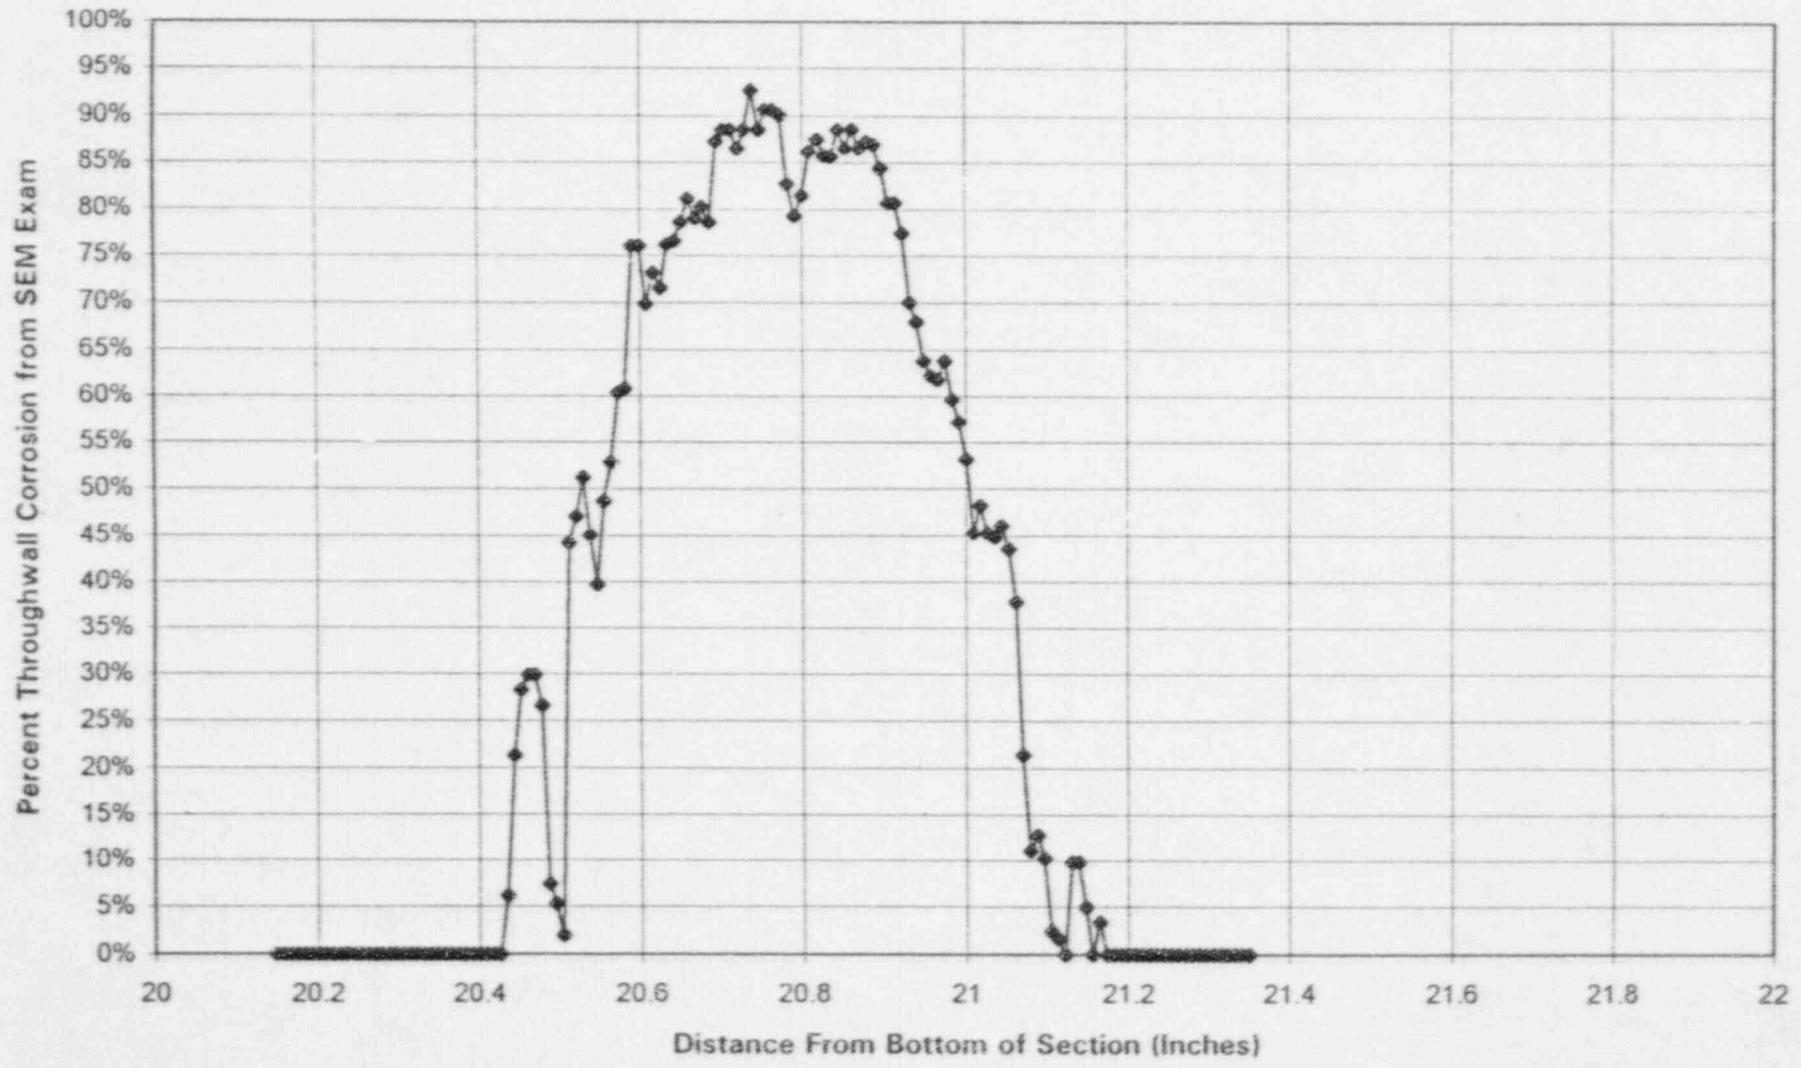
Figure 2, Profile of Axial Degradation at Dented Eggcrate Support Location in R94 C32

One tube was removed to gain information on this degradation mechanism. One of the three removed tubes (Row 94 Column 32) was affected by inside-diameter-initiated axial cracking at the fourth hot leg eggcrate support. This cracking had been detected by the eddy current bobbin probe, and was confirmed and further characterized with a rotating probe with a Plus-Point* coil and a high-frequency shielded pancake coil.

The length/depth profile of this degradation, determined by scanning electron microscopy, is illustrated in Figure 2.

Laboratory Leakage and Burst Testing was performed at this location. The results at this location are shown in Table 3. The axial cracking at this dented location did not exhibit leakage at a pressure comparable to MSLB accident conditions, and met the structural integrity margins addressed in RG 1.121.

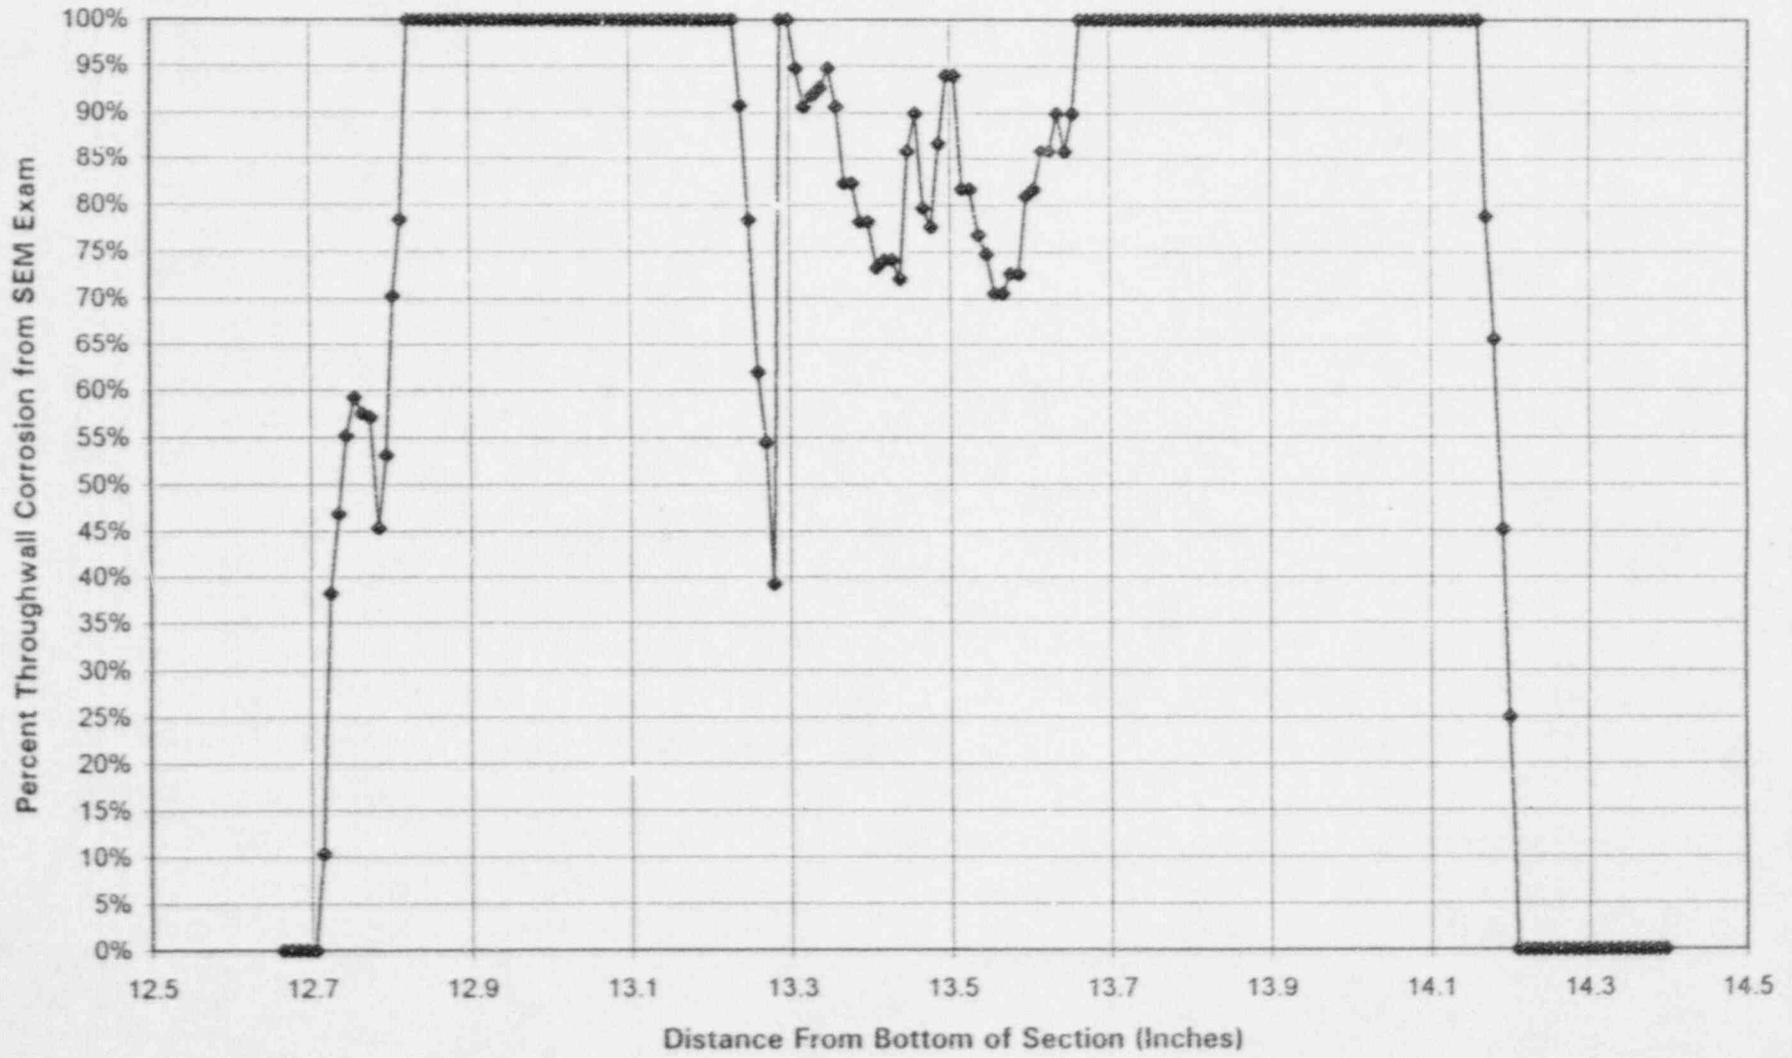
Figure 3, Profile of Axial Degradation Undented Eggcrate Support Location in R61 C111

One tube was removed to gain information on this degradation mechanism. One of the three removed tubes (Row 61 Column 111) was affected by inside-diameter-initiated axial cracking at the seventh hot leg eggcrate support. This cracking had been detected by the eddy current bobbin probe, and was confirmed and further characterized with a rotating probe with a Plus-Point* coil and a high-frequency shielded pancake coil.

The length/depth profile of this degradation, determined by scanning electron microscope, is illustrated in Figure 3. The eddy current bobbin probe indicated there was no denting. Dimensional measurements in the laboratory corroborated that there was no detectable denting.

Laboratory leakage and burst testing results are shown in Table 3. These results and associated calculations indicate that the axial cracking at this location exhibited leakage of 1.35 gpm at a pressure comparable to MSLB accident conditions. Calculation of this leakage was necessary because it exceeded the capabilities of test equipment at a pressure of 2100 psi. Structural integrity at MSLB accident conditions was demonstrated. Maximum achievable test pressure was 3515 psi, which is below the target pressure of 4746 psi. The pressure of 4746 psi would have demonstrated structural integrity at a pressure simulating normal operating differential pressure multiplied by a factor of 3.
