TRANSIENT ASSESSMENT PROGRAM REPORT
ON
CRYSTAL RIVER UNIT 3 REACTOR TRIP
OF
JUNE 16, 1981

Report Number - CR-3-81-10

Prepared and Released by
Florida Power Corporation

CRYSTAL RIVER 3 - JUNE 16, 1981
REACTOR TRIP AND LOSS OF OFF-SITE POWER

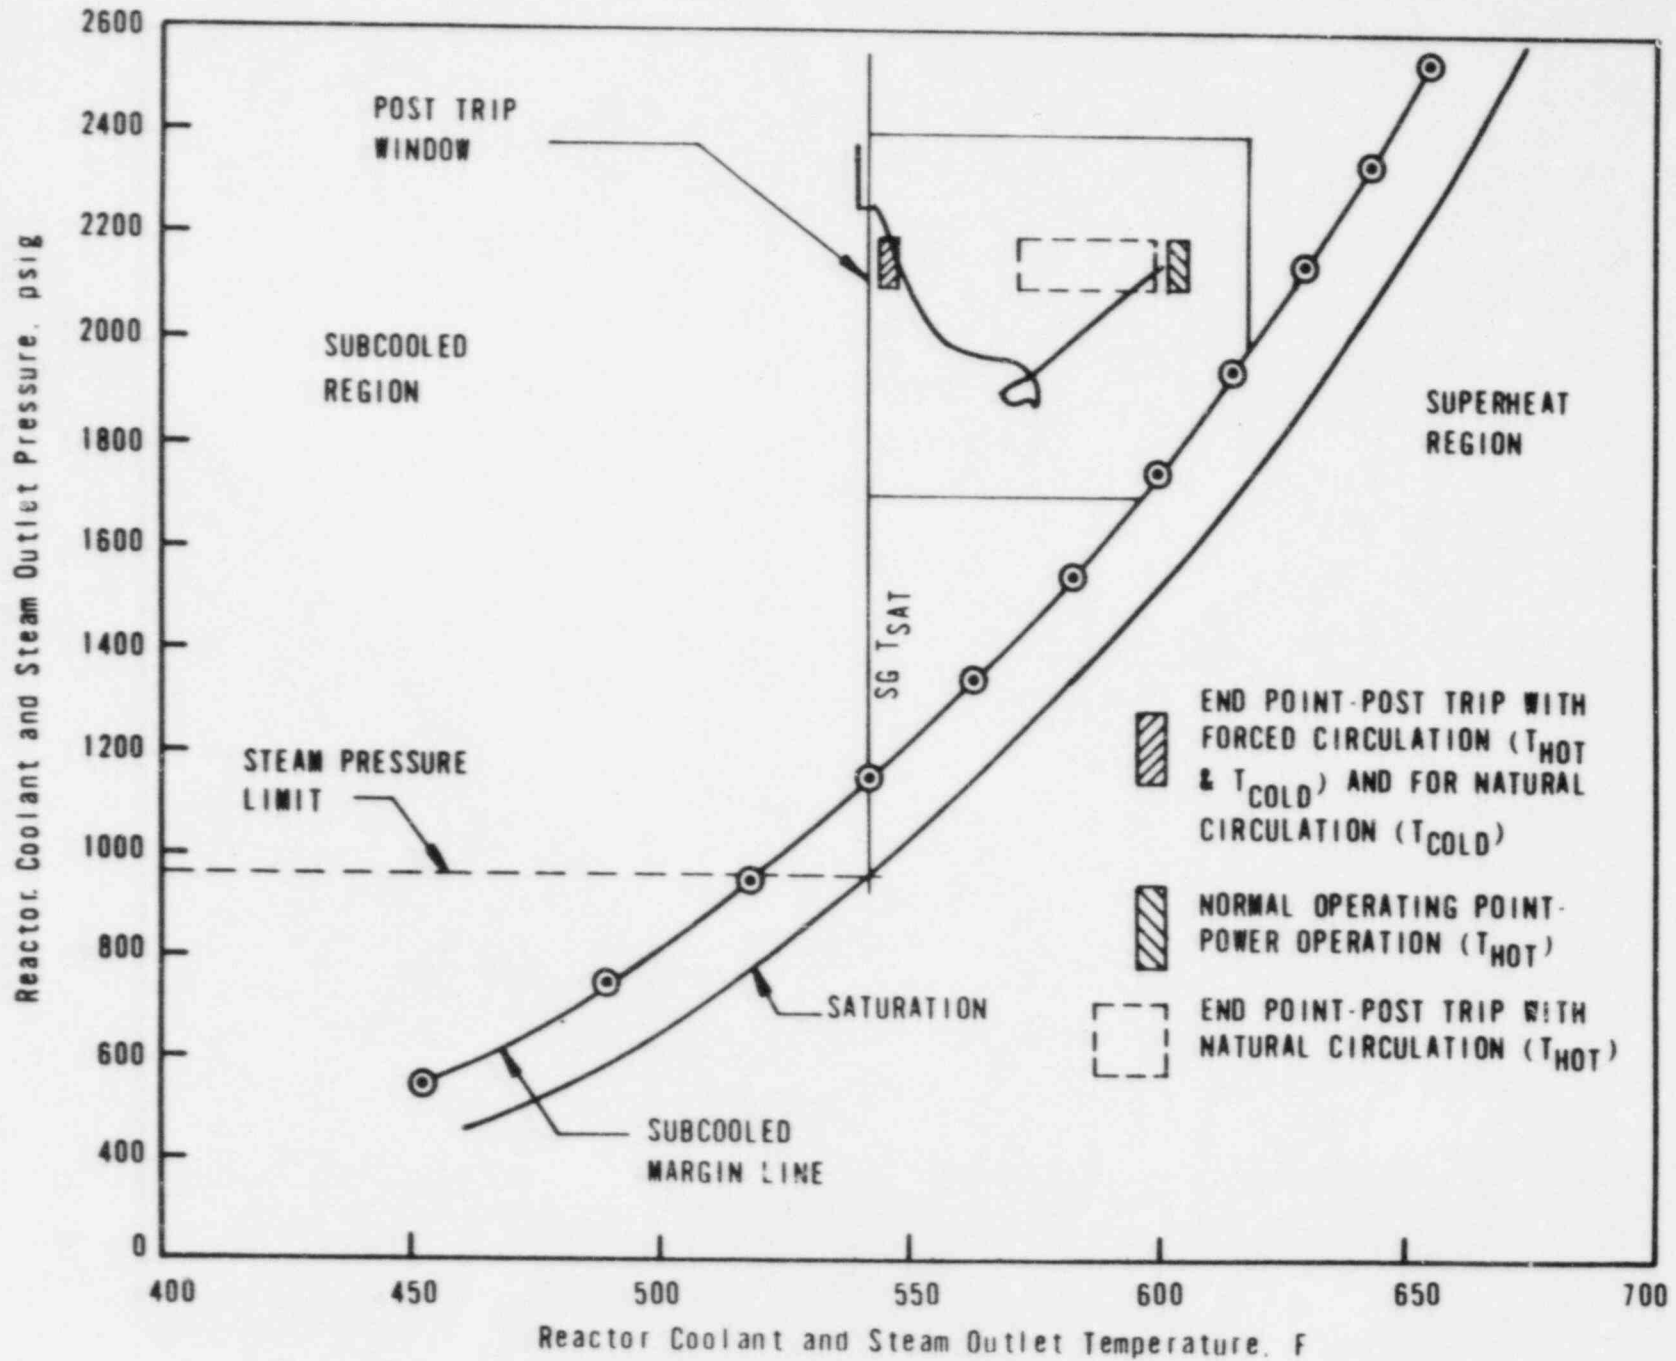
Figure 2

AS CAN BE SEEN FROM THE ATTACHED FIGURES, RC FLOW TOOK ABOUT THREE MINUTES TO COAST DOWN AND ABOUT ONE AND A QUARTER MINUTES INTO THE TRANSIENT NATURAL CIRC FLOW WAS BEGINNING TO TAKE OVER. THE TRANSITION CAN BE SEEN BY USING THE PLOT OF REACTOR T VS TIME, WHERE T BEGINS TO INCREASE NATURAL CIRCULATION FLOW IS BEGINNING TO PREDOMINATE. THIS FLOW IS BEING SET UP BY THE EMERGENCY FEEDWATER SYSTEM FILLING THE OTSG'S.
