LICENSEE EVENT REPORT (LER)

FACILITY NAME (1) D. C. Cook Nuclear Plant, Unit 1	DOCKET NUMBER (2) 0 5 0 0 0 3 1 1 5 1	PAGE (3) 1 OF 0 6
---	--	----------------------

TITLE (4) Reactor Trip System Interlock Setpoints Not in Literal Compliance with Technical Specifications Due to Misinterpretation of Requirements

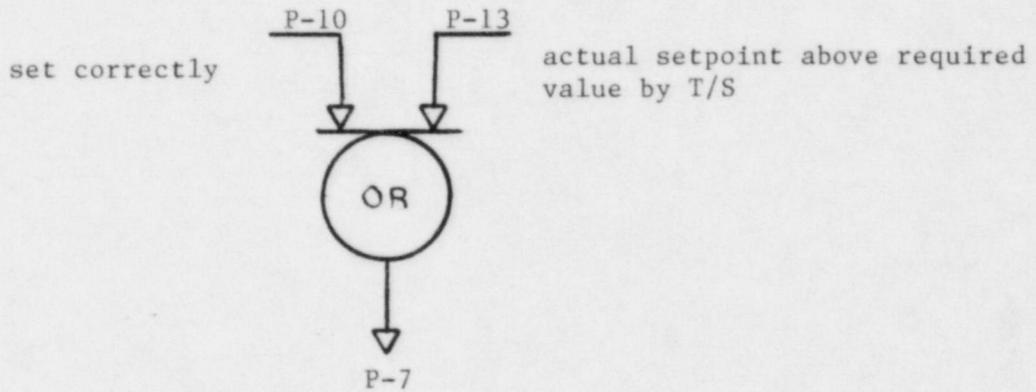
A. POWER INCREASE

On a power increase P-7 is developed when either RTS interlocks P-10 or P-13 (turbine first stage pressure) reach their setpoint values. The T/S's require that P-7 is functioning to defeat the automatic blocks of the above P-7 related trips prior to reactor thermal power reaching 11 percent RTP or turbine first stage pressure reaching 37 psig in Unit 1, or 66 psia in Unit 2. The applicable calibration procedures correctly established the setpoint for P-10 at < 11 percent RTP. The P-13 setpoint value was misinterpreted and was specified by the procedure to be set at between 50.7 to 51.3 psig, and 87.0 to 87.9 psia for Units 1 and 2, respectively, which is non-conservative with respect to the T/S requirements. As a result, should turbine power (P-13) have reached the required T/S setpoint value prior to reactor power

(P-10) reaching its setpoint value, then RTS interlock P-7 would not have functioned to defeat the automatic block of reactor trip when required.

If turbine power would have reached T/S required value before Reactor Power, P-7 would not have defeated the automatic reactor trip blocks.

Setpoint calibration procedures for both units have been revised. All permissives will be reset to these new procedural requirements before changing to a mode in which the interlock is required to be operable.

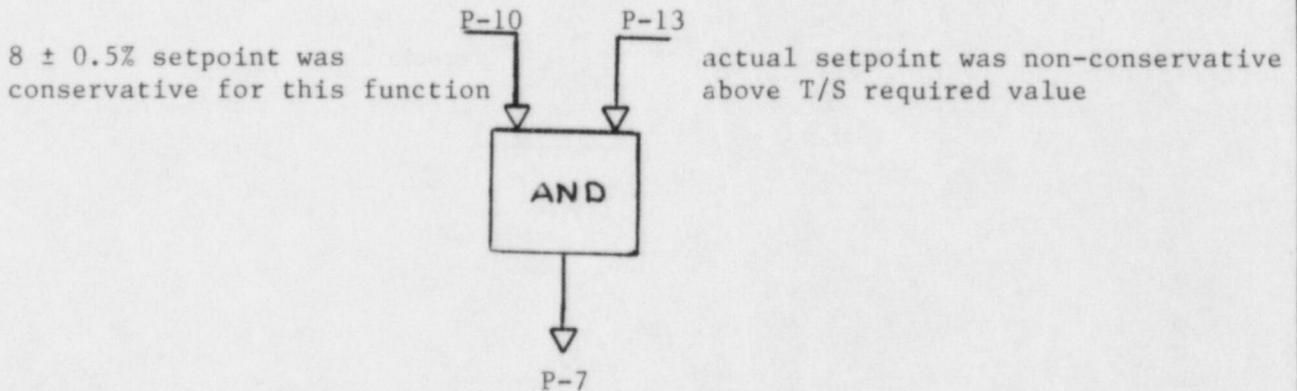
B. POWER DECREASE

On decreasing power, P-7 functions to automatically block the above reactor trips. For P-7 to be reset, both P-10 and P-13 must reach their reset setpoint.

The P-13 input to the P-7 interlock would have reset at a non-conservative value because the actual setpoint was set higher than the T/S value (37 psig for Unit 1 and 66 psia for Unit 2).

The P-10 input to the P-7 interlock as described above was set to reset at 8 percent \pm 0.5 percent RTP which is conservative with respect to the T/S requirement for the defeating of the reactor trips.

Therefore, since both P-10 and P-13 must reach their reset value, the reset value for P-7 was conservative. (See the attachment for a pictorial description.)

Since both P-10 and P-13 inputs are required, P-7 would have blocked Reactor Trips at a value below allowable. That is, the automatic trips would have remained in place at a lower power level than required.
