LICENSEE EVENT REPORT (LER)

FACILITY NAME (1) Three Mile Island, Unit 1	DOCKET NUMBER (2) 05000289	PAGE (3) 1 OF 10
--	-------------------------------	---------------------

TITLE (4)
VOLUNTARY LER REGARDING INCREASING FAILURE RATE OF ESAS RELAYS

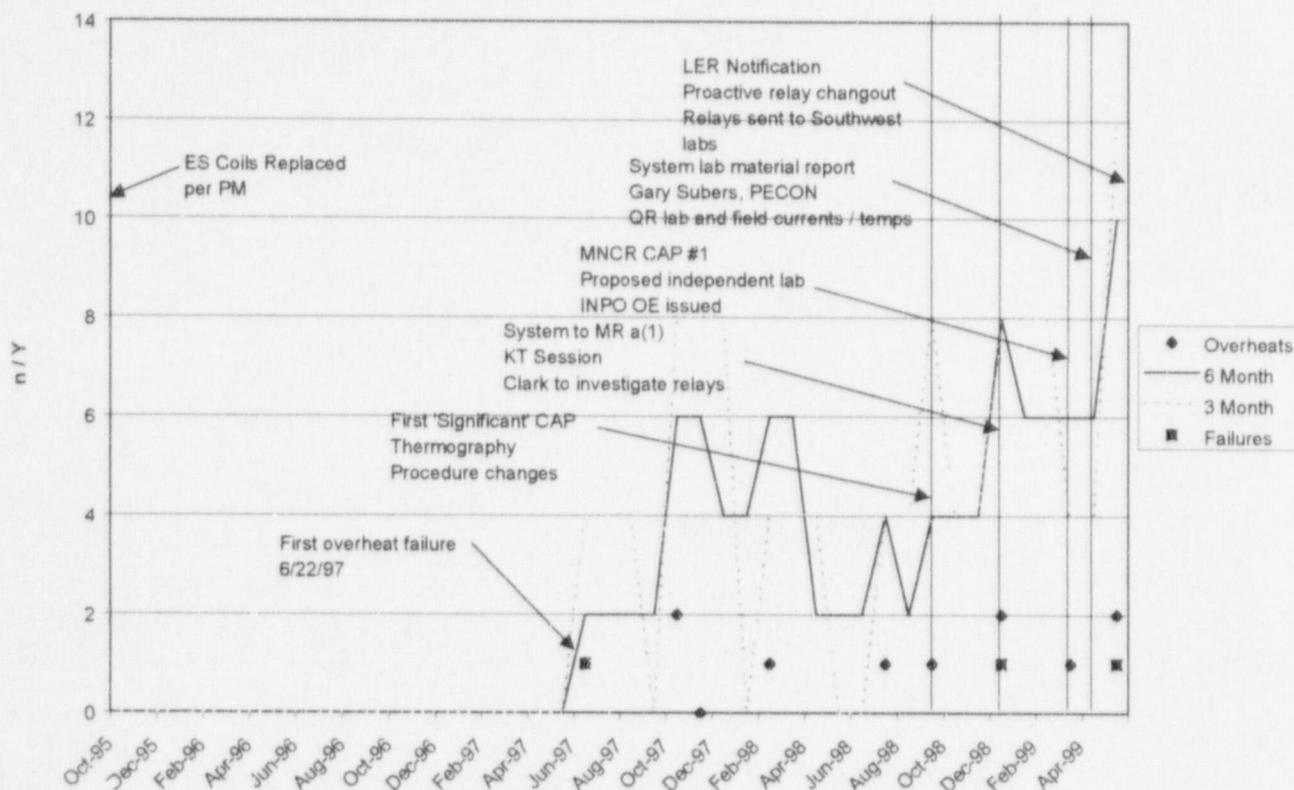
ESAS Relay Overheat Rate

In the period from June 1997 to June 1999, a total of 11 relays have overheated, resulting in the requirement to replace the relay coils. In two cases the coils overheated to the extent where a small flame was evidenced and in one case overheating resulted in the coil opening.

Nine of the eleven relays affected used TB 130-1 coils, the strongest coils available for this variety of relay.

Ten of the eleven relays that overheated were in the fan-out to component logic in the ESAS Actuation cabinets, in normally energized applications. In this application, if the relay coil were to overheat to the point of failing open, the relay would travel to its actuated state. Failure in this state places the ESAS for the affected components in one out of two logic, instead of the usual 2/3 logic.

Procedure changes have been made to have technicians check relays for signs of overheating following regularly scheduled surveillances that cycle ESAS relays.

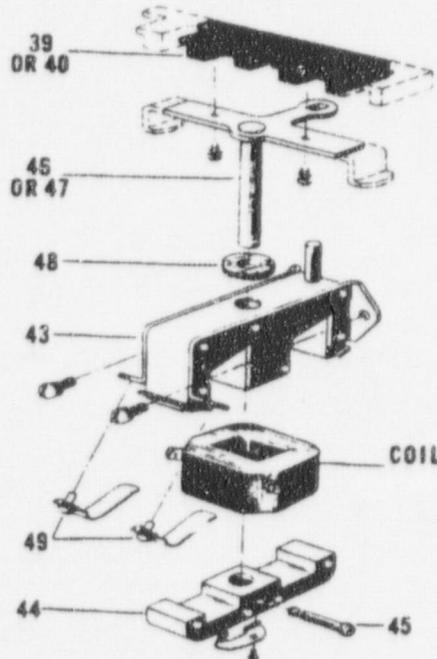
**Contact Arm and Magnet
and Rod Assembly**

Clark type PM relays are commercial grade industrial relays that are dedicated for use in safety related systems by GPU Nuclear. The following diagram details the assembly of the magnet kit and coil. Up to fourteen removable contacts are ganged and mounted to part 39 and 46.

TMI utilizes part 42, not 41 in its ESAS relays.

GPUN has identified an increased friction of the Magnet and Rod assembly, (piece #42) due to loose screws that mount the stationary magnet (piece #43) to the mounting plate. In addition, GPUN identified that increased friction of the relay contacts due to age related wear, and possible misalignment of the bottom-most two relay contacts as contributing to the increased force that relay coils must overcome.

- **Approximately 64 relays, including all 14-contact relays are planned to be replaced in 13R. Any spare, unused pairs of contacts on these replacement relays will be removed.**
- **All relays will be inspected and have the screws that mount the core piece to the mounting plate tightened in 13R.**
