LICENSEE EVENT REPORT (LER)

FACILITY NAME (1)  
Susquehanna Steam Electric Station

TITLE (4)  
Two Scrams Due to Water in Crossaround Pipe

SUSQUEHANNA STEAM ELECTRIC STATION  
LICENSEE EVENT REPORT 84-017-01  
ER 100450 FILE 841-23  
PLAS - 233

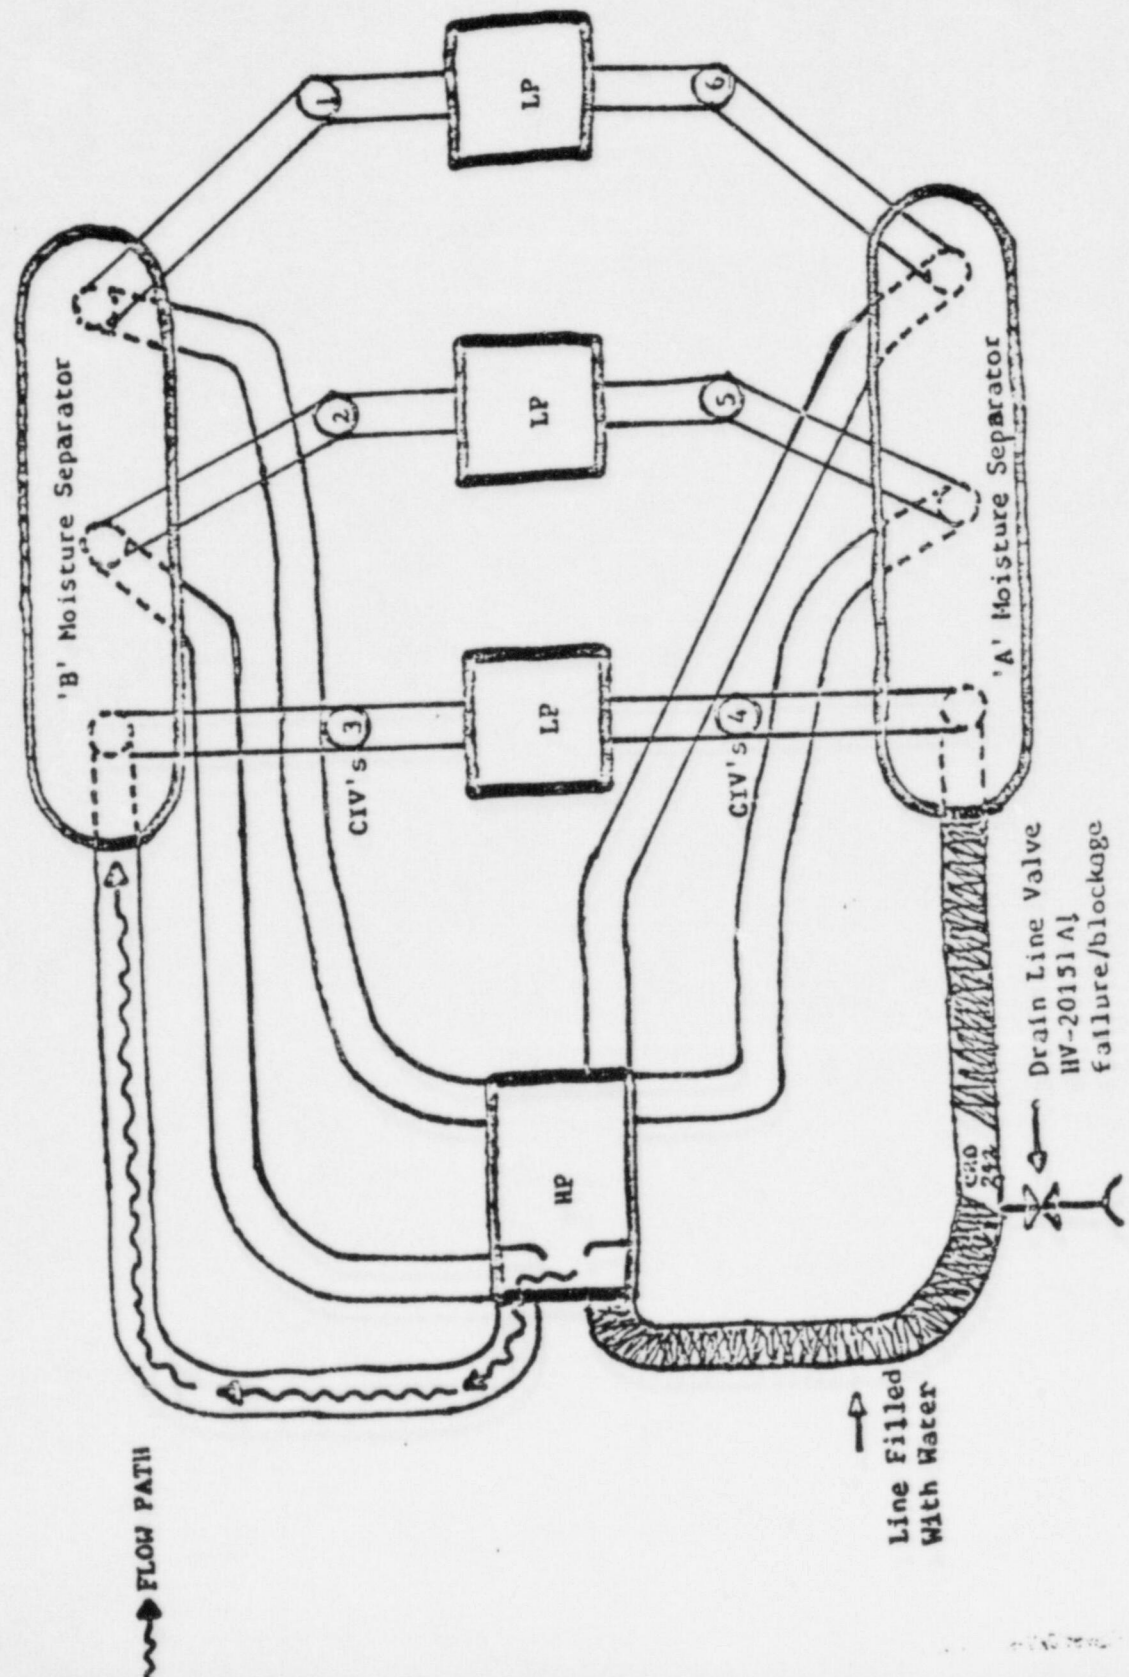
FLOW PATH

The resulting scenario was developed to explain the relationship between the moisture separator level problems and the crossaround piping damage: Drain valve HV-20151A1, located on CRO-242 was not cycling as required during normal turbine startup. The result was that when CIV4 was cycled during testing, it caused a pressure differential on moisture separator "A" which was sufficient to force water out of CRO-242, into the belly of the high pressure turbine and out into the "B" moisture separator crossaround line to moisture separator "B". This extra water could not be handled by the moisture separator's drain and dump system and resulted in the drain tank high level.

Line Filled With Water

Drain Line Valve  
HV-20151A  
failure/blockage

The crossaround piping was drained and the drain valve operator (Limitorque SMB-000) was successfully reworked. A test procedure (which required the installation of special monitoring instrumentation) verified a drain path from each of the six (6) crossaround lines prior to performing additional CIV testing, which was performed at 5% power increments from 20% to 50%. No scrams occurred during this testing. The manways on the remaining five (5) crossaround lines were removed, a cleanliness inspection was performed and the manways were re-installed.
