SG-99-04-005, Revision 3

**South Texas Project
1RE08 Outage Condition Monitoring Report
and
Final Operational Assessment**

August 1999

Westinghouse Electric Company LLC

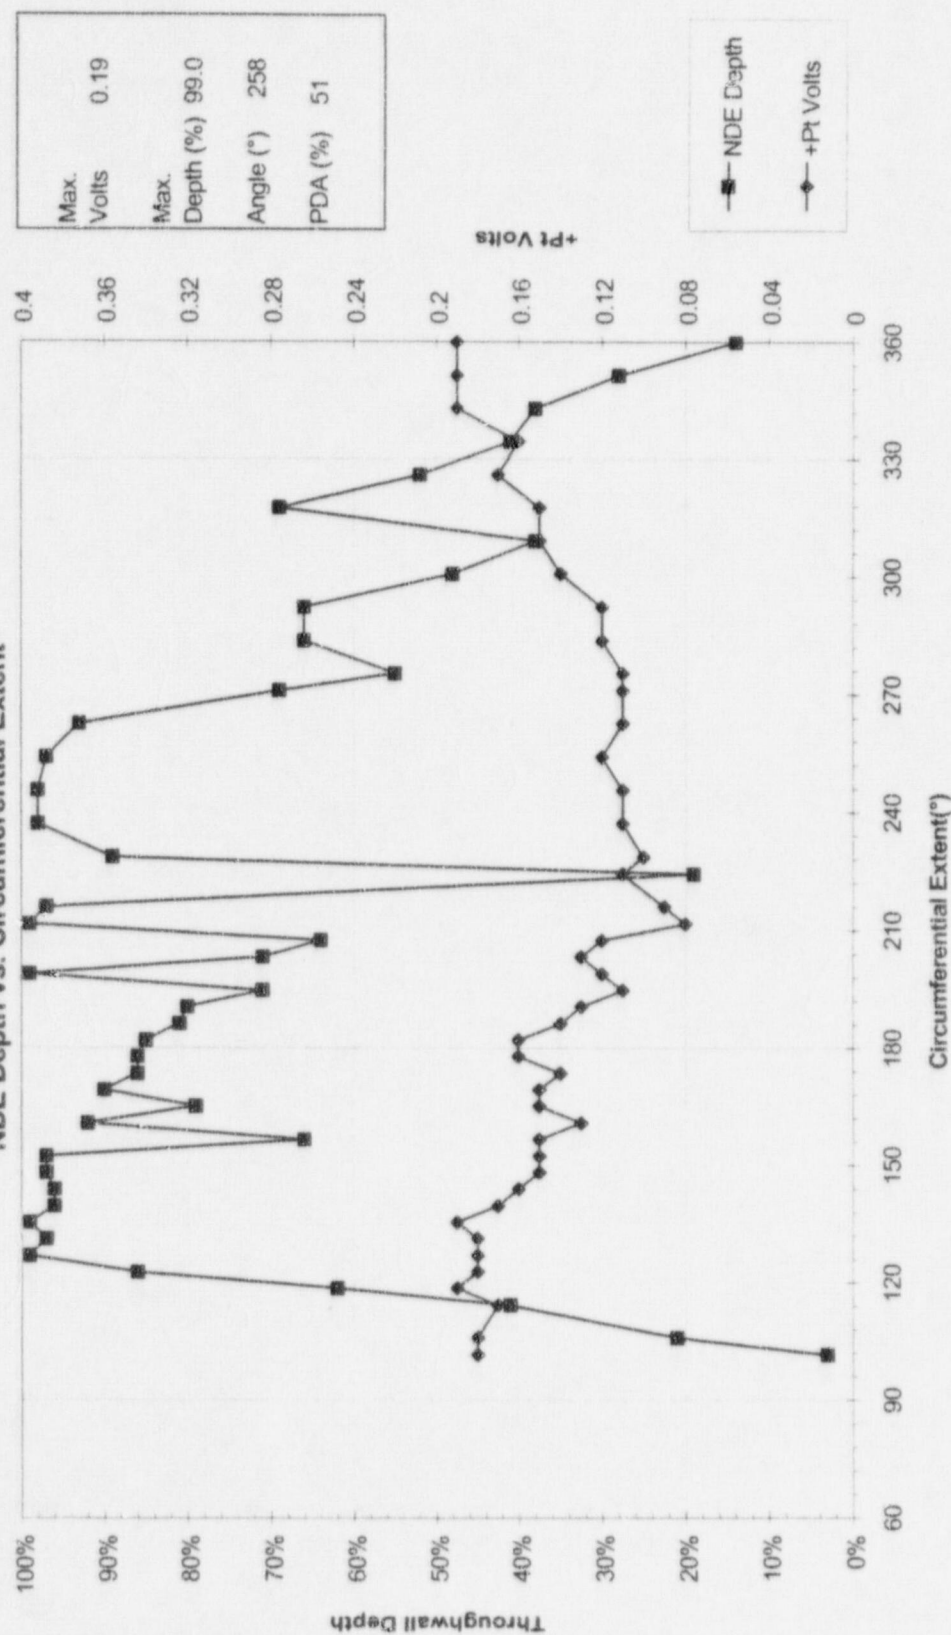
Figure 2

The total ding population (>0.75 volts by bobbin) for STP Unit 1 is 8297 dings, and includes cold leg, hot leg, and U-bend dings. The number of dings > 5 volts is 475. All dings > 5 volts were +Pt inspected. A circumferential indication was reported in a 3.91 volt ding, located about 2.1" below the bottom of the top cold leg TSP, in tube R43 C42 in SG D. A second circumferential indication was reported in tube R42 C68, located about 14" below the bottom of the top cold leg TSP, SG C. This indication was observed in a 0.77 volt ding. Both were detected while traversing from the 11C cold leg TSP to a ding to be inspected near the 12C TSP. The NRC agreed that a 20% RPC sample of all dings was a sufficient sampling program, and requested that all reported circumferential freespan indications be in situ pressure tested. A total of approximately 815 dings were +Pt inspected as part of the initial program scope. The +Pt ding inspection was expanded to include 20% of the total ding population, or approximately 1700 dings. One additional circumferential indication was detected in R37 C55, SG C at 6.5" below the 11C TSP as part of the expansion program. The NRC was informed of this condition, since detection of freespan circumferential indications represents a new degradation mechanism. Based on the manufacturing details, it was judged that the most likely location of such indications would be within about 25" of the bottom of the upper TSP, in Rows 30 and greater. All dings in this region in SG C were +Pt inspected. All freespan circ indications were leak and proof in situ pressure tested to 5000 psi, or approximately 16% greater than the 3ΔP based circumferential flaw proof test pressure of 4315 psi. There was no reported change in the +Pt characteristics of these flaws following proof test to 5000 psi. This suggests that either the flaws are smaller than indicated by the depth profiles or could possibly be false calls. A summary of the pre and post in situ test NDE results are provided in Table 5 for these flaws. A graphical representation of the pre and post NDE depth profiles for these larger indications is provided in Figures 2, 3, and 4.

South Texas - R42C68 - TSP11C (-14.2") SGC

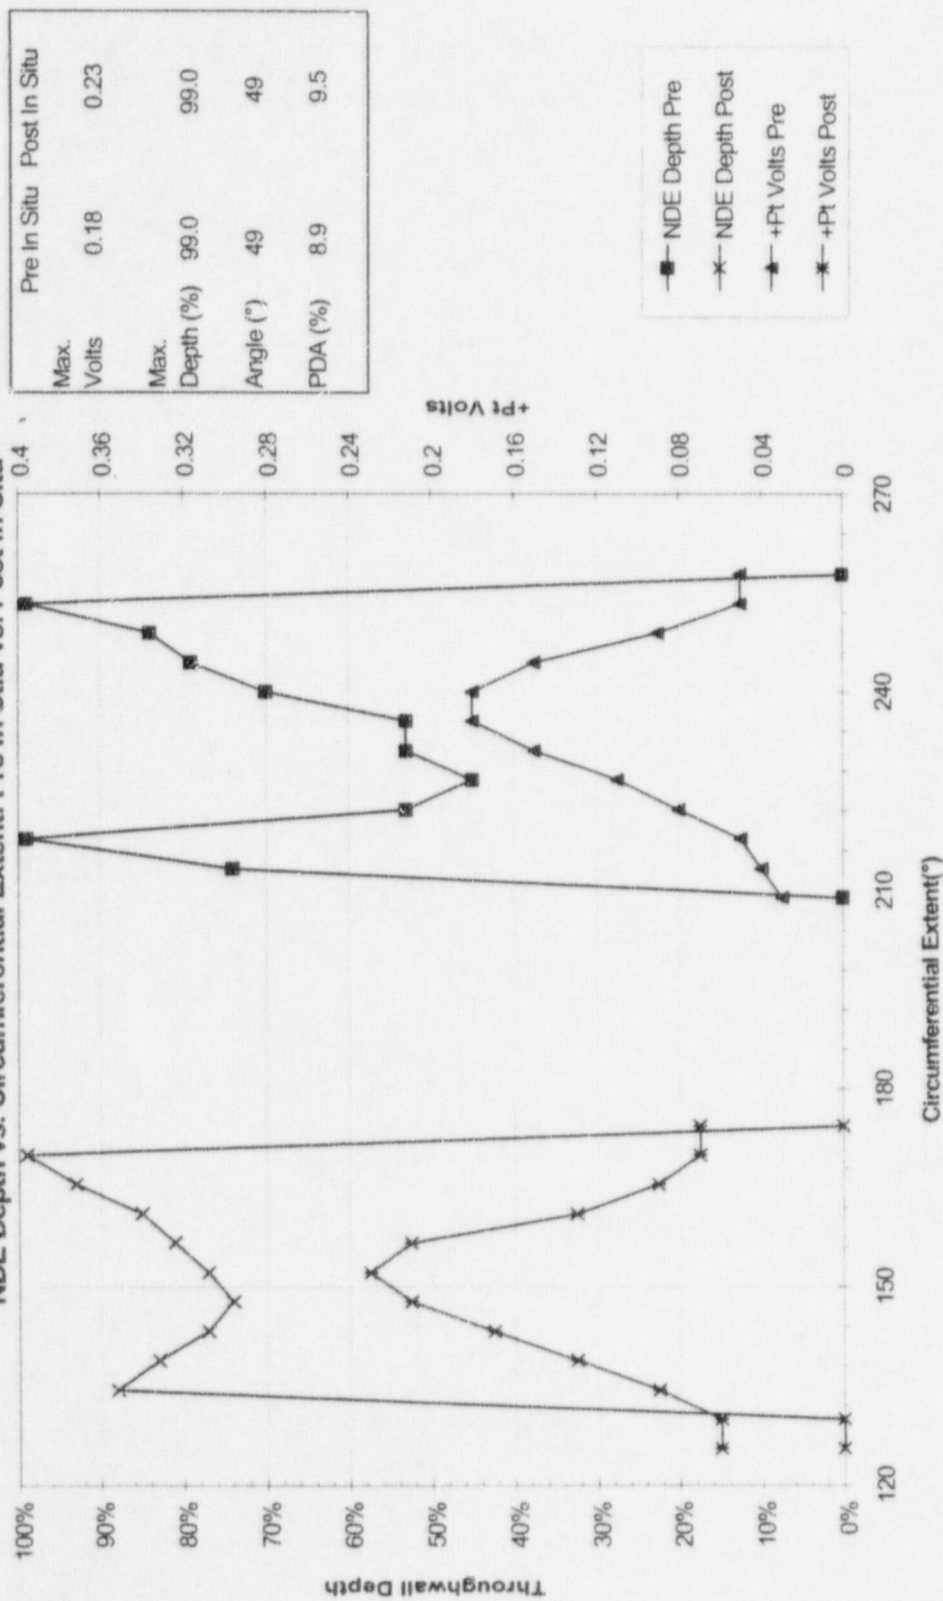
Figure 3

NDE Depth vs. Circumferential Extent: Pre In Situ vs. Post In Situ

Max. Volts	0.18	0.23
Max. Depth (%)	99.0	99.0
Angle (°)	49	49
PDA (%)	8.9	9.5

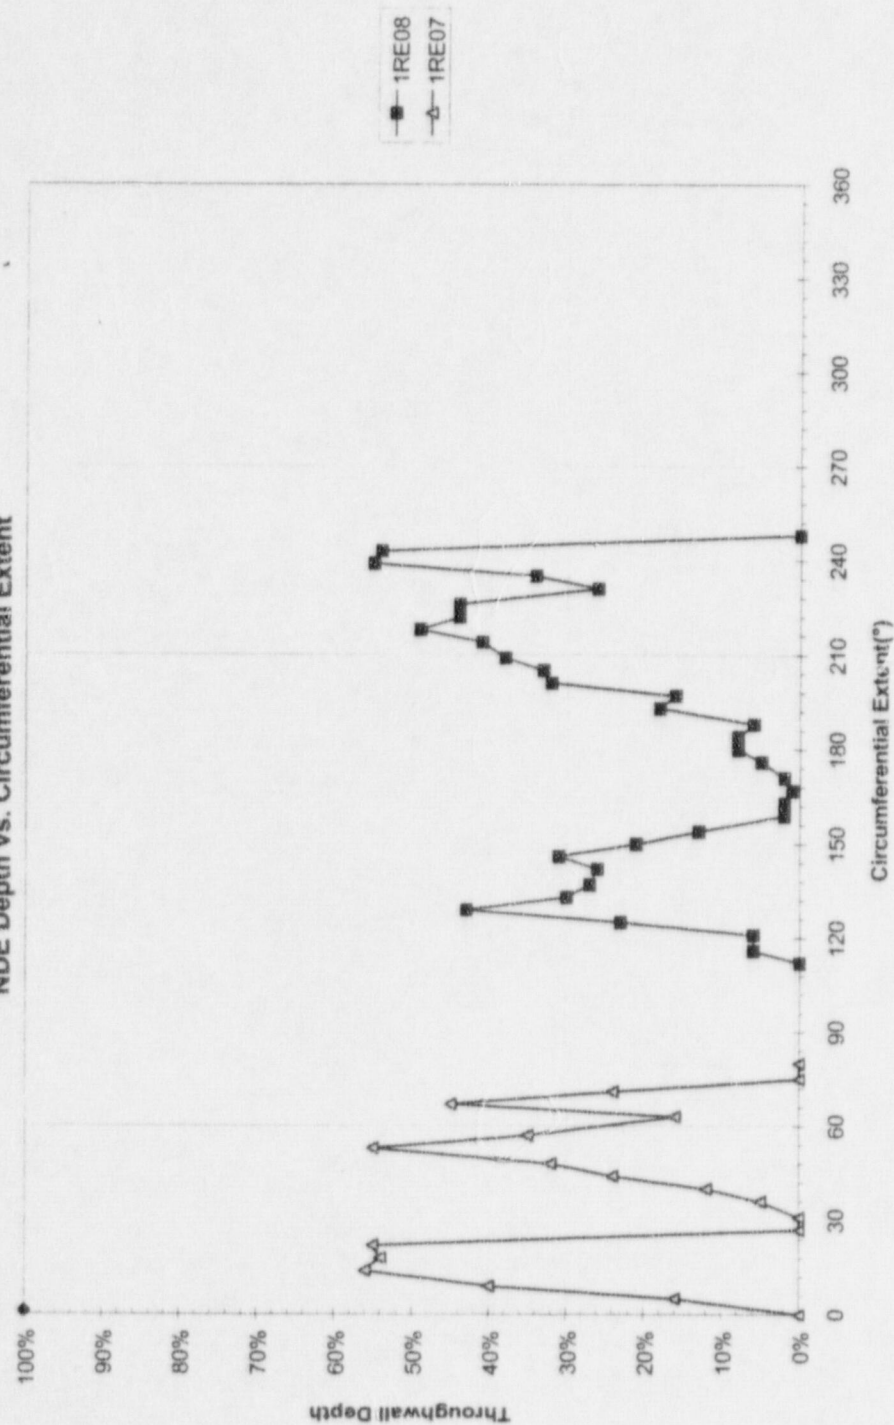
Figure 9

The 4 largest arc length circumferential indications ($> 100^\circ$ arc) and one with a reported depth of 100% from profile analysis reported at the hot leg TTS were reviewed for arc length growth. The 1RE07 hot leg TTS RPC data (115 mil pancake coil) was reviewed to determine if these flaws were present; all were determined to be observed using the 1RE07 data, based on the knowledge of a

STP Unit 1 - R23C73 - TTS - SG C
1RE08 vs 1RE07 115 pancake coil
NDE Depth vs. Circumferential Extent
