SUBJECT: MEETING SUMMARY - ST. LUCIE AND TURKEY POINT NUCLEAR PLANTS

**Florida Power and Light  
Nuclear Engineering /  
NRC Interface Meeting**

**September 8, 1999**

## **St. Lucie Unit 1 Manual Reactor Trip on Low Condenser Vacuum**

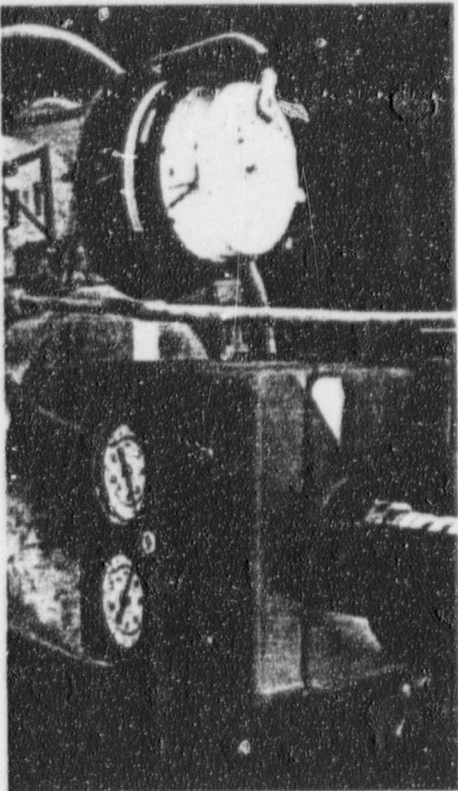
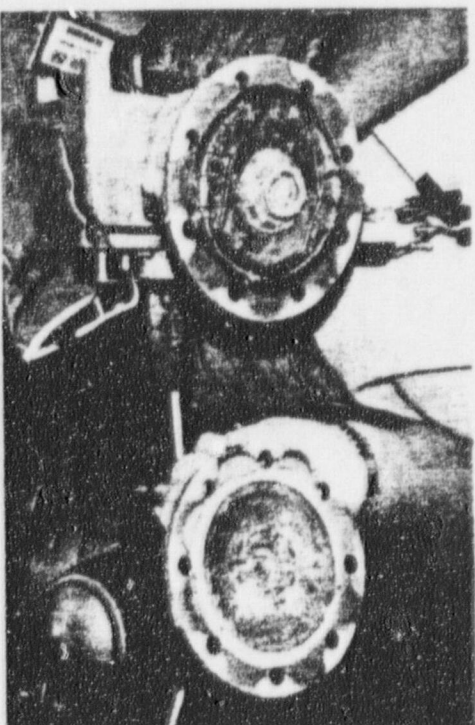
Actuator. Dirt and corrosion byproducts present

- Gland steam regulator failed, causing loss of low pressure turbine gland steam
- Pilot regulator malfunctioned due to plugged port
- Root cause is inadequate preventive maintenance (PM) on pilot regulators.
- Corrective Actions:
  - Replaced the failed pilot assembly (complete)
  - Inspected/tested all other Unit 1 gland steam regulators (complete)
  - Inspect/test Unit 2 gland steam regulators
  - Develop PM program for gland steam regulators for both units

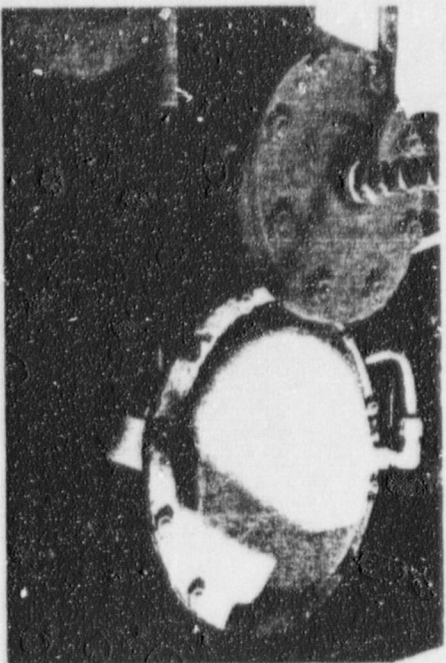
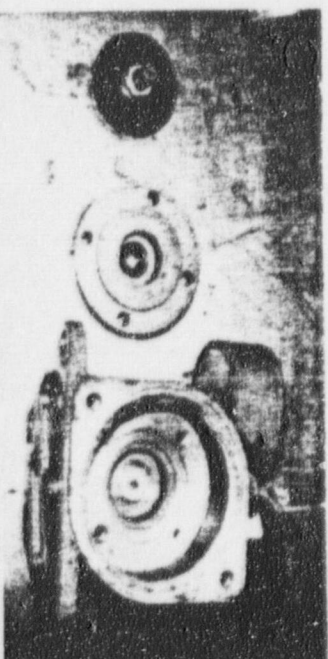
Pilot Regulator Nozzle : Powdery dirt found in supply port. Vent nozzle found binding due to dirt.

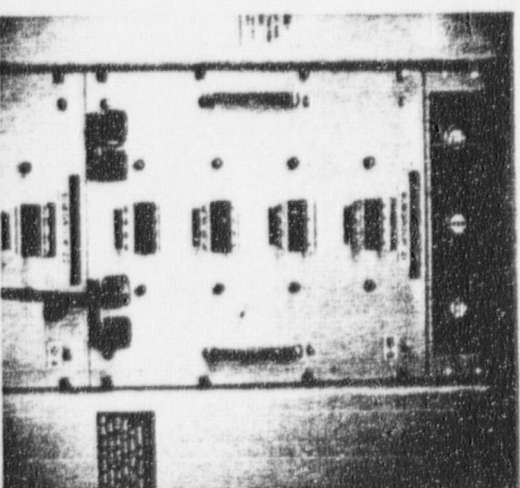
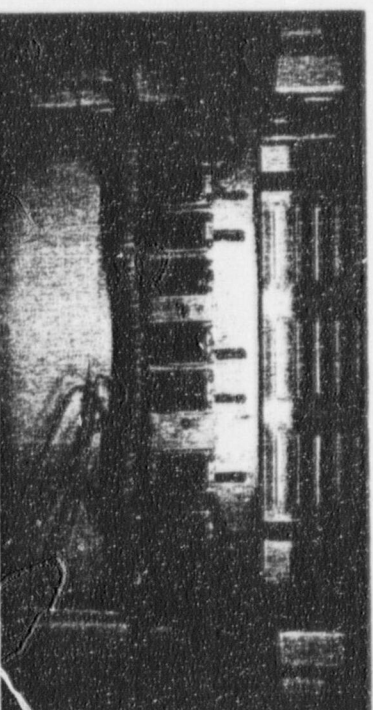
Power  
Switch 21  
Panel

- Replacement PS not seated into back plate
- Inadequate PS installation procedure.
- Blind transfer from hold bus was contributing factor.

- Phase-to-ground shorts found in PS 9, 21.
- Failed Mylar washer (PS-21).
- Anomalies (PS-9).

Power Switch back plate - view looking into  
cabinet with power switch removed

- Replaced PS-9, 21.
- Successful Megger test of CEDMCS.
- All coil traces verified to be acceptable.

1. Enhanced procedure for installing power switches
2. Megger test CEDMCS to detect grounds during Refueling Outages
3. Perform Coil checks of 25% of CEA's during quarterly FLC EA tests

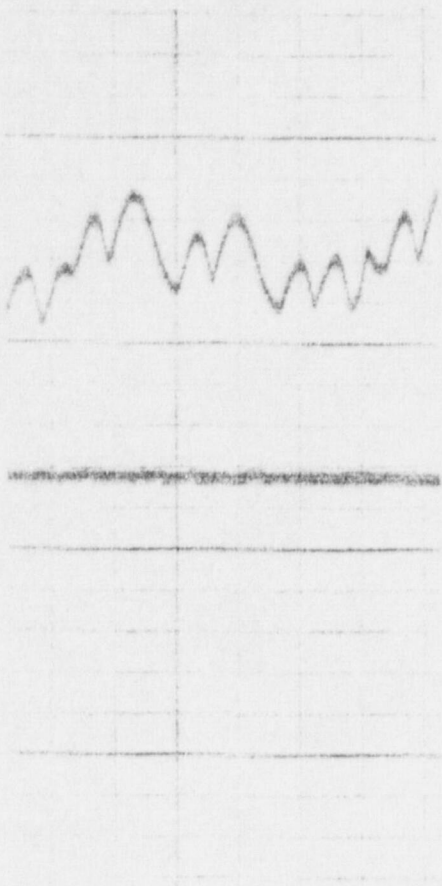
*Handwritten:* CEA #38

CEA #38 As-found condition shows an erratic upper gripper coil waveform caused by a missing phase in the power switch.

CEA #38 After repairs. Upper gripper coil trace shows a waveform balanced between the three phases. There are no indications of noise superimposed on the signal.

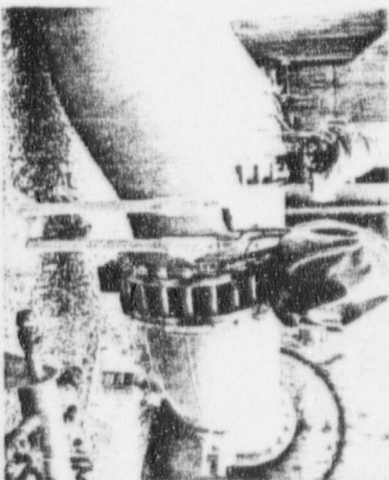
24" ECCS PIPE FROM RWT TO PIPE TUNNEL

- **Unit 1 (1996)**
  - Indication of "through wall leak" on 24" line at circumferential weld
  - Minor leakage, NO SAFETY SIGNIFICANCE
  - Defect removed and branch connection installed to arrest leak

- Failure mechanism - stress corrosion cracking
  - Expanded inspection to include applicable circumferential welds
  - Applied protective coating to circumferential welds

- Replace piping during Spring 2000 refueling outage
- Install more corrosion resistant material
- Installation duration of 26 days at a cost of approximately \$1.7 million

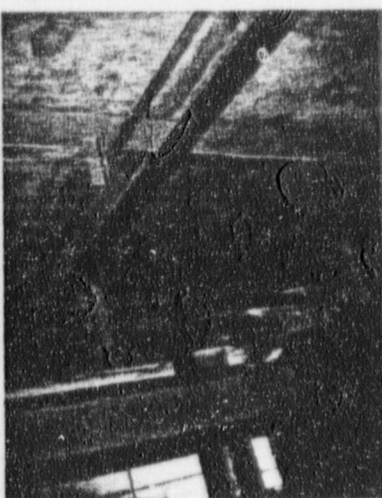
24" ECCS PIPE ENTERING PIPE TUNNEL

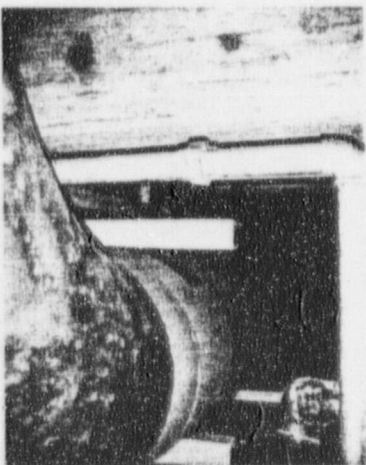
24" ECCS PIPE IN PIPE TUNNEL

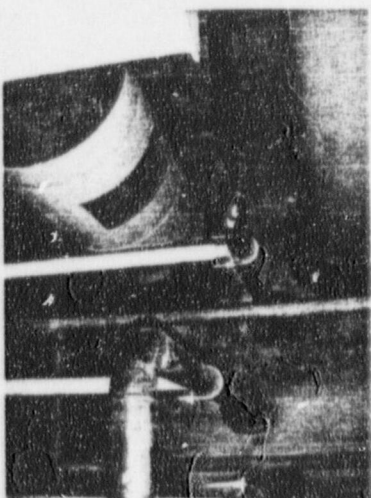
24" ECCS PIPE EXITING PIPE TUNNEL AT RAB EAST WALL

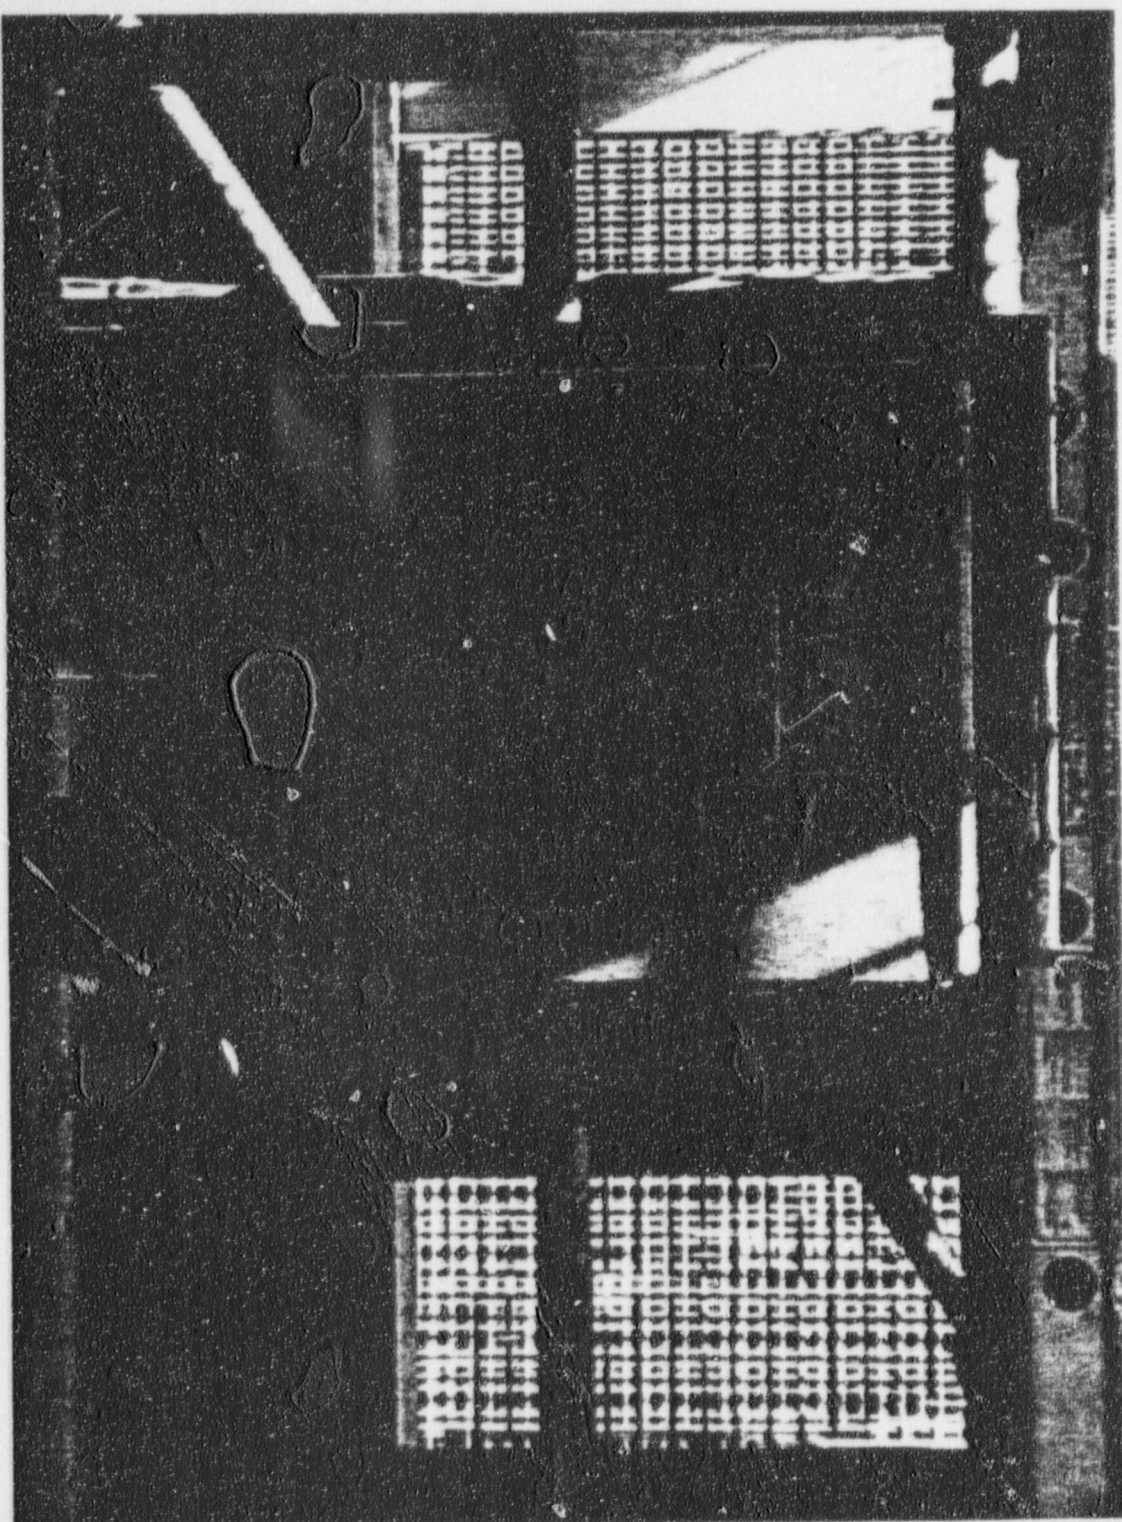
B1507 (NEMA-4) (View C)

- Limiting break locations potentially affect only two components:
  - MV-09-11 (AFW Pump 1C to S/G 1A)
  - Push button station for MV-09-12 (B1507)
- MV-09-11 is qualified to inside containment EQ criteria.
- B1507 will not be directly impacted
  - Distance from break to box is ~ 21 feet
  - Push button construction - an electrical box installed within a weathertight box
  - Line-of-sight to break location is severely limited due to several obstructions
  - Altran analysis shows that break influence is less than 11 feet
- Leakage Crack were also conservatively investigated.
  - 12 potential locations identified
  - Only 1 leak location potentially impacted redundant safety related equipment
  - closest equipment is ~ 13 feet
  - Altran analysis shows leakage crack influence is less than 3 feet
