KKL IN-SERVICE EXPERIENCE WITH

EPG - BALL VALVES

(NIAGARA MOHAWK TASK NO. GE-1)

OCTOBER 1986

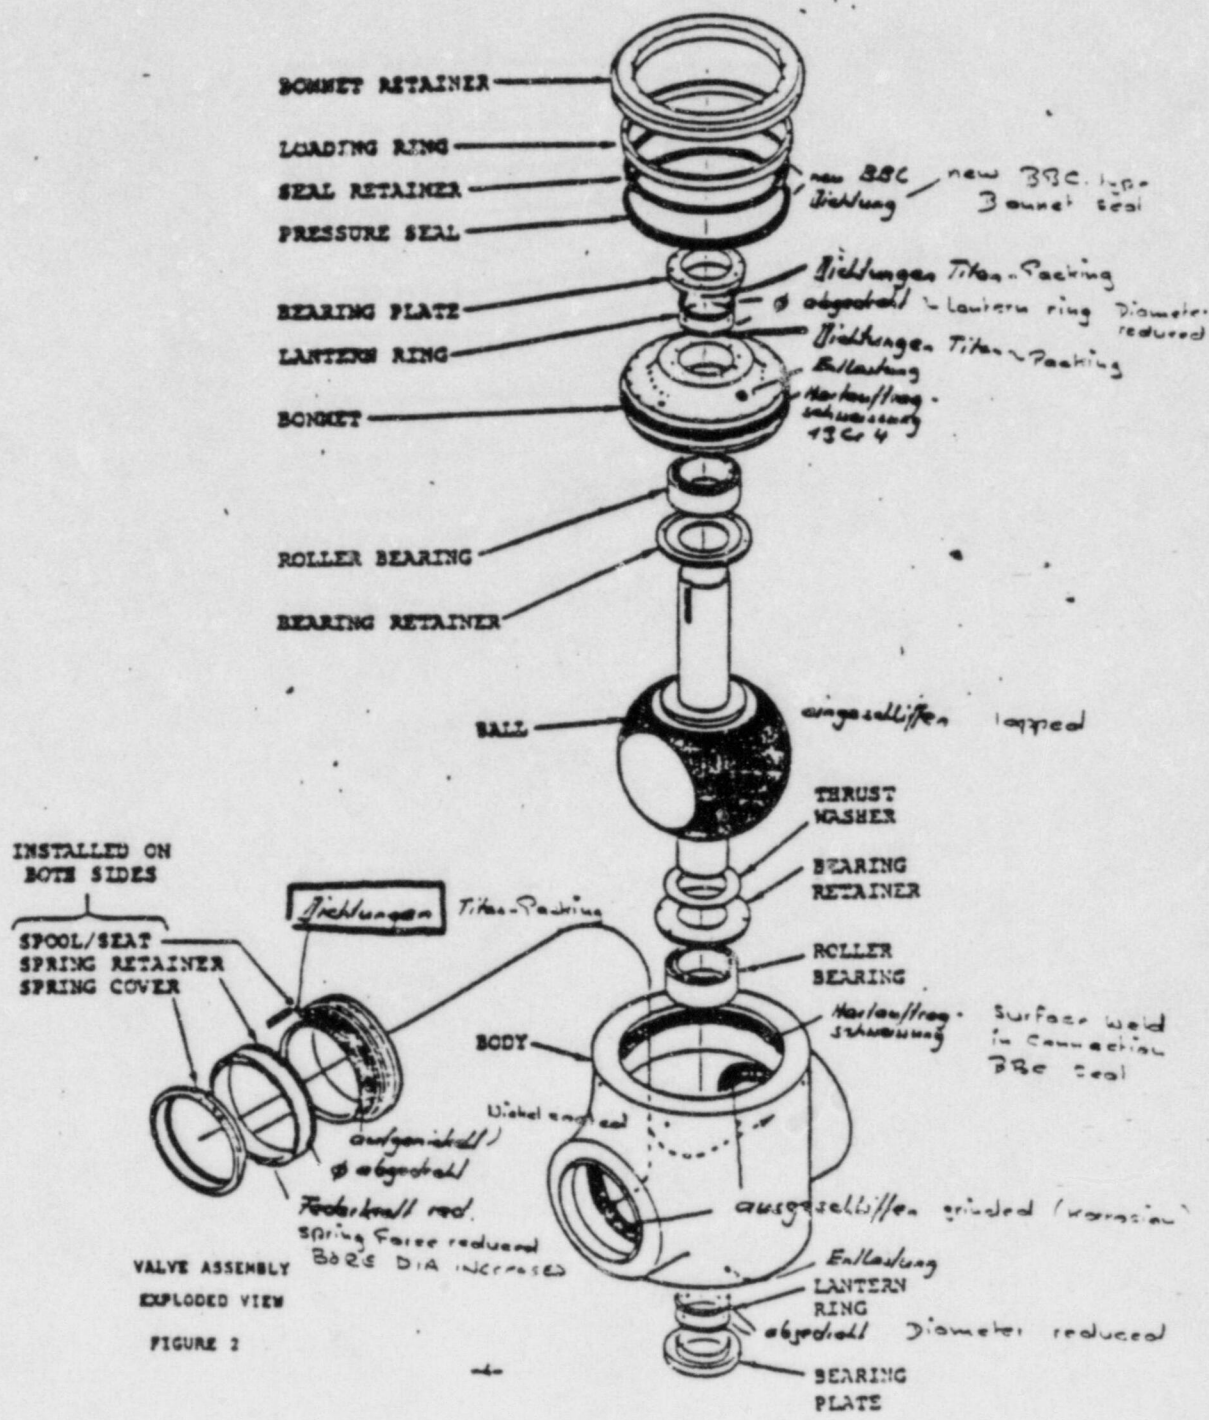
FIGURE 2

7.1 KKL identified that numerous problems were experienced with the EFCOMATIC Series 600 actuator. The problem areas experience are highlighted on the attached figures 2 and 3. The types of problems ranged from leaking seals, broken bracket, cracked roller bearing to misalignment of parts. Due to the short time schedule for the visit, specific details were not discussed for each problem area. Essentially, KKL replaced or repaired parts or re-aligned features depending upon the cause. Modification efforts were limited to beefing up the bracket and changing the mechanical manual trip lever.

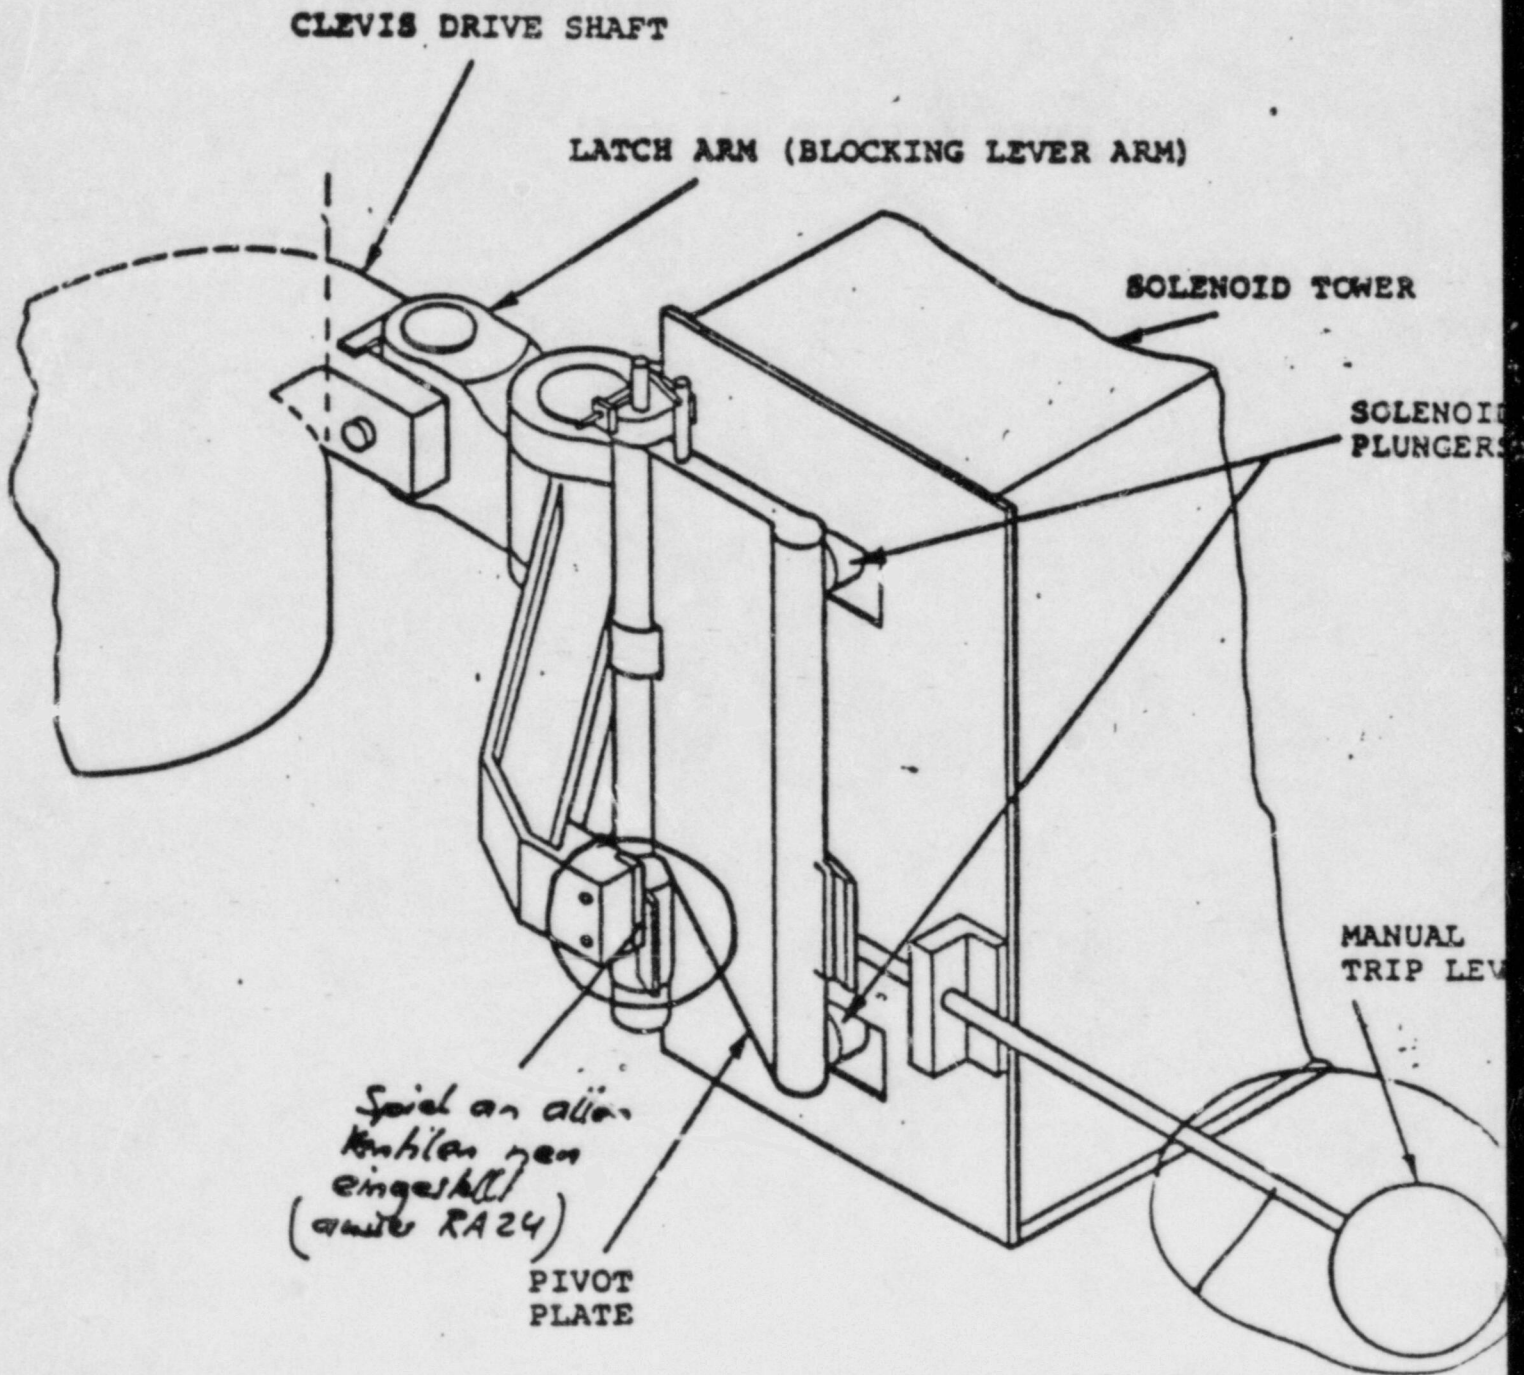
FIGURE 2-3

November 1983 - Modifications Complete, Testing Resumed - Problems were encountered with the latch mechanism. The problem was scoring and binding of the trip solenoid. KKL modified all solenoids by removing the seal (Seal Ring No. 28) which caused the binding.

November 1983 - MSIV 22 - Wouldn't close during functional test due to failure of the solenoid trip.

August 1986 - Valves were actuated with no pressure and only MS22 failed to close. The trip solenoid was frozen in place due to the lubricant which had hardened.

- 5.8 All trip solenoids were modified by removing the sleeve (PC #28) which had been the cause for malfunction on the feedwater valve.
- 5.9 The manual operator (actuator) trip lever was modified to permit manual mechanical tripping from the above flooring. In addition, the modified trip lever design incorporated a greater mechanical advantage to assure mechanical tripping of the actuator.
