SUBJECT: IE BULLETIN 80-20 CLOSEOUT

Closeout of IE Bulletin 80-20: Failures of Westinghouse Type W-2 Spring Return to Neutral Control Switches

CLOSEOUT OF IE BULLETIN 80-20:
FAILURES OF WESTINGHOUSE TYPE W-2
SPRING RETURN TO NEUTRAL CONTROL SWITCHES

FAILURES OF WESTINGHOUSE TYPE W-2 SPRING RETURN TO NEUTRAL CONTROL SWITCHES

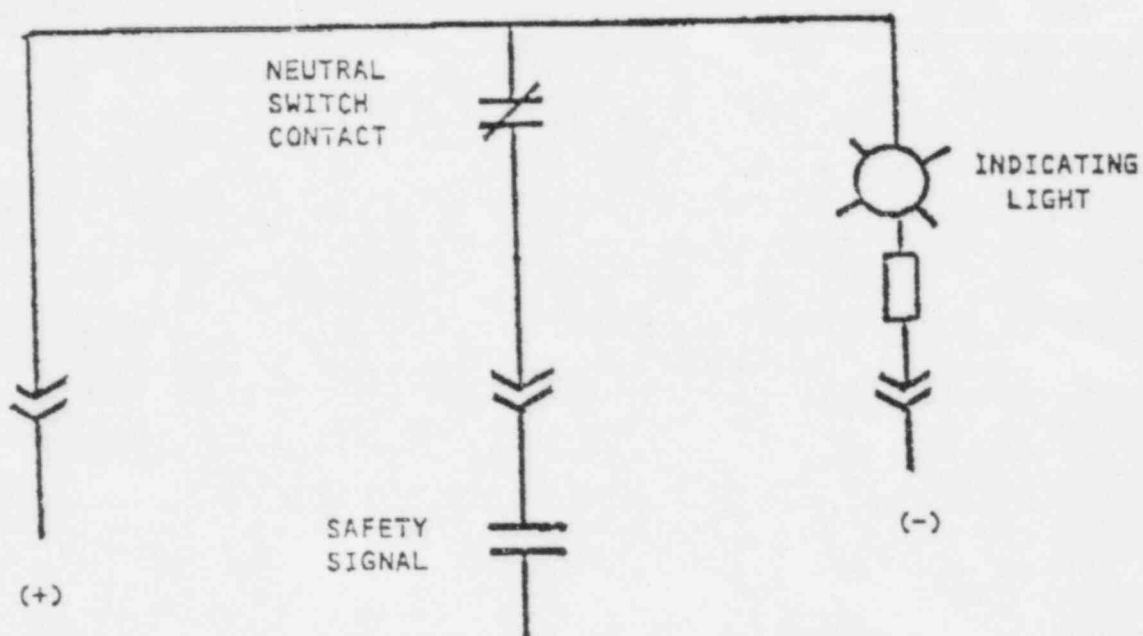
EXISTING INDICATING LIGHT CIRCUIT (TYPICAL)

Depending on how the indicating light circuit is wired, loss of continuity thru the neutral position contact of a W-2 switch could remain undetected until the equipment associated with the switch were called upon to operate. Since such a failure would be equivalent to by-passing the system associated with the switch, consideration should be given to rewiring the switches used in safety-related applications as shown in Figure 1. Such rewiring would provide an acceptable means for detecting contact failure, provided the indicating light is in the control room and readily visible by the operator. If the indicating light is not so located, consideration should be given to annunciating the neutral position contact failures at the control room to alert the operator of the inoperable status of a safety-related system. In addition, consideration should be given to adding redundant contacts to the W-2 switches or to replacing the W-2 switches with others having a more positive contact wiping action.

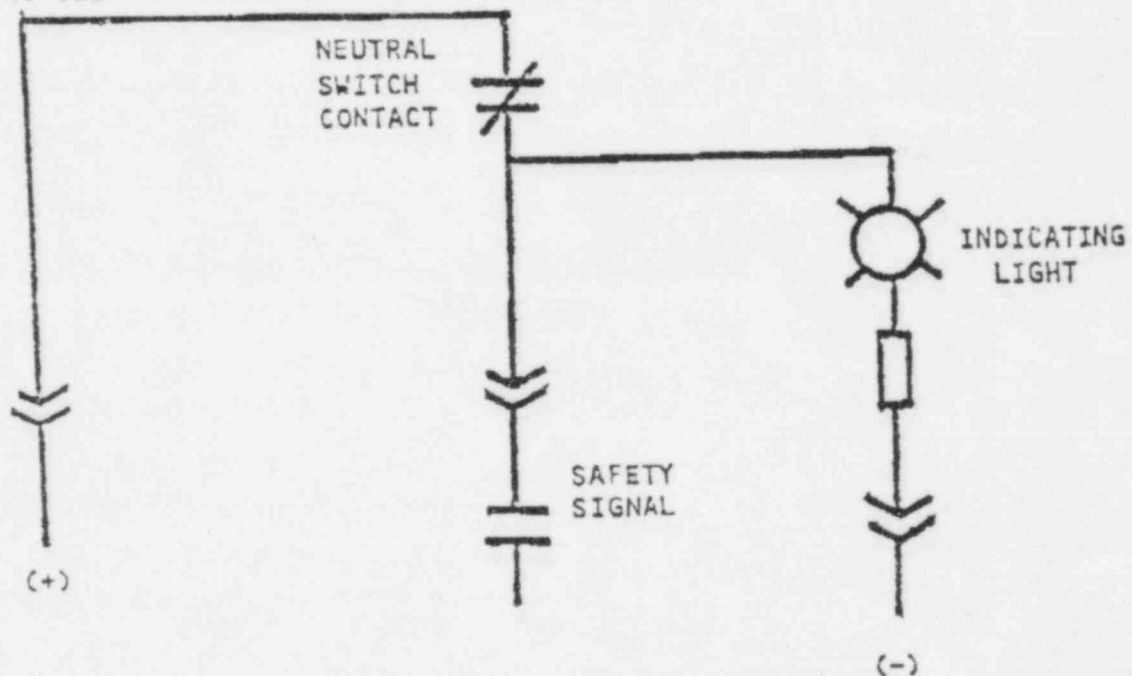
PROPOSED REWIRING OF INDICATING LIGHT CIRCUIT (TYPICAL)

REWIRING OF INDICATING LIGHT CIRCUIT OF W-2 SWITCHES
AS RECOMMENDED BY WESTINGHOUSE TECHNICAL BULLETIN NSD-TB-80-9

A review of this matter by Westinghouse led to the issuance of NSD Technical Bulletin No. NSD-TB-80-9 to the utility owners of all Westinghouse operating plants. The recommendations contained in the Westinghouse technical bulletin include: (i) testing the neutral position contacts of the subject W-2 switches for continuity, and (ii) rewiring of the indicating light circuit to permit the early detection of a neutral contact failure as shown in Figure 1.
