FINAL REPORT

REVIEW OF

HOMESTAKE MINING COMPANY

MILAN MILL

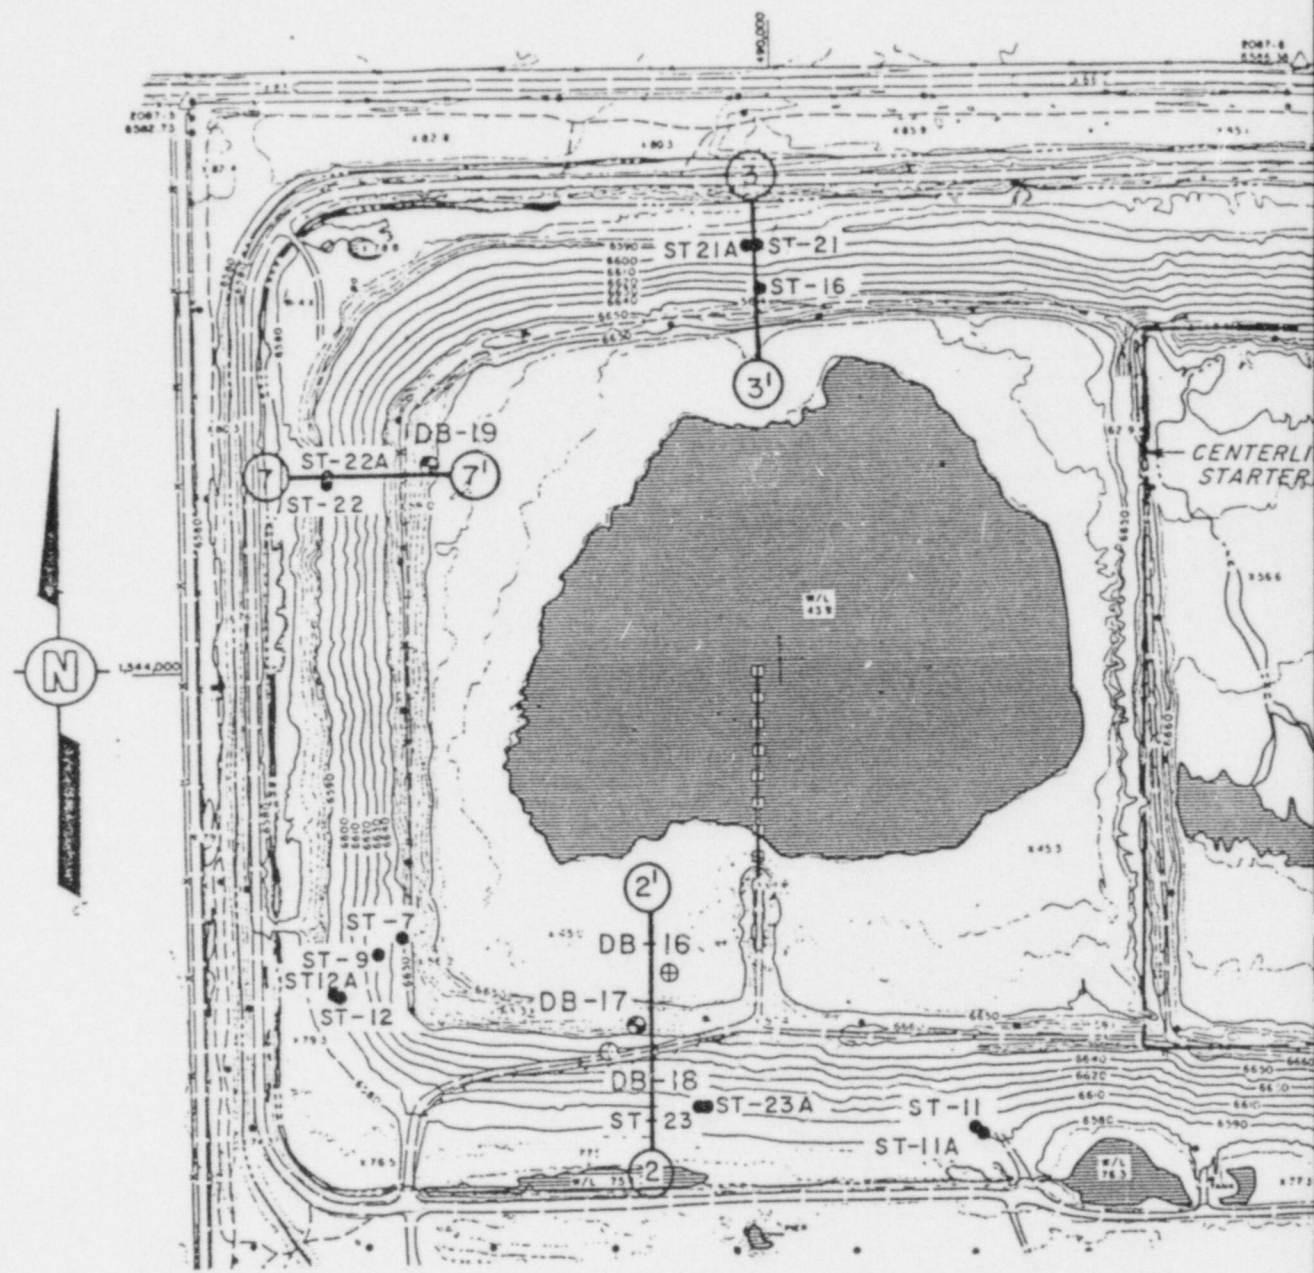
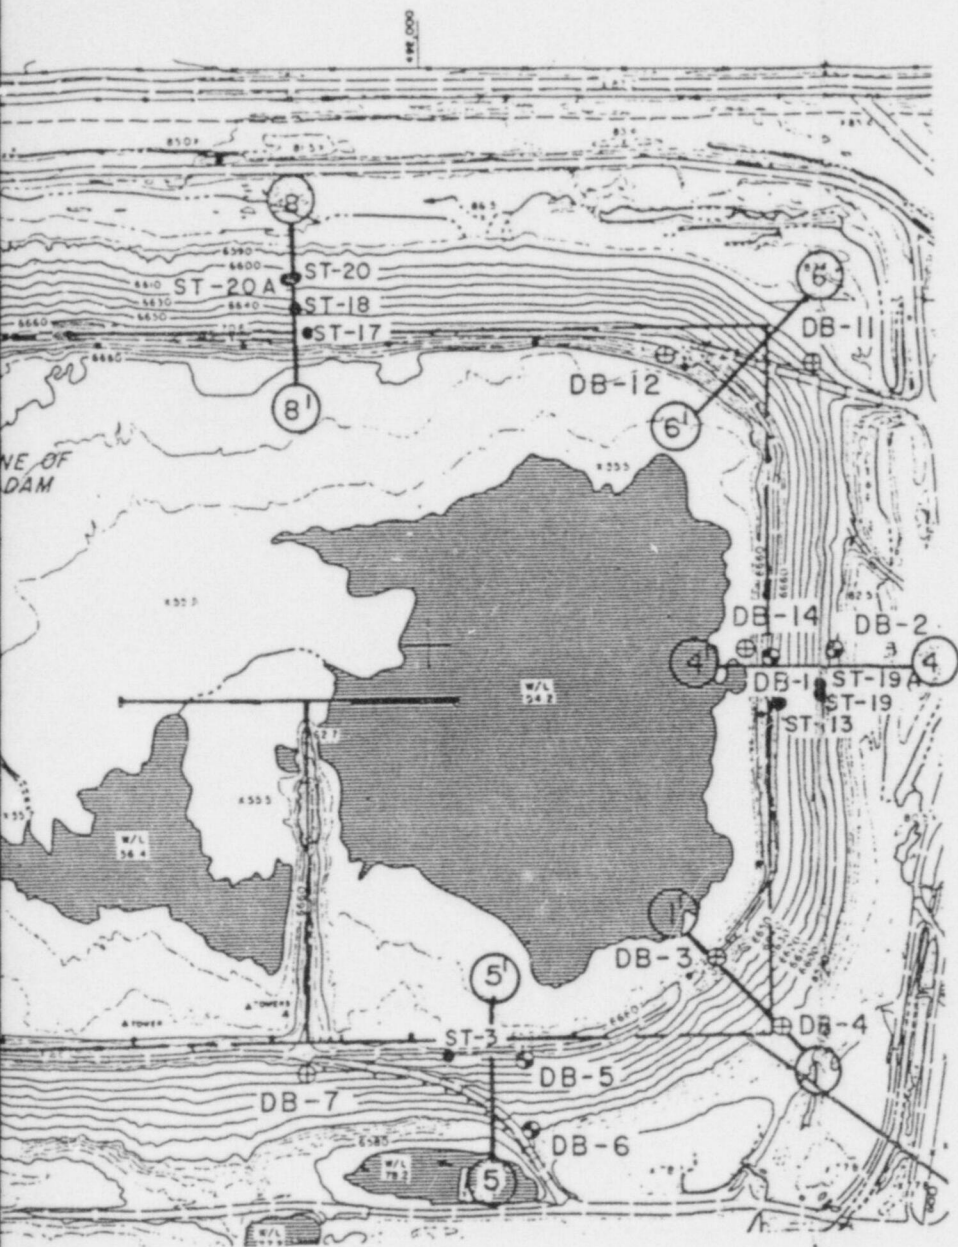
Figure 1

As noted in the D'Appolonia Report, stability analyses were performed on embankment cross sections taken at eight different locations (1-1' through 8-8', shown on Figure 1). Factors of safety at three locations, 1-1', 4-4', and 5-5' (Figure 1) did not meet the requirement of a 1.5 safety factor as specified in the NRC Regulatory Guide 3.11.

Additional slope stabilization was being performed at the time of the onsite examination in the area of Section 3-3' (Figure 1), which has a relatively low factor of safety as indicated in the table above. The slope stabilization consisted of moving the crest of the embankment towards the pond, resulting in a general flattening of the slope. Based upon the stability analyses performed, this procedure does increase the factor of safety of the slope.
