WCAP-11330

NRC PRESENTATION REPORT ON
STEAM GENERATOR TUBE INTEGRITY
FOR DC COOK UNIT 2, SEPTEMBER 1986

SEPTEMBER, 1986

WESTINGHOUSE ELECTRIC CORPORATION
POWER SYSTEMS
P. O. BOX 355
PITTSBURGH, PA 15230-0355

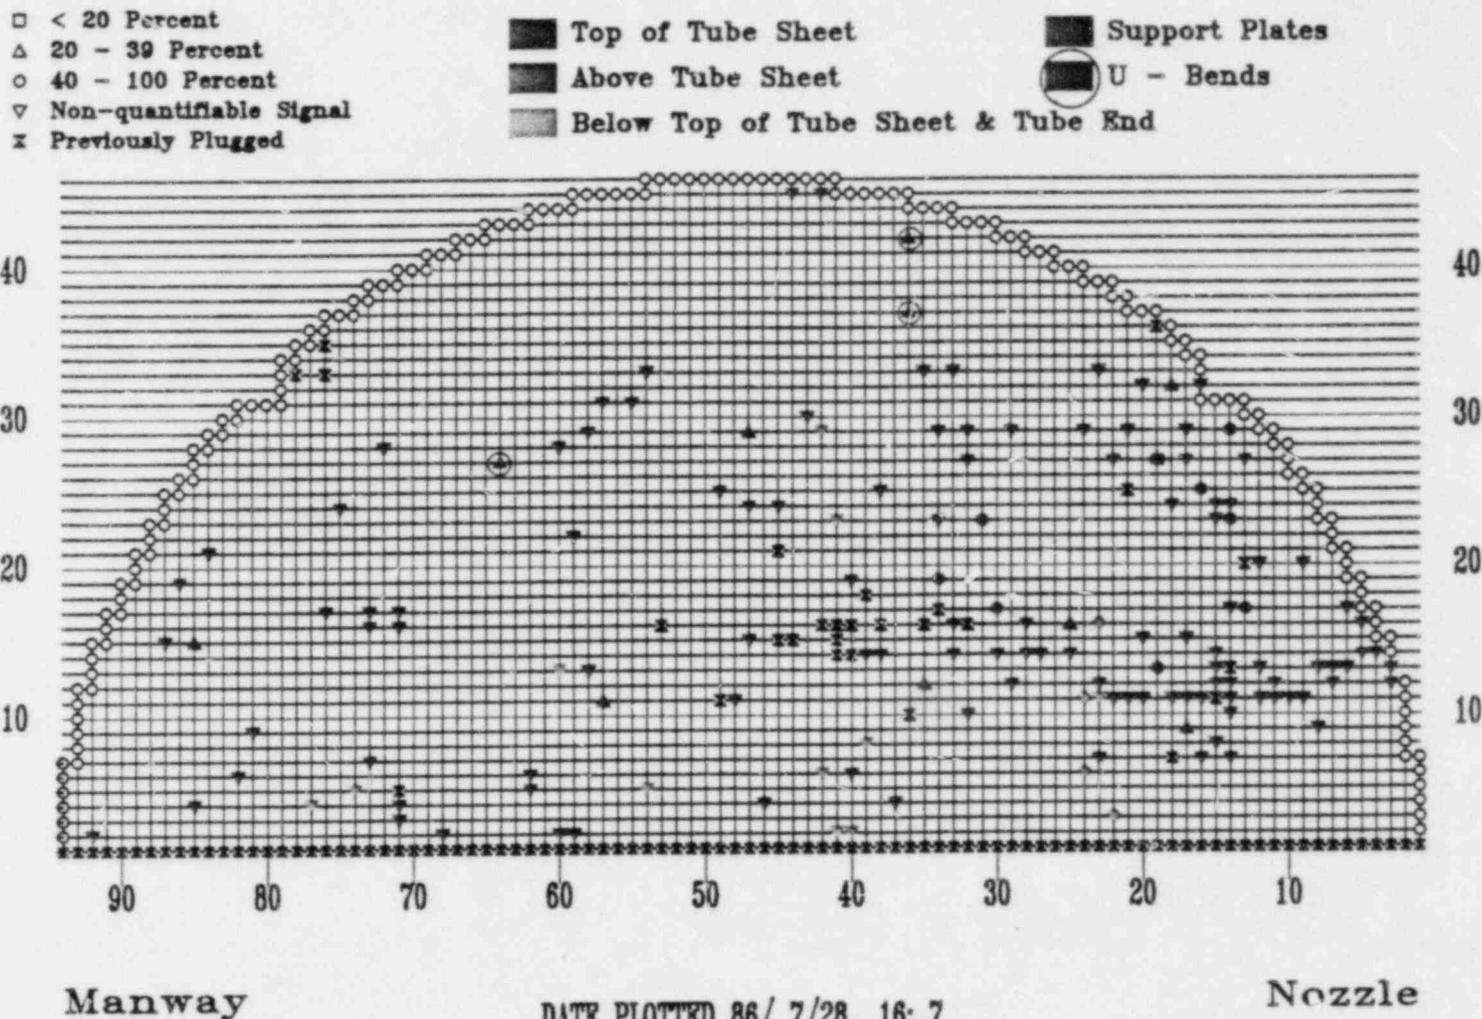
Figure 2.3.1

Figures 2.3.1 through 2.3.6 demonstrate the spatial location and extent of wall degradation in the steam generator tubing. Figure 2.3.6 indicates the areas of pluggable indications and demonstrates the contribution of pluggable indications both on the basis of quantifiable percent wall loss based upon typical eddy current data interpretation as well as the areas of less quantifiable interpretation which were administratively plugged. This figure shows that the crevice area is the dominant area of tube degradation followed by the area at the tubesheet surface (which is significantly influenced by the conservative plugging limit imposed in which all evidence of degradation was removed from service). Most importantly, tubes with wall degradation at the hot leg tube support plate intersections in excess of 40% wall loss have been removed from service.

March 1986 Hot Leg Inspection

% Indications/Non-Quantifiable Indications

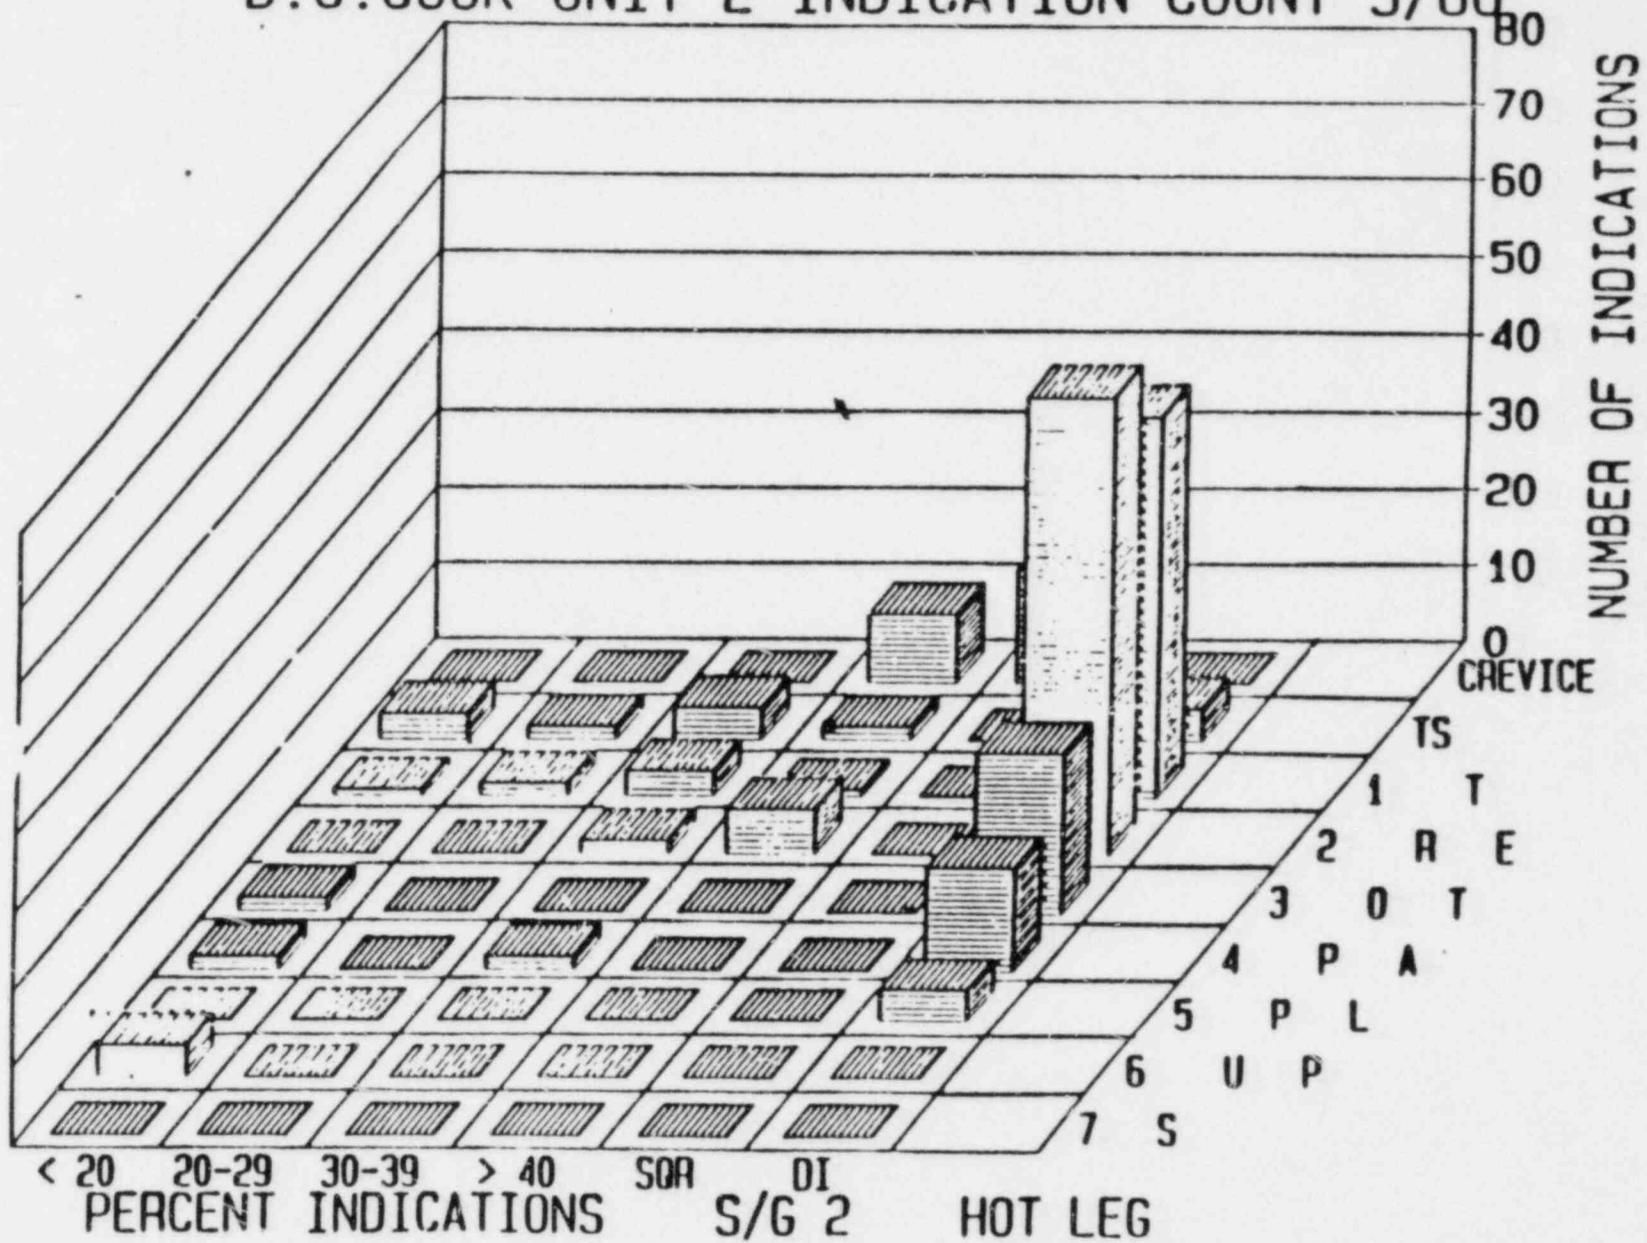
Figure 2.3.3

D.C. COOK UNIT 2 INDICATION COUNT 3/86

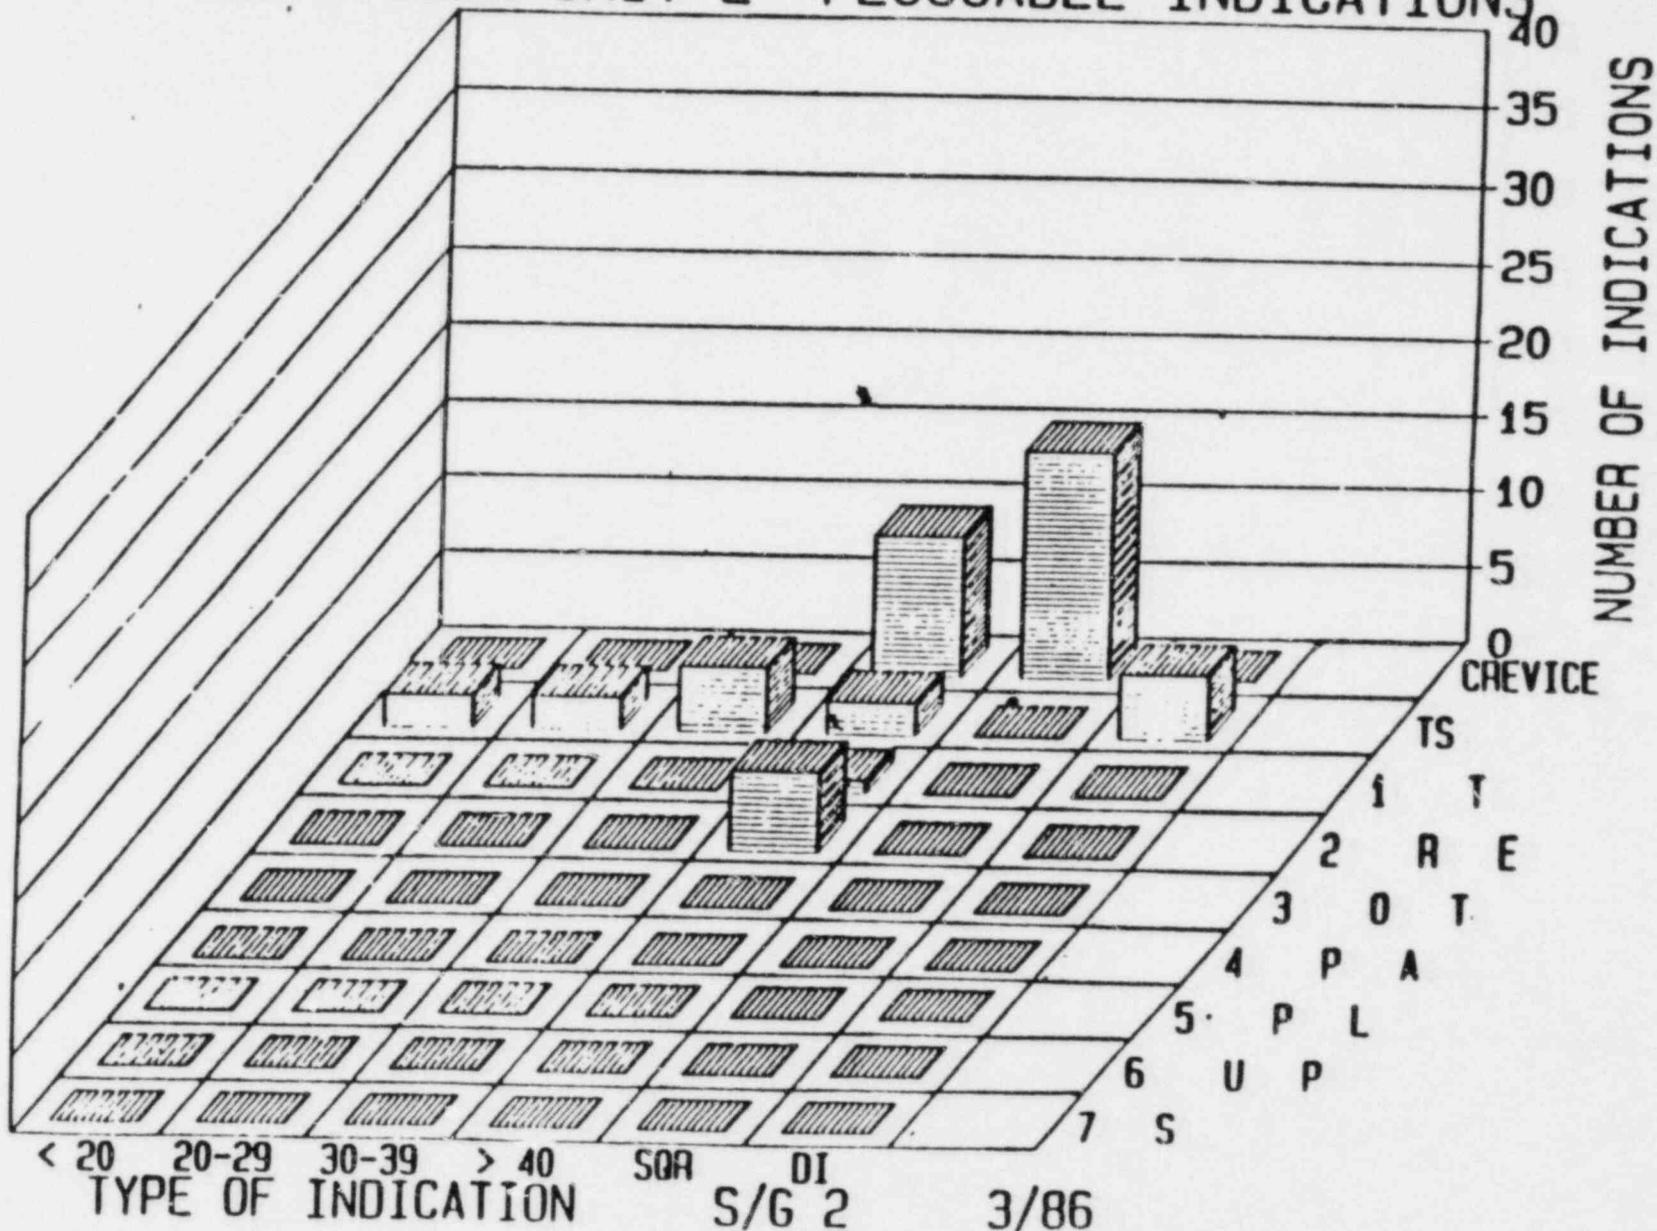
Figure 2.3.5

D.C. COOK UNIT 2 PLUGGABLE INDICATIONS
