# LICENSEE EVENT REPORT (LER)

FACILITY NAME (1) <b>DIABLO CANYON UNIT 1</b>	DOCKET NUMBER (2) <b>0500002751</b>	PAGE (3) <b>OF 04</b>
--	--	--------------------------

TITLE (4)  
**REACTOR TRIP DURING TESTING OF THE REACTOR TRIP SWITCHGEAR**

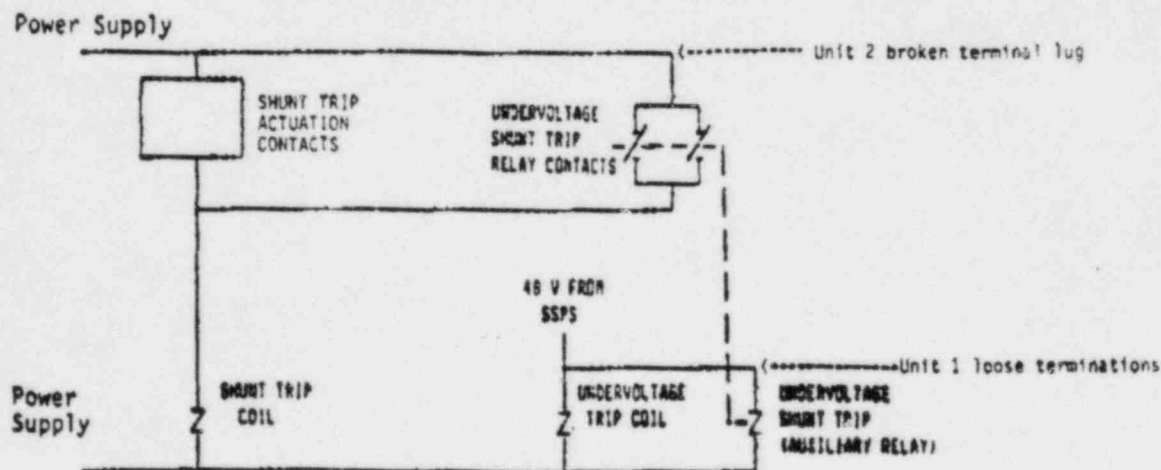
SIMPLIFIED SCHEMATIC REACTOR TRIP BREAKER UV AND SHUNT TRIP CIRCUITRY

A loose termination on the coil of the undervoltage shunt trip (auxiliary) relay momentarily broke contact, allowing reactor trip breaker A to open.

### C. Reactor Trip UV and Shunt trip circuitry simplified schematic.
