Subject: Request for Information on Westinghouse Rod Cluster  
Control Assembly Performance

### Summary of Visual Inspections of RCCAs at the Point Beach Nuclear Plant

# Westinghouse Rod Cluster Control Assembly Performance Review

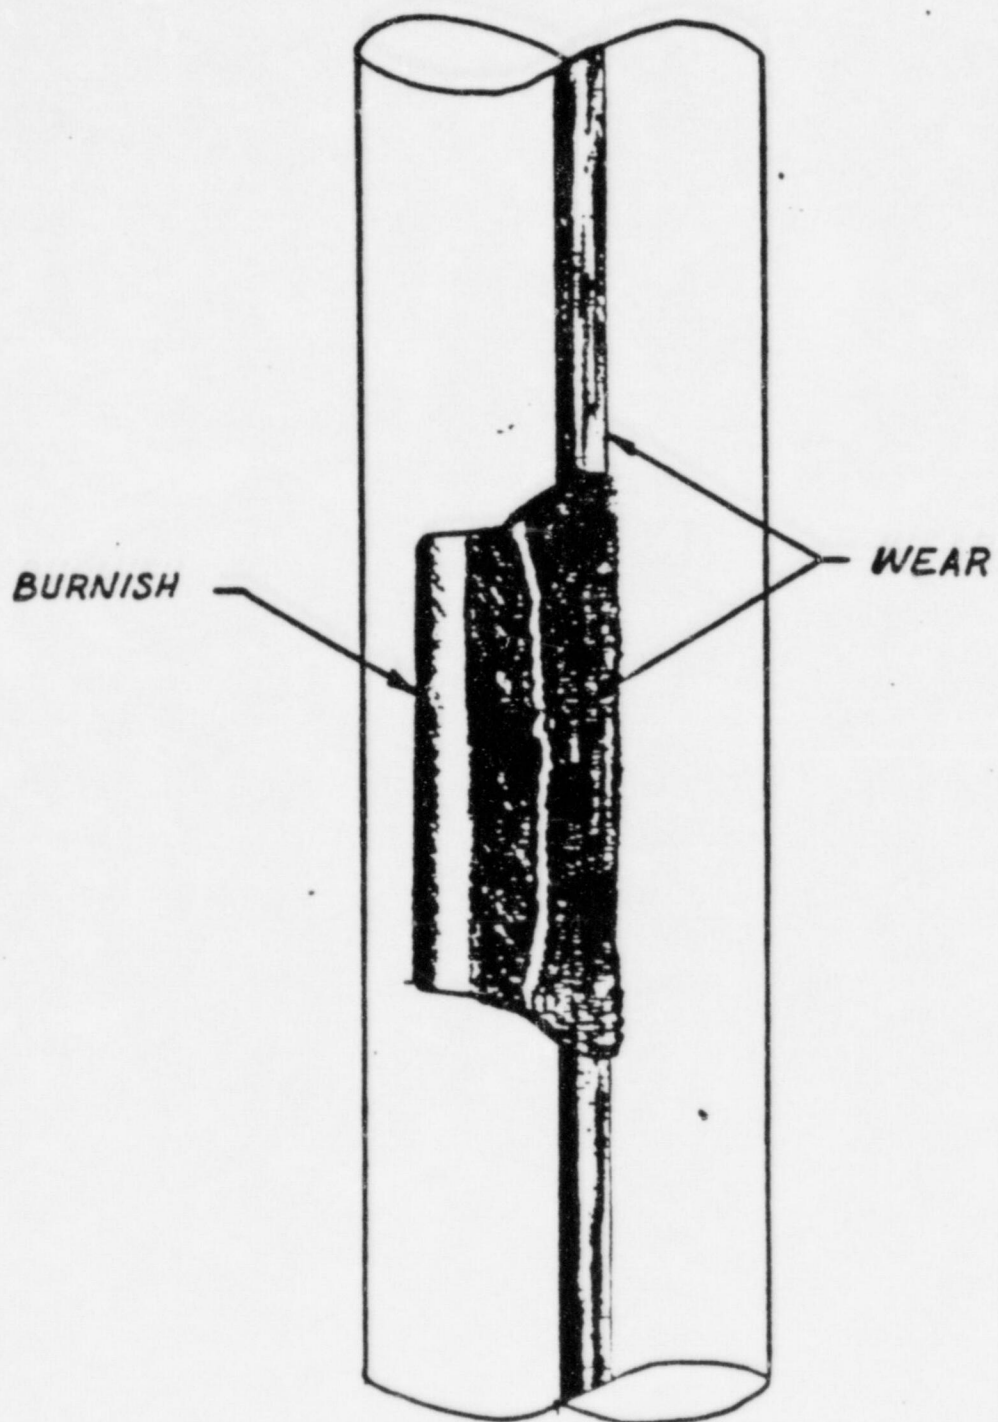
SKETCH SHEET

Two types of wear patterns were observed and are characterized as follows: (1) Axially continuous wear scar on the rodlet of varying depth probably caused by ROCA axial stepping motion and scrams; (2) Approximately one-inch long score marks at elevations corresponding to the guide plate surfaces.

The wear indications are predominantly on the portion of the cladding surface facing the center or hub of the ROCA. The attached sketch shows wear patterns which are typical of the worst observed wear. Note that, by design, some wear is expected due to contact between the ROCA rodlets and the guide surfaces.

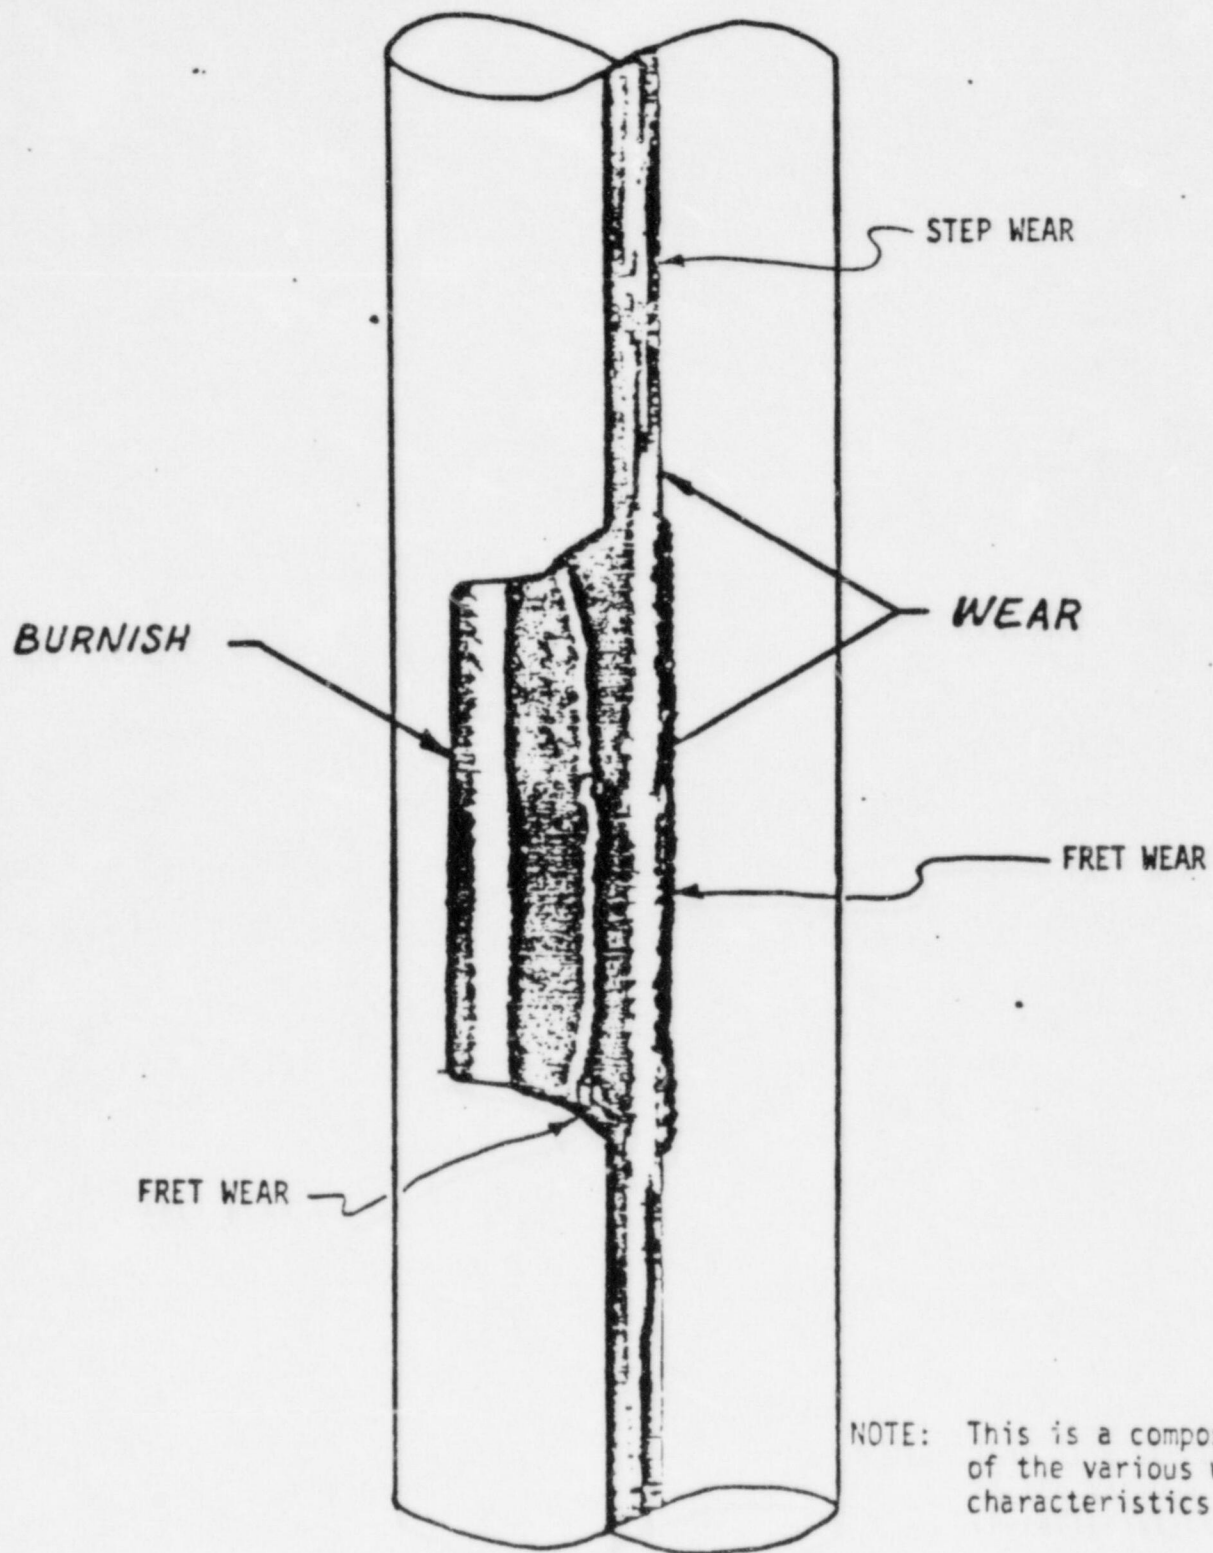
FIGURE 1 - SKETCH OF VARIOUS WEAR CHARACTERISTICS

During the inspections it was observed that both types of wear occurred at the interface between the RCCA and the upper internals guide tube guide plates. Based on this study as well as previous studies, no unusual or significant wear has occurred at the interface between the RCCA rodlet tip and the fuel assembly guide thimble tube. Therefore, the observed RCCA wear has no adverse impact on the operation or safe performance of Westinghouse fuel assemblies.

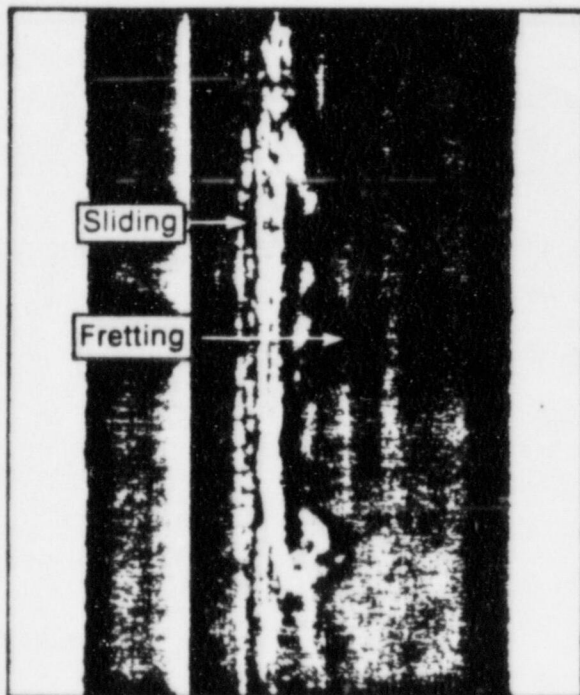
#### 1. Fretting Wear

Wear spots at specific locations along the length of RCCA rodlets were noted. These locations corresponded to locations of the control rod guide cards in the upper reactor internals when the RCCA would be fully withdrawn from the core (i.e. the parked position). There are eight guide cards in each control rod guide tube, which function to provide lateral support for individual RCCA rodlets when the RCCA is withdrawn. There is also a longer continuous guide directly above the upper core plate.

Fretting wear is a result of vibrational contact between RCCA rodlets and the guide cards which provide lateral support for the rodlets when RCCAs are withdrawn from the core. Vibration is hydraulically induced by flow of the reactor coolant, and is therefore a continuous process when the reactor coolant pumps are in operation. In general, wear scars resulting from fretting were found to be approximately one-half inch in length and included approximately one-third of the circumference of the rodlet. Depths of clad penetration observed varied in approximate correspondence with the amount of time the RCCAs were in the parked position and location. The degree of wear varied at different guide card elevations. The worst measured depth of clad penetration from fretting wear was approximately 65% of nominal cladding thickness. Since there is a large margin in load-bearing capability for RCCA cladding, the immediate concern if breach were to occur would be deposition of radioactive isotopes into the reactor coolant.

Based on the history of this particular RCCA, a wear rate of approximately 10% of cladding thickness per 10,000 hours reactor operation was calculated.
