NUCLEAR REGULATORY COMMISSION WASHINGTON, D. C. 20555

Subject: Inspection No. 50-354/86-41

50354-860808

Hope Creek Generating Station

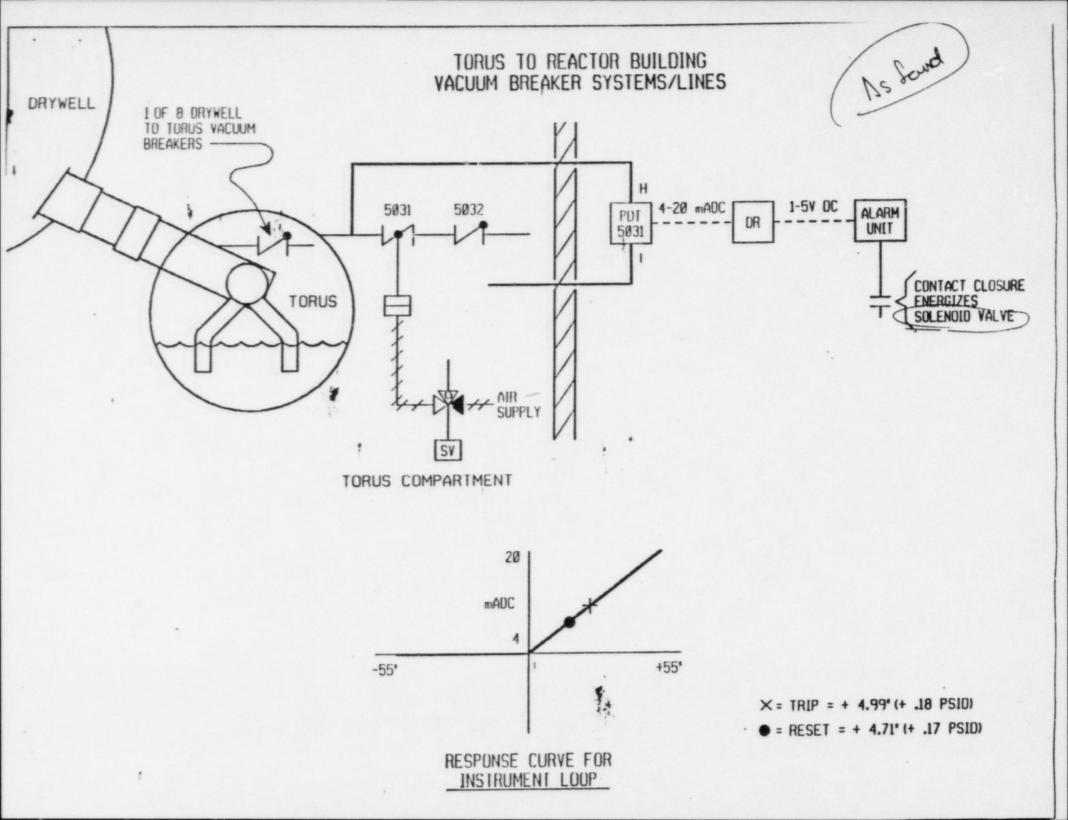
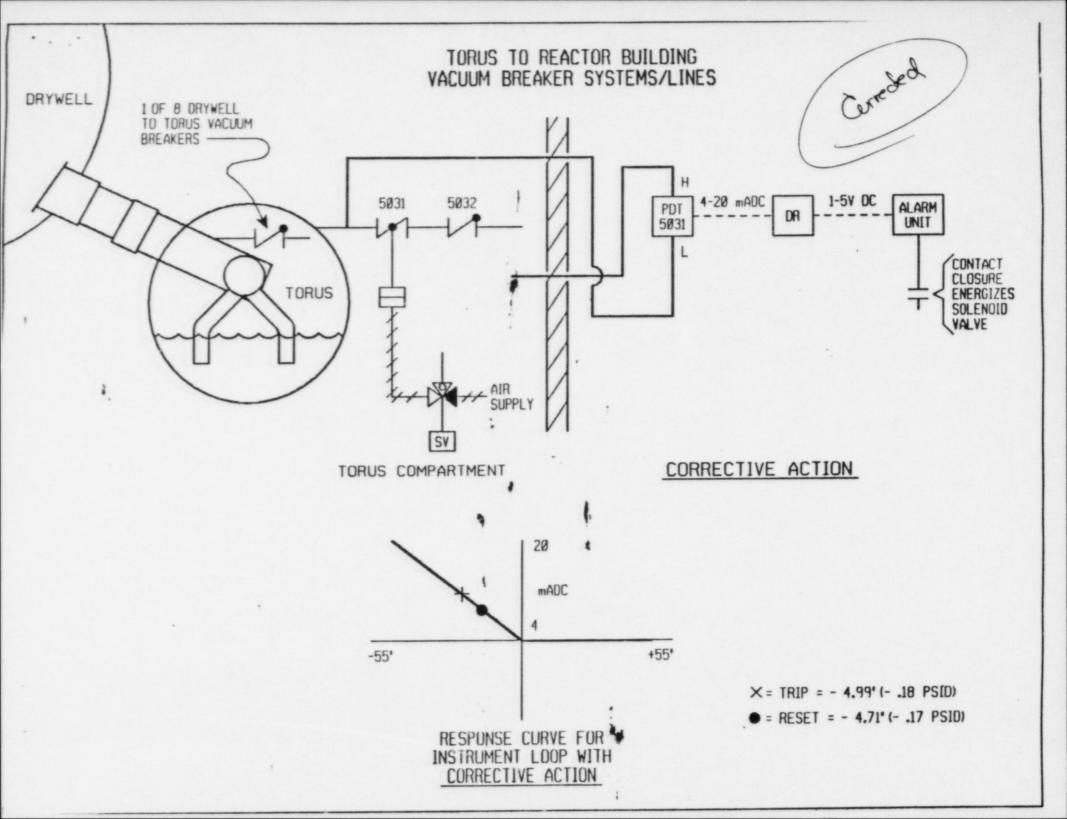
- PRESIDENT TO INVESTIGATE FORCED
 SHUTDOWN
- O 8/13/86 TASK FORCE REPORT CONCLUDES ROOT

CAUSE TO BE DESIGN DEFICIENCY

(ISOMETRIC DRAWINGS SHOW TUBING

TO PDT REVERSED).
