RIO GRANDE BASIN
SOHIO L-BAR
TAILINGS DAM

NM00413

PHASE I INSPECTION REPORT

FOR: U.S. ARMY CORPS OF ENGINEERS & THE
STATE OF NEW MEXICO
AUGUST, 1979

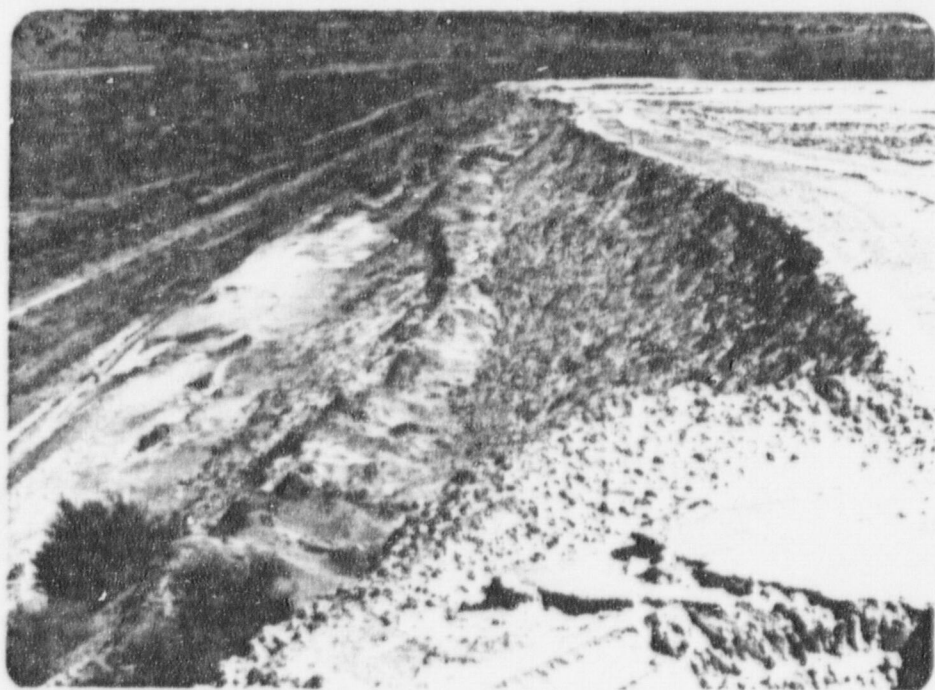
PHOTO 6 - VIEW OF DOWNSTREAM SLOPE OF STAGE 1 LIFT OF TAILINGS DIKES. NOTE ROAD ON CREST OF STARTER DAM AND SEEPAGE ON TOE OF STAGE 1 LIFT OF TAILINGS DIKES

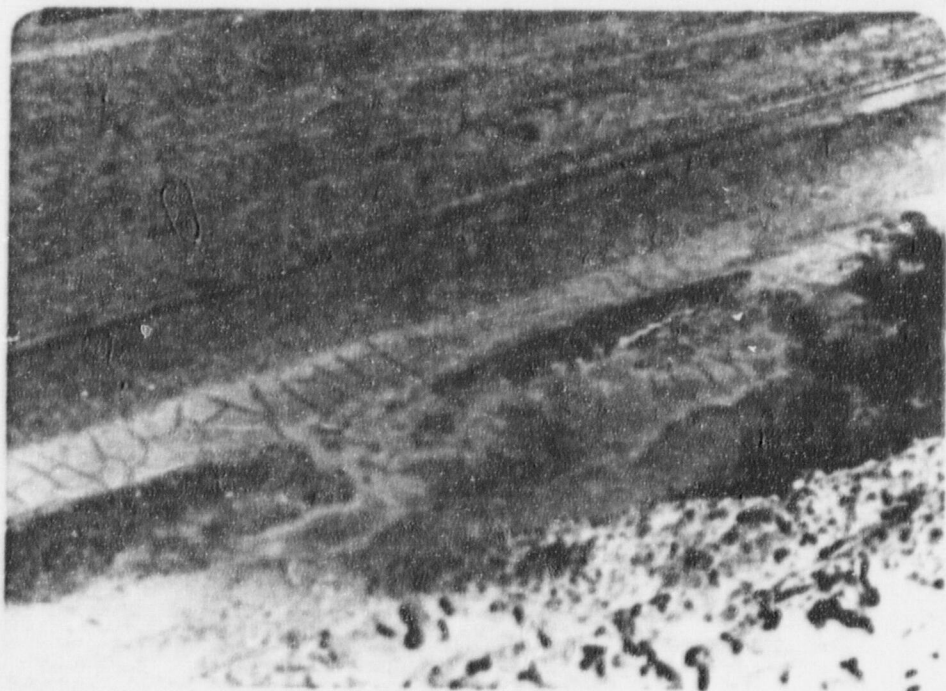
The chimney drain is exposed on the crest surface of the starter dam. See photo 10, Appendix F. On the lower starter dam slopes, there are cracks which appear to be erosion channels and holes in a dispersive soil. See photos 35, 36 and 37, Appendix F. At the toe, seepage is emerging from the finger drains quite high on the slopes. See photos 25, 26, 27 and 28, Appendix F. Solution waters ponded in the seepage collection channel appear to be reacting with the underlying soils as evidence by bubbling and scum on the surface. See photo 29, Appendix F.

PHOTO 10 - VIEW OF CREST OF STARTER DAM. NOTE CHIMNEY DRAIN (GRANULAR MATERIAL IN CENTER OF PHOTO).

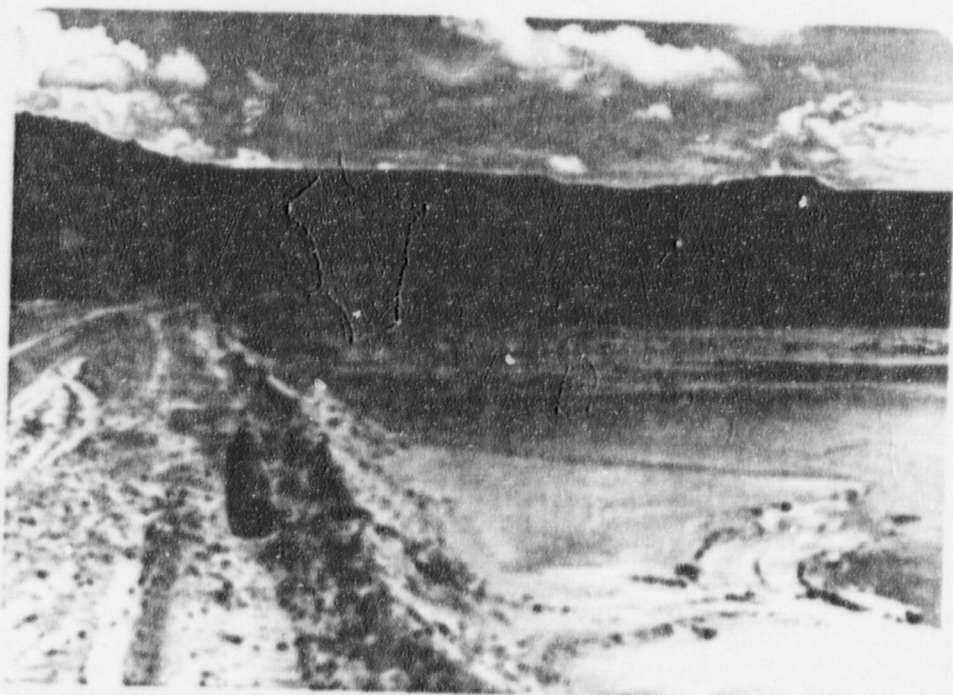
PHOTO 13 - VIEW OF UPSTREAM SLOPE LOOKING FROM SOUTH TO NORTH.
NOTE SLIME DEPOSITION NEAR NEW DIKE CREST.

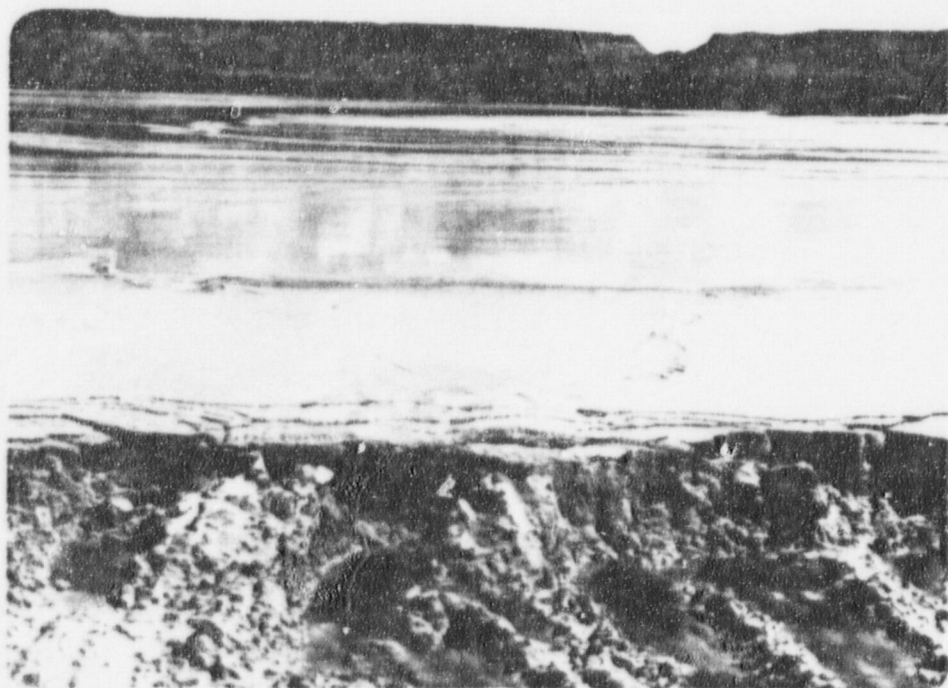
PHOTO 17 - VIEW OF RESERVOIR LOOKING SOUTH. NOTE PIT IN
BEACH APPROXIMATELY 2 FEET DEEP.

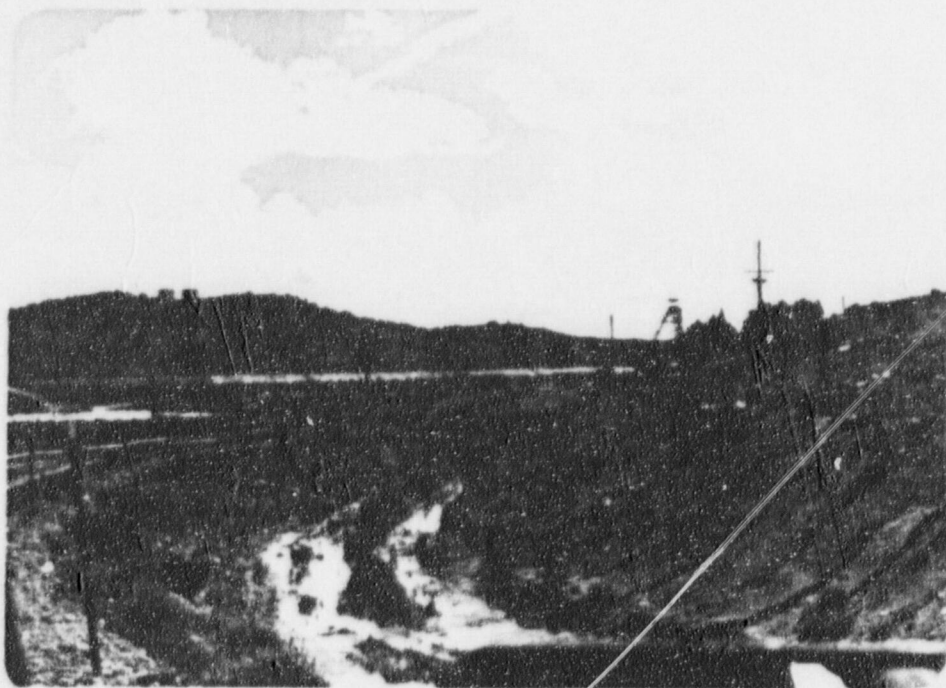
(3) Upstream Diversion Channels. The upstream diversion channels are not designed to carry the flows required by Corps of Engineer's criteria for dam evaluation. The channels have stated capacity of 280 C.F.S. and 840 C.F.S. The Corps' criteria indicates a Probable Maximum Flood (PMF) of 388 C.F.S. and 2000 C.F.S. from the north and south watersheds respectively. The Corps' values were obtained using the chart labeled "Maximum Experienced Peak Discharges" presented in Appendix C. The channels are in good condition with no noted blockages. Photos 20 and 21, Appendix F, show the south channel.

PHOTO 20 - VIEW OF SOUTH DIVERSION CHANNEL LOOKING FROM SOUTH TO NORTH.

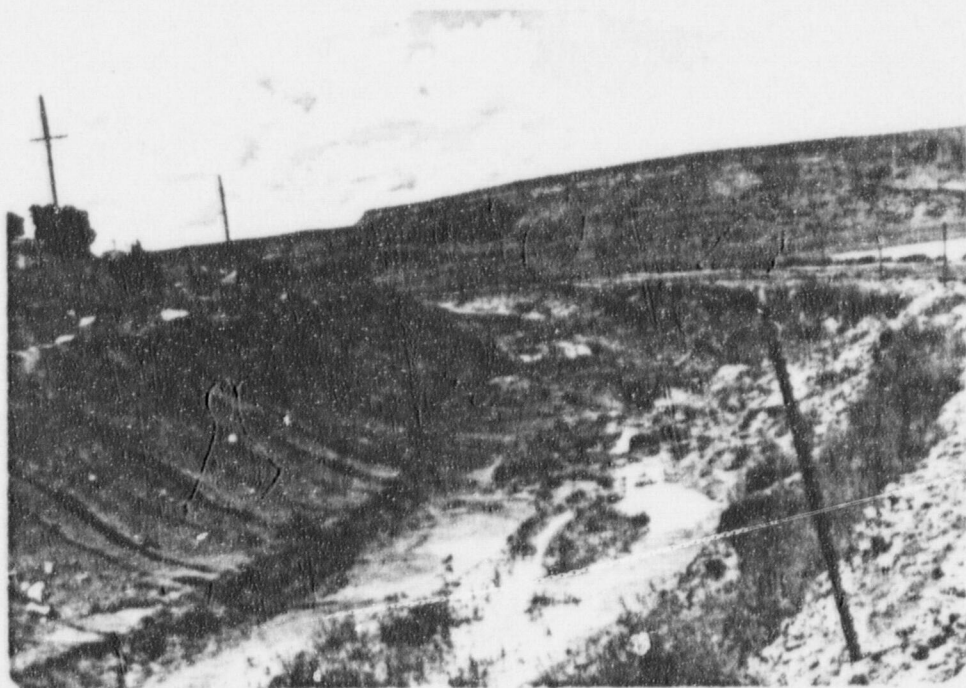
PHOTO 21 - VIEW OF SOUTH DIVERSION CHANNEL LOOKING FROM NORTH TO SOUTH.

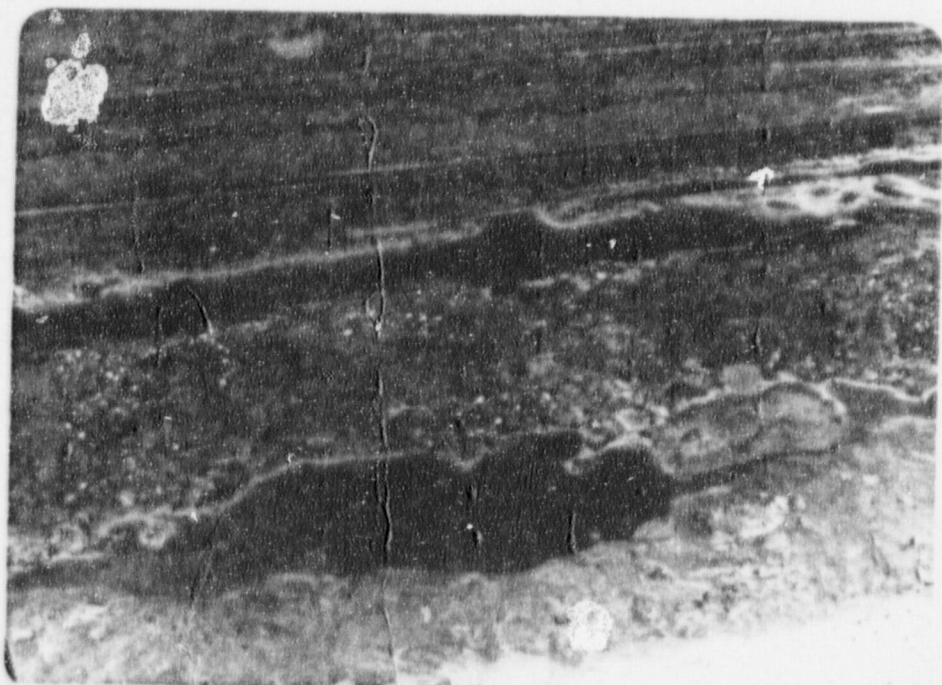
Seepage and boils were noted at the toe
of the first stage tailings dam. Seepage
is also emerging on the slope of the
starter dam at each of the finger drains.

PHOTO 22 - VIEW OF SEEPAGE AND BOILS AT TOE OF STAGE 1 DIKE
ON CREST OF STARTER DAM.

Seepage sloughs and boils or solution cavities are present on the downstream slope and toe. These should be repaired and seepage discharge faces armored, filtered or otherwise designed and constructed to provide a controlled discharge that does not allow sloughing or boils. Additional piezometers should be installed and monitored and seepage and stability studies should be performed after piezometer data is available to assure the stability of the dam, to determine if liquefaction is a problem, and to determine the nature and criticality of the downstream boils.

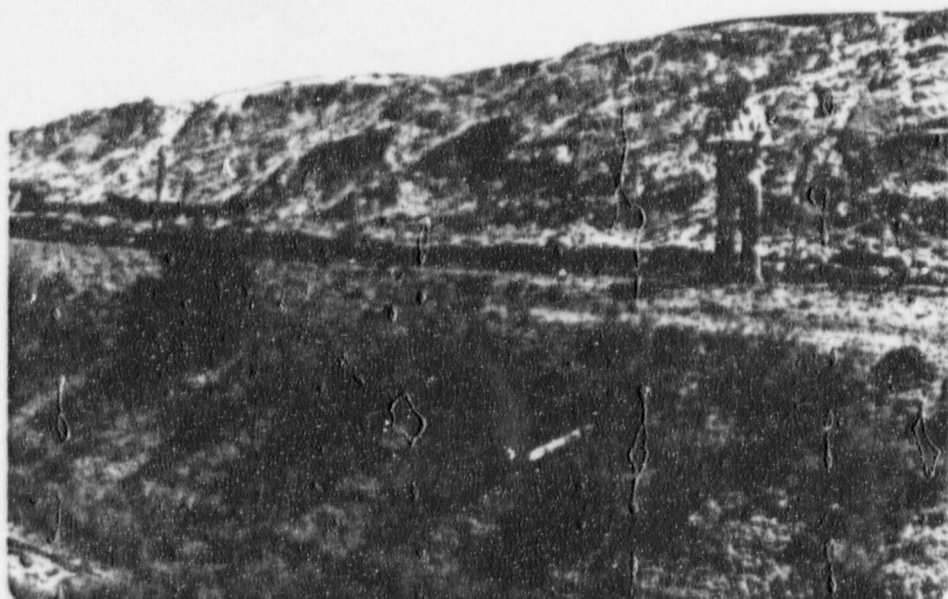
PHOTO 24 - VIEW OF SLOUCHING AND EROSION ON DOWNSTREAM SLOPE
OF STAGE 1 TAILINGS DIKE.

Maintenance is required on the downstream slopes to fill in sloughed areas caused by seepage. The sloughs tend to steepen slopes and provide areas of low stability. The road system should be upgraded to assure accessibility to all parts of the main dam and saddle dam even in bad weather. A warning system should be established and maintained on the dam. This could take the form of an emergency shut-off on the mine tailings lines and lighting of the structure so that trained patrols could observe the structure at night. Seepage should be monitored to assure that quantity or character of flow does not change dramatically in a short time.

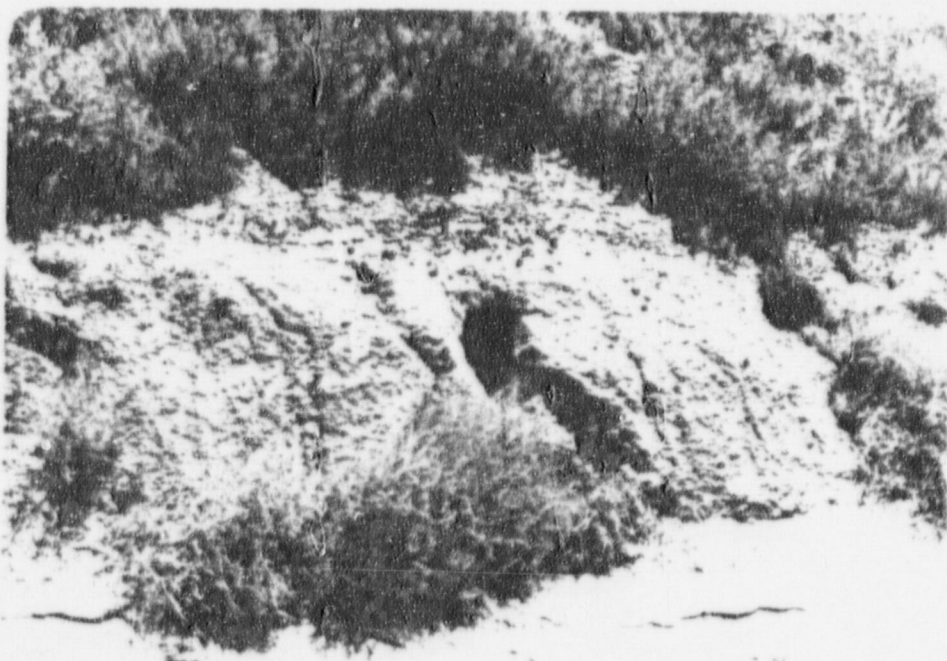
PHOTO 26 - VIEW OF FINGER DRAIN AND EROSION HOLE. NOTE POSSIBLE DISPERSIVE SOIL.

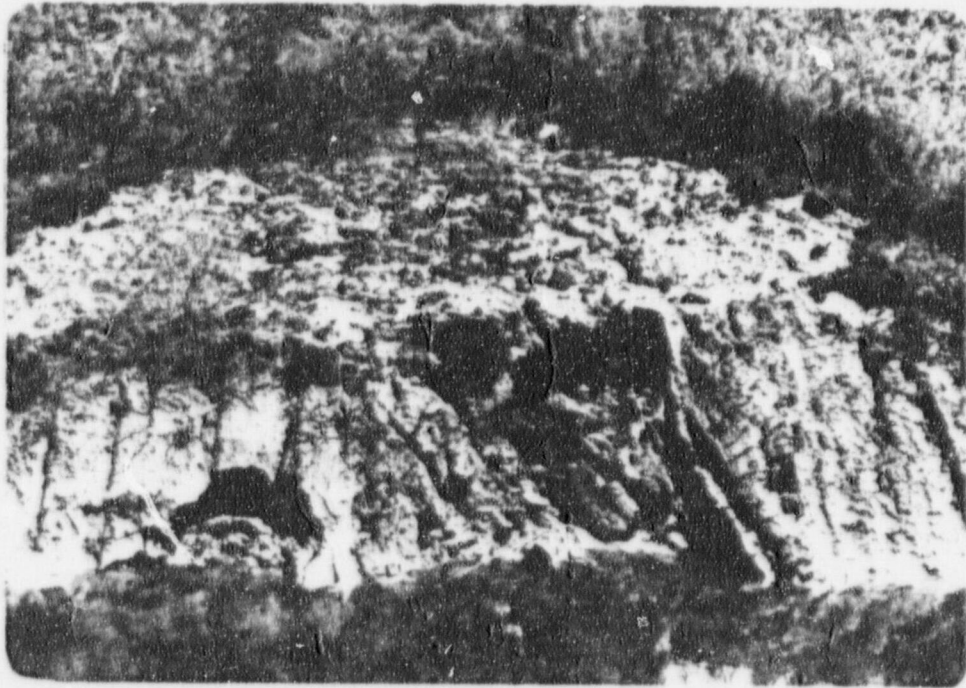
PHOTO 27 - VIEW OF FINGER DRAIN AND RESULTING EROSION AND SLOUGHING.

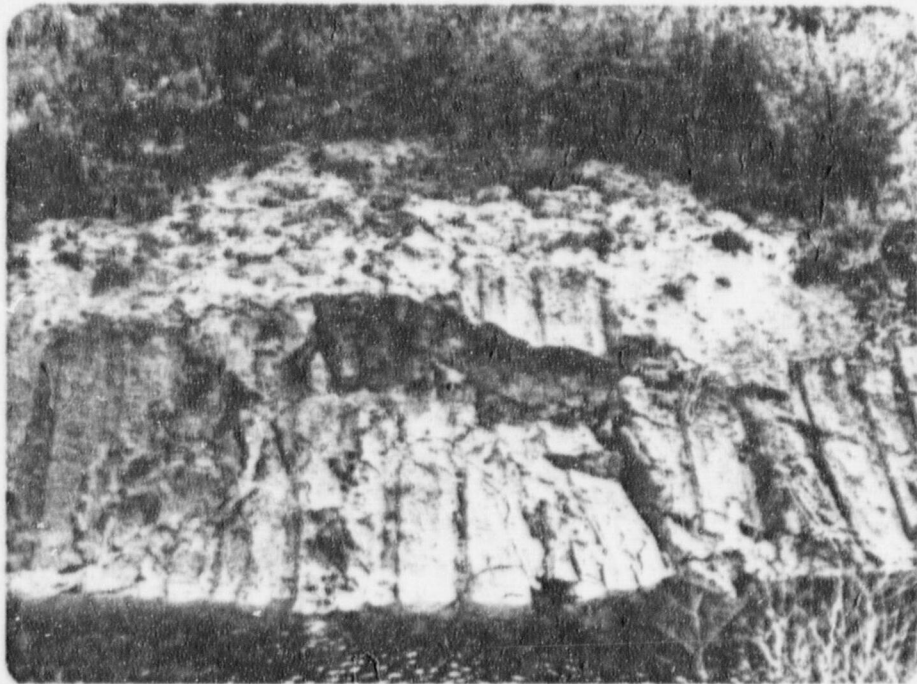
PHOTO 28 - VIEW OF FINGER DRAIN AND RESULTING SLOUGHING.

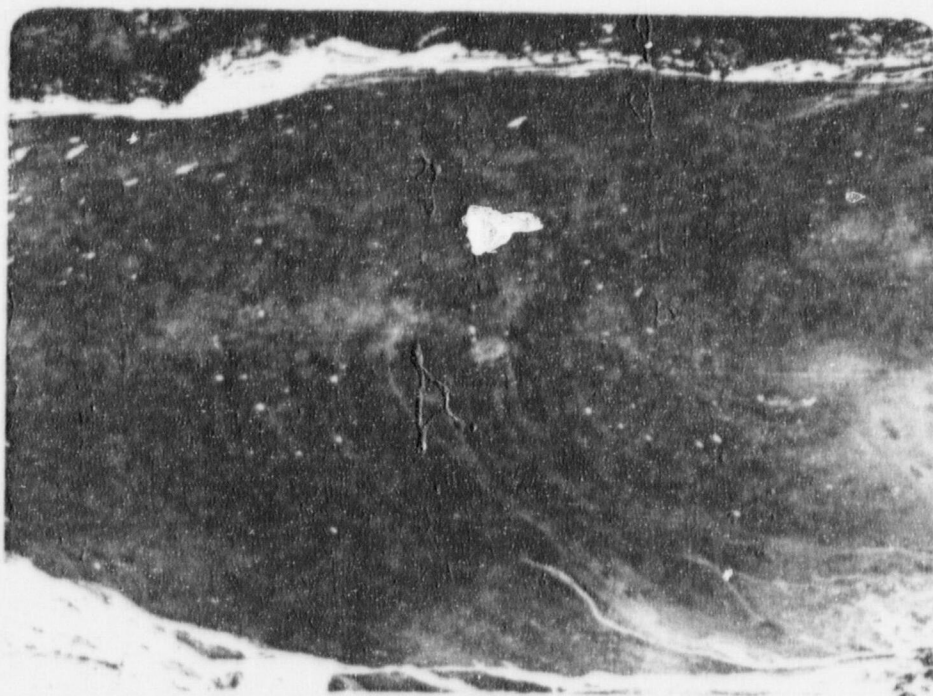
The seepage was clear at the time of our inspection. Air bubbles were observed in the bottom of the ditch. According to Sohio officials who accompanied the inspection, the bubbles are caused by acid reactions with clays in the overburden beneath the dam. The acid is caused by seepage from the seepage collection ditch which gathers water from the finger drains, rather than underseepage. The dam has been affected by erosion gullies, shrinkage cracks and animal burrows according to all inspection reports on file; such features along with possible incipient piping were visible at the time of our visit. Drainage in the seepage ditch and runoff from the road on the dam contribute to the erosion problems.

PHOTO 29 - VIEW OF SEEPAGE COLLECTION DITCH. NOTE GAS BUBBLES
IN CENTER OF PHOTO CAUSED EITHER BY CHEMICAL REACTIONS OR A
SAND BOIL.

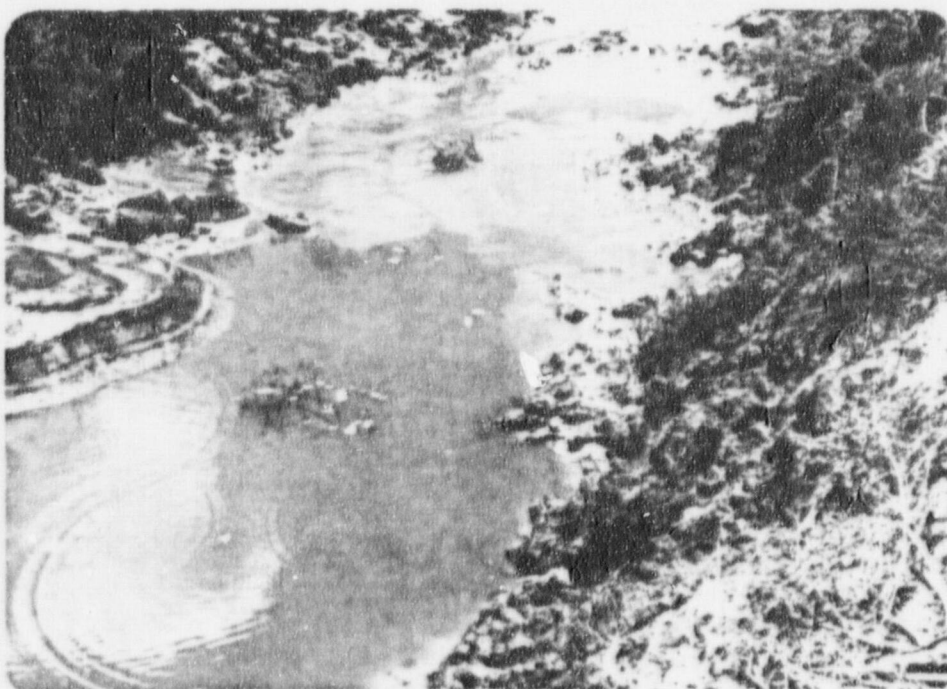
PHOTO 30 - VIEW OF SEEPAGE COLLECTION DITCH. NOTE IRON
OXIDE DISCOLORATION IN SEEPAGE WATER.

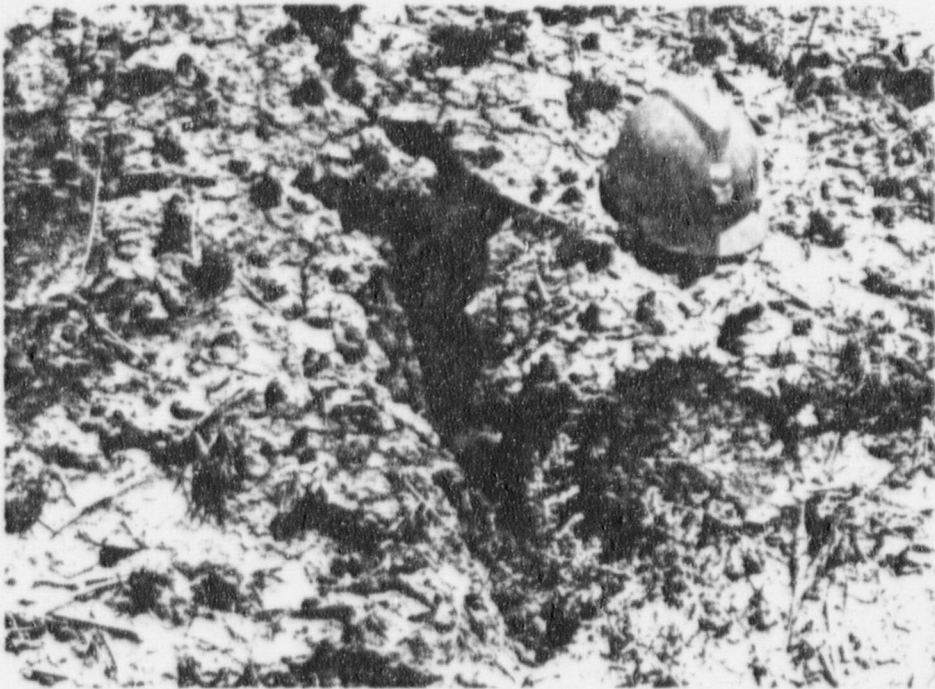
Cracks were noted on downstream face of the starter dam starting approximately 100 feet from the piezometer line and continuing 200 feet north. These cracks run downstream on the face and seem to be concentrated mostly mid-way on the dam. The largest crack is about 6 inches wide, perhaps more than 2 feet to 3 feet deep and approximately 10 feet to 15 feet long. See photo 35, Appendix F.

PHOTO 35 - VIEW OF CRACKING ON DOWNSTREAM SLOPE APPROXIMATELY
HALFWAY UP EMBANKMENT.

VISUAL EXAMINATION OF	OBSERVATIONS	REMARKS OR RECOMMENDATIONS
SURFACE CRACKS	Several cracks and holes were observed on the downstream slope of the starter dam. The cause is not apparent.	A study should be conducted to evaluate the source of cracking.
UNUSUAL MOVEMENT OR CRACKING AT OR BEYOND THE TOE	Sloughing is present at the location of the finger drain exits. Bubbling and scum are present in the toe drain indicating that chemical activity is occurring.	Evaluate chemical activity.
SLOUGHING OR EROSION OF EMBANKMENT AND ADJUTMENT SLOPES	The first stage tailings dam has a number of sloughs which should be repaired. The starter dam has erosion gullies caused by runoff from the crest and/or seepage from the first-stage tailings dam.	Provide safety berms on roads and safe discharge faces for seepage. Also provide seepage collection system.
VERTICAL AND HORIZONTAL ALINEMENT OF THE CREST	No data available

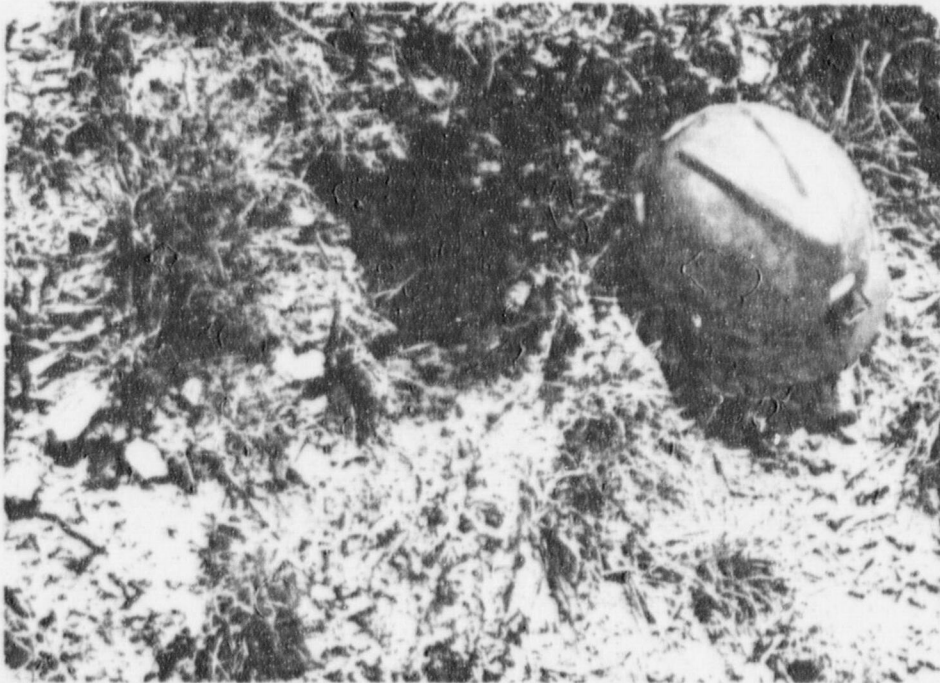
PHOTO 36 - VIEW OF HOLE IN DAM. NOTE: CRACKING OR HOLES
ARE NOT CONTINUOUS.

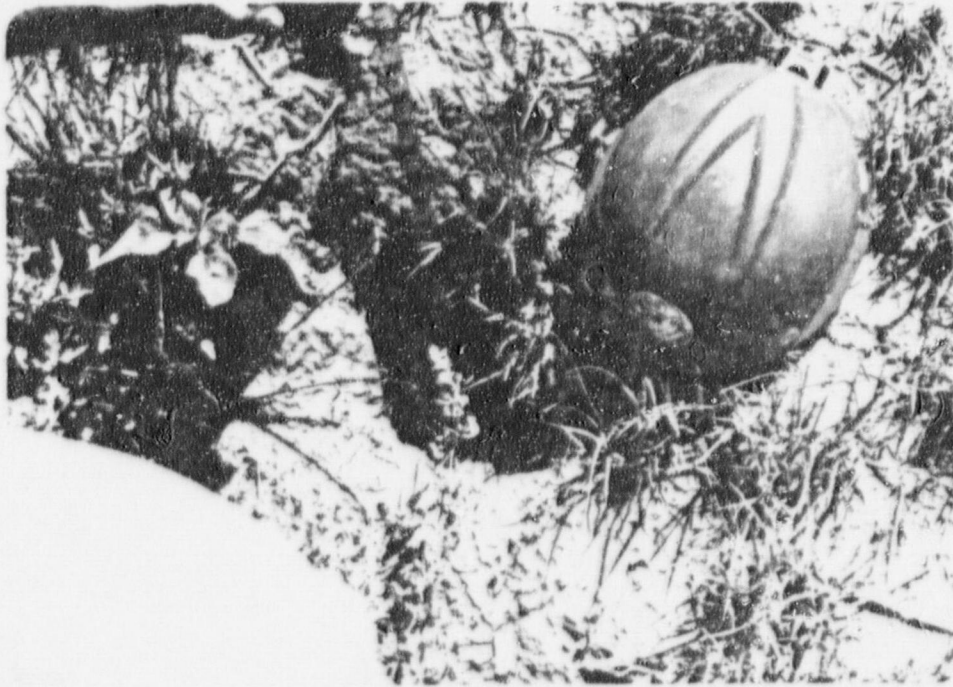
PHOTO 37 - CLOSE-UP VIEW OF HOLE IN DAM.

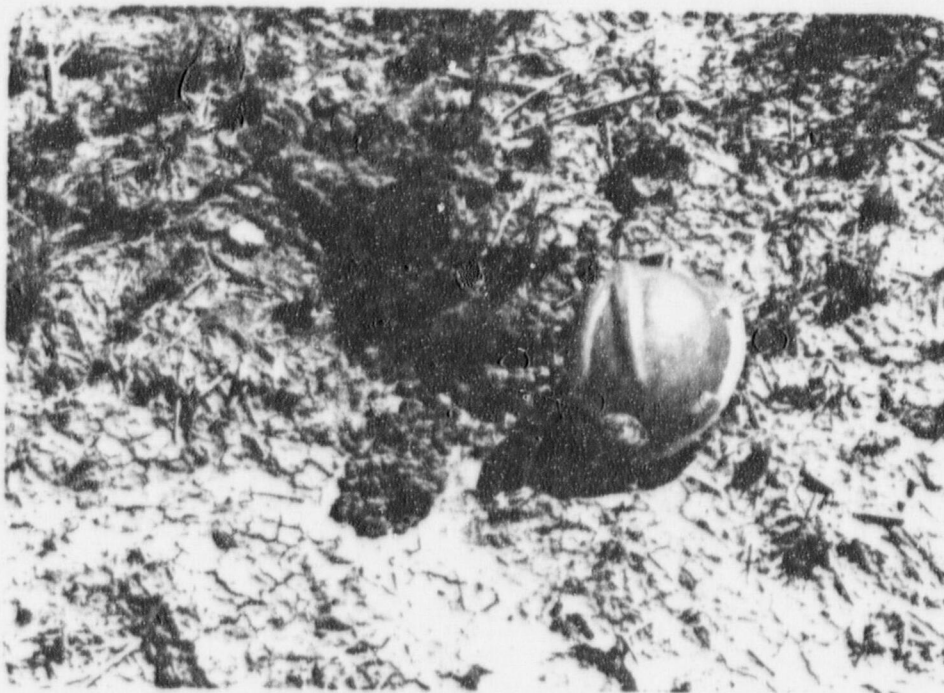
(5) Saddle Dam. The saddle dam appears to be in good condition except for rodent activity and the apparent reaction of solution waters with the earth dam or foundation at the upstream (west) toe. This is evidenced by bubbling and scum on the surface. Rodent activity was present at all levels of the dam from the crest to the downstream toe, however, most of the burrows were located near the downstream toe to about the mid-height of the dam. See photos 40 through 43, Appendix F, for the saddle dam.

PHOTO 42 - VIEW OF ANIMAL BURROW.

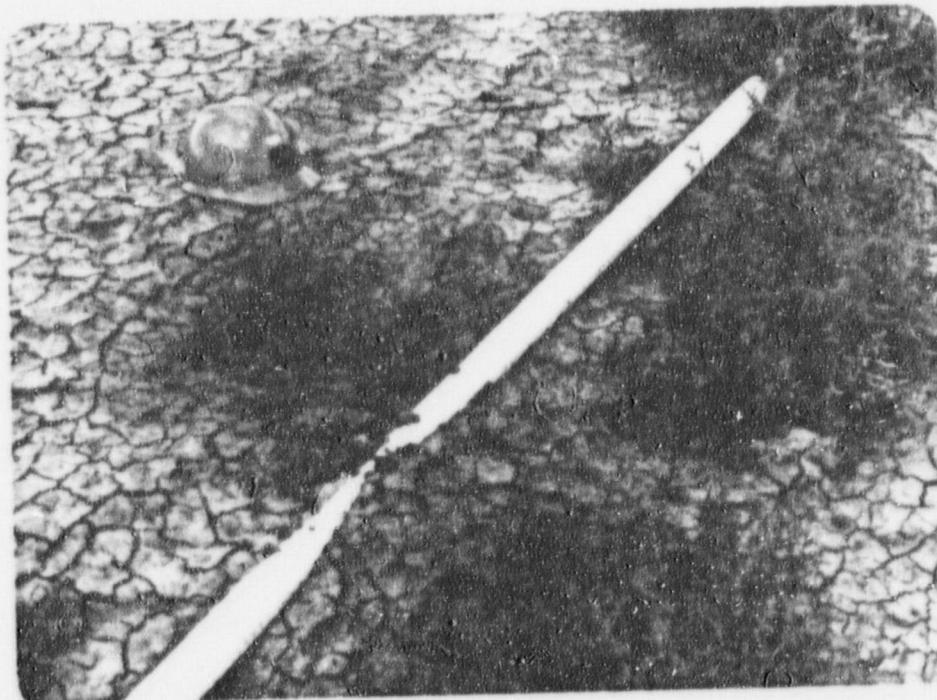
PHOTO 43 - VIEW OF ANIMAL BURROW.
