Subject: Arkansas Nuclear One - Unit 1
Docket No. 50-313
License No. DPR-51
ANO-1 Relief Request For LPI/DHR Pump Casing Repair

**ARKANSAS NUCLEAR ONE – UNIT 1
3rd TEN YEAR INTERVAL
REQUEST NO. 99-1-001, Revision 0**

**Stress Analysis for
Decay Heat Removal Pump**

**Evaluation of Flaw Remaining After Repair of
Decay Heat Removal Pump P-34B**

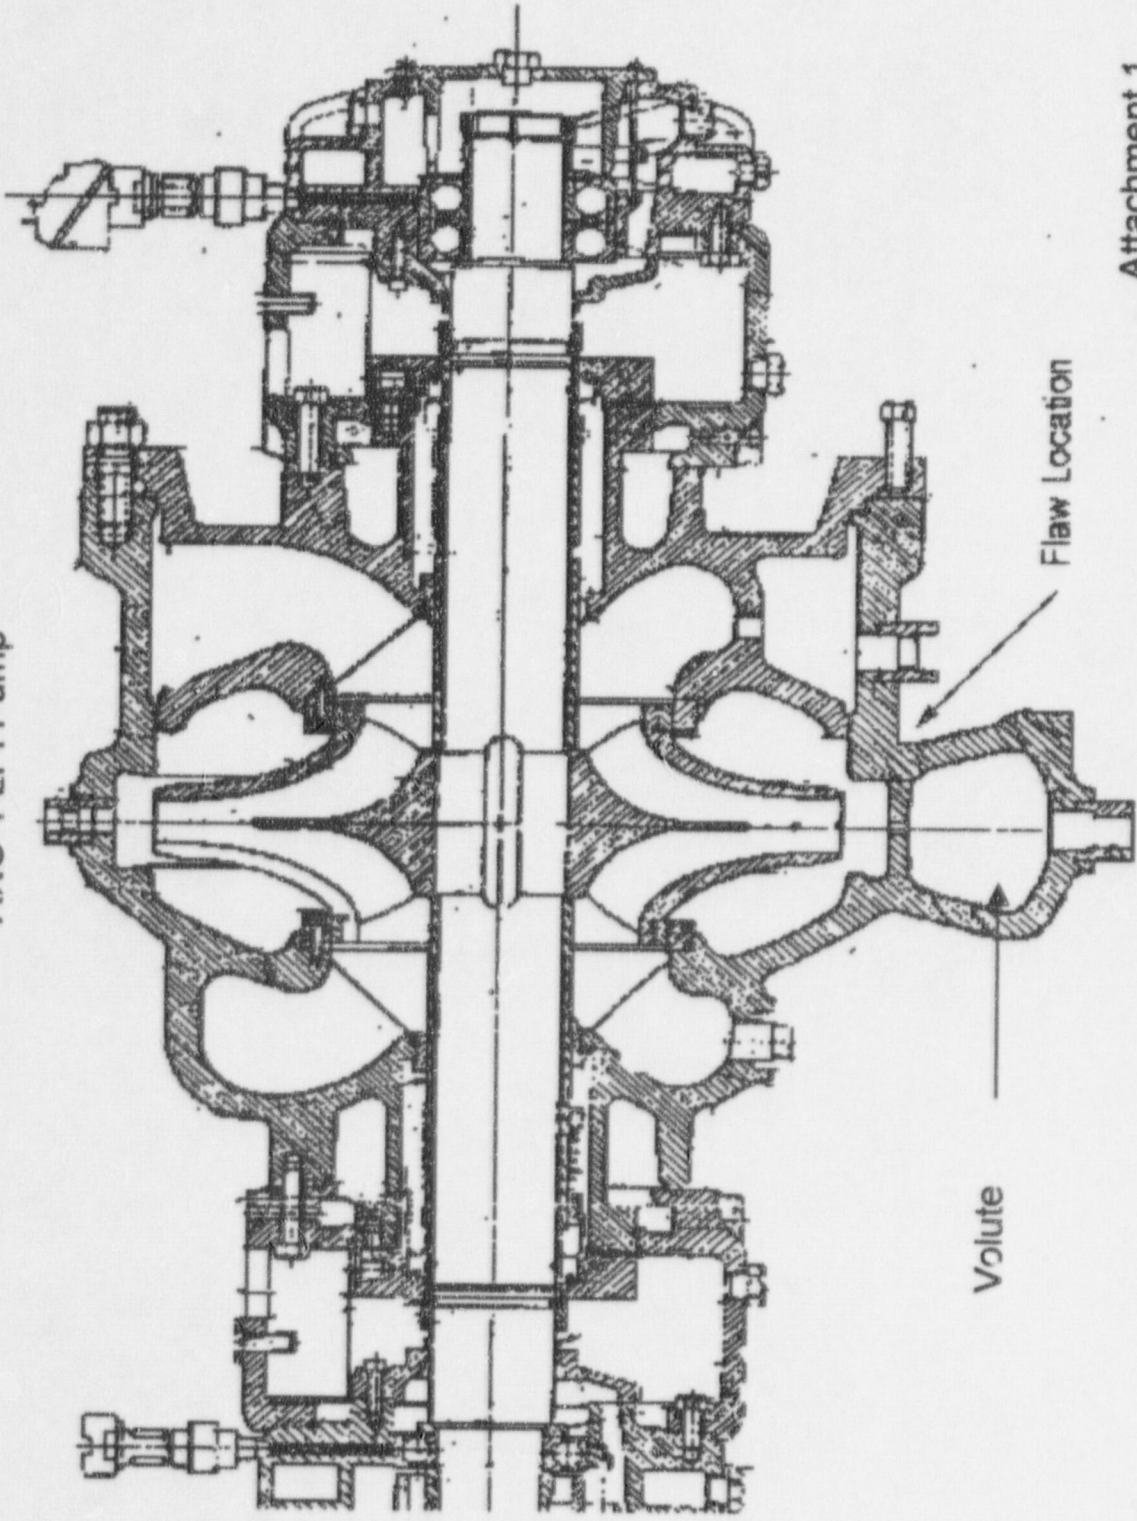
ANO-1 LPI Pump

During performance of a scheduled Section XI pressure test in accordance with Reference 1, evidence of leakage was detected on the surface of the Arkansas Nuclear One – Unit 1 (ANO-1) low pressure injection (LPI)/ decay heat removal (DHR) pump. The leakage was located at approximately bottom dead center of the pump casing in an inside radius where the pump casing and pump casing volute intersect (See Attachment 1). From careful observation, weepage was identified from a rounded indication appearing as a pit. The pit or opening measured approximately 0.062 inches in diameter.

Volute

Flaw Location

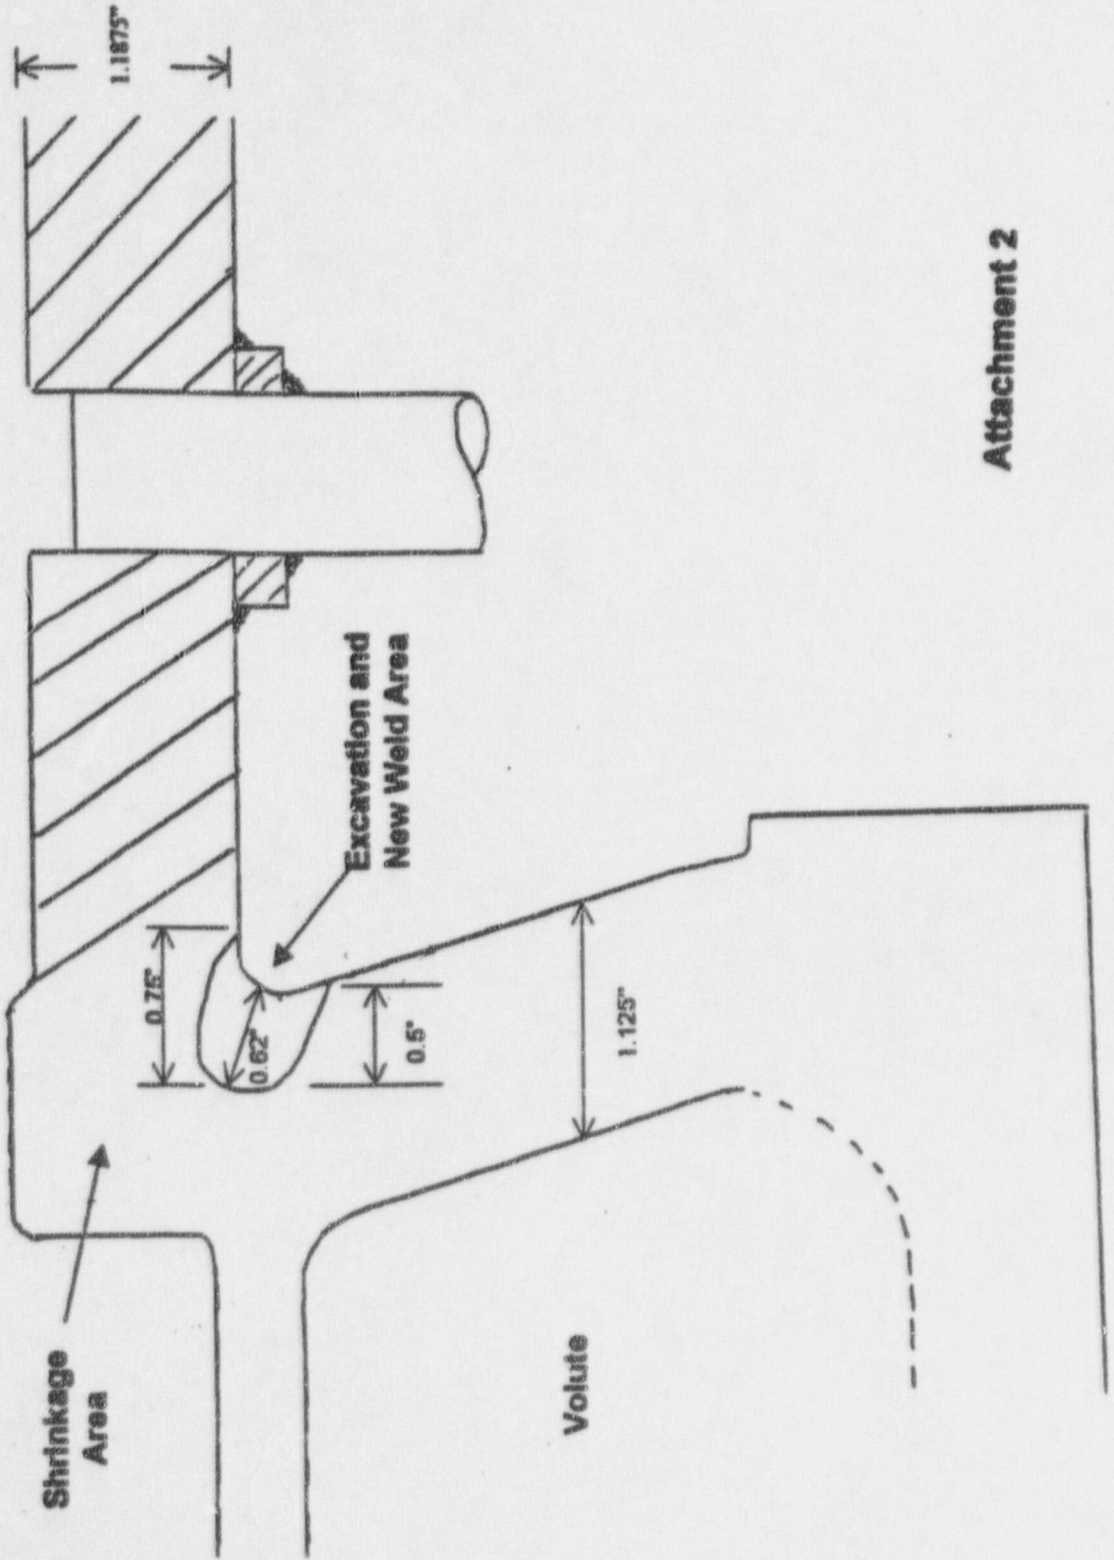
Excavation and Repair Depth of P34B Pump Casing Flaw

During the repair process described in Section II, it was determined that the flaw permitting the through wall leak could not be completely removed or reduced to an acceptable size as required by the Construction Code governing the repair. Alternatively, the flawed area was excavated from the outside surface to a depth

of approximately 0.500 inches leaving a remaining ligament of approximately 1.250 inches. As the excavation gained depth the flaw changed from a rounded indication into a linear indication with a length of approximately 0.750 inches at the depth when excavation was ceased.

The geometry, materials and results of the stress analysis are described in Reference 4. Measurements taken during the cavity excavation and following the weld repair process show that the excavated cavity was 0.5 inches in depth as measured from the original outside surface in the region of the intersection between the pump casing and volute. In the finite element modeling, this region was modeled with a total diagonal thickness of 1.75 inches. This yields a flaw depth-to-thickness ratio (a/t) equal to 0.715. This is less than the maximum allowable size for flaws in austenitic stainless steel piping per Section XI IWB-3640 of $a/t = 0.75$.

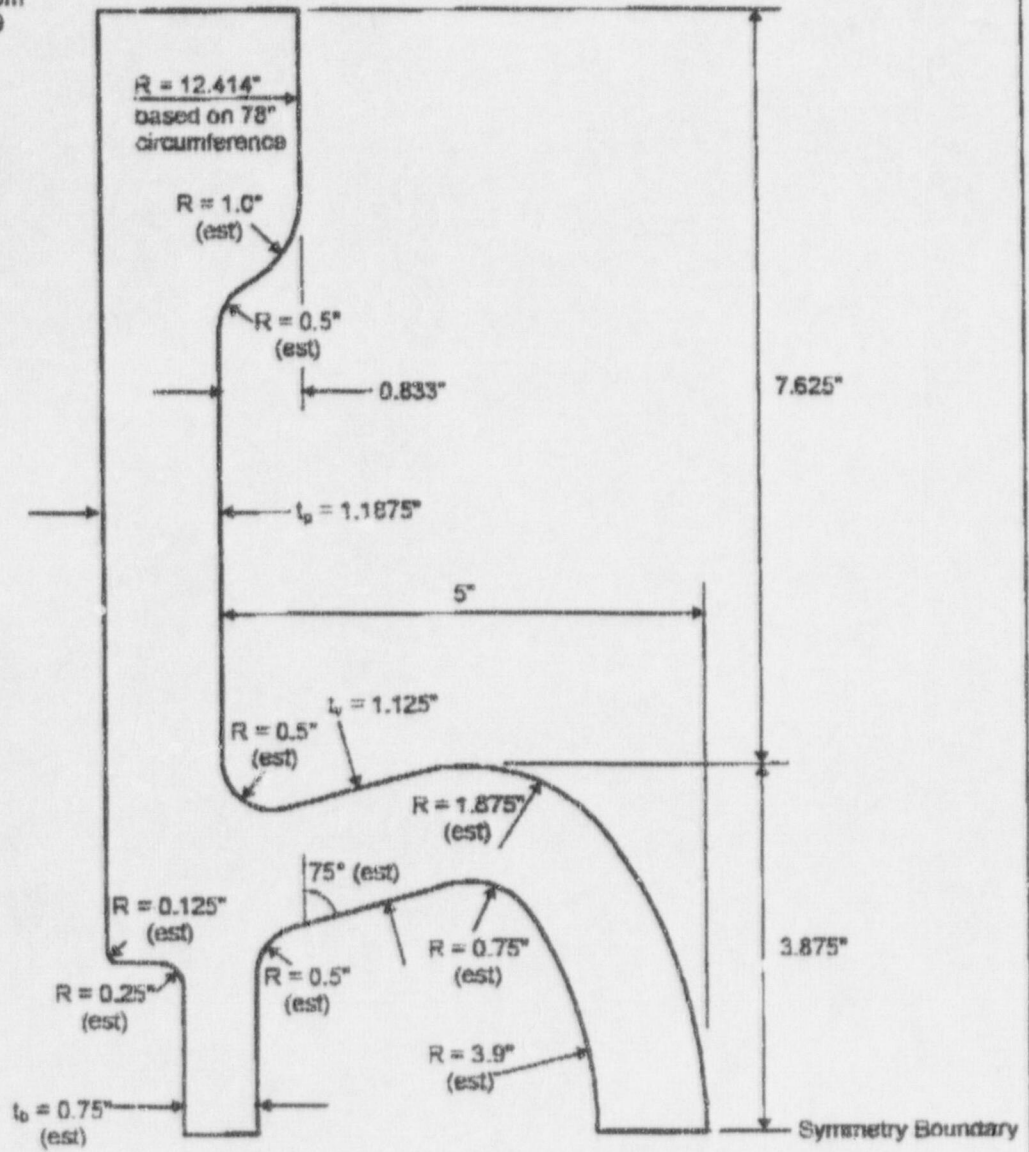
Figure 1. Geometry

The geometry of the pump was taken from field measurements provided by Ken Panther. These are reflected in Figure 1. The general shape of the pump was taken from arrangement drawing 6600-MIH-39, Rev. 6 [1]. The material is A-351 CF8 304 stainless steel [1].

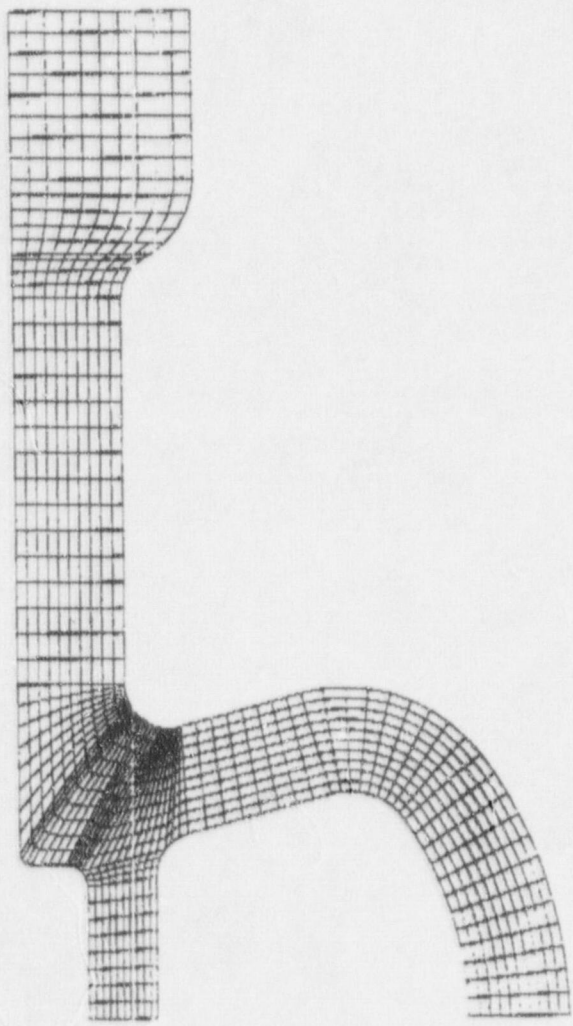
Figure 2. Finite Element Model

A two dimensional axisymmetric finite element model, depicted in Figure 2, was constructed using the ANSYS finite element program (Version 5.3). Based on the available information, the model was contoured to match the arrangement drawing. The model assumed symmetry about the center of the pump impeller since the main interest was in the region of the intersection of the volute and the cylindrical pump casing. The boundary conditions allowed free radial movement at the symmetry line.

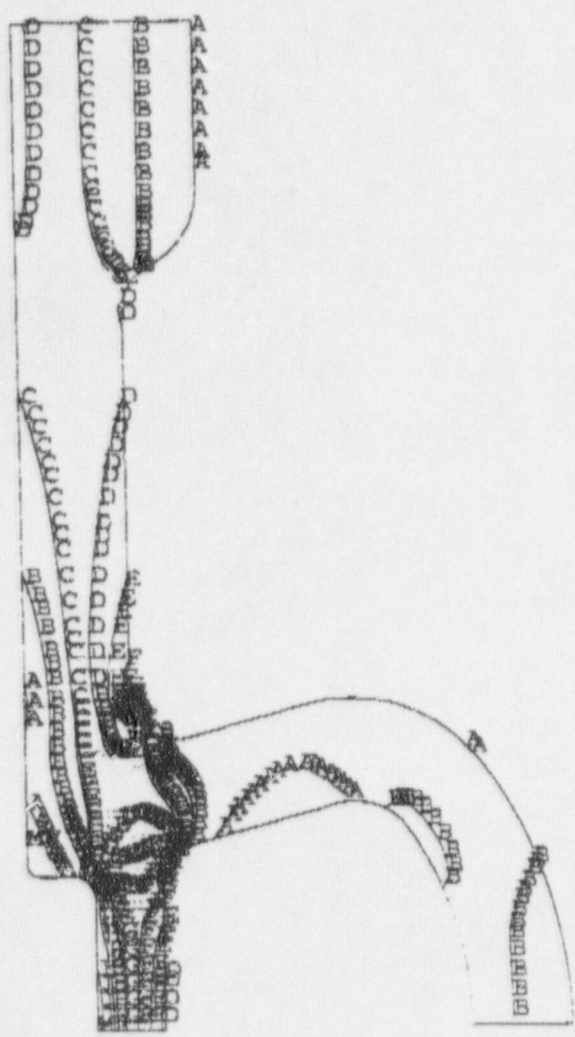
Figure 4. Axial Stress Due to Pressure

Figures 3 to 6 show the hoop, axial, and radial stresses and the stress intensity in the pump casing. Due to the thickness of the pump casing and the relatively low pressures, the stresses are very low, even at locations of local stress concentration. For the region of cracking, the most applicable stress for flaw evaluation is the stress perpendicular to the observed leakage path, which is the radial stress.
