Radiological and Engineering Assessment

Vicinity Property No. CAN 318

FINAL
THE RADIOLOGICAL AND ENGINEERING ASSESSMENT
AND FINAL DESIGN
FOR
CANONSBURG PROPERTY
CA-318
August 15, 1985

REPORT OF INCLUSION SURVEY AT LOCATION CA00318
McGRAW-EDISON POWER SYSTEMS DIVISION
P.O. BOX 440
CANONSBURG, PENNSYLVANIA 15317

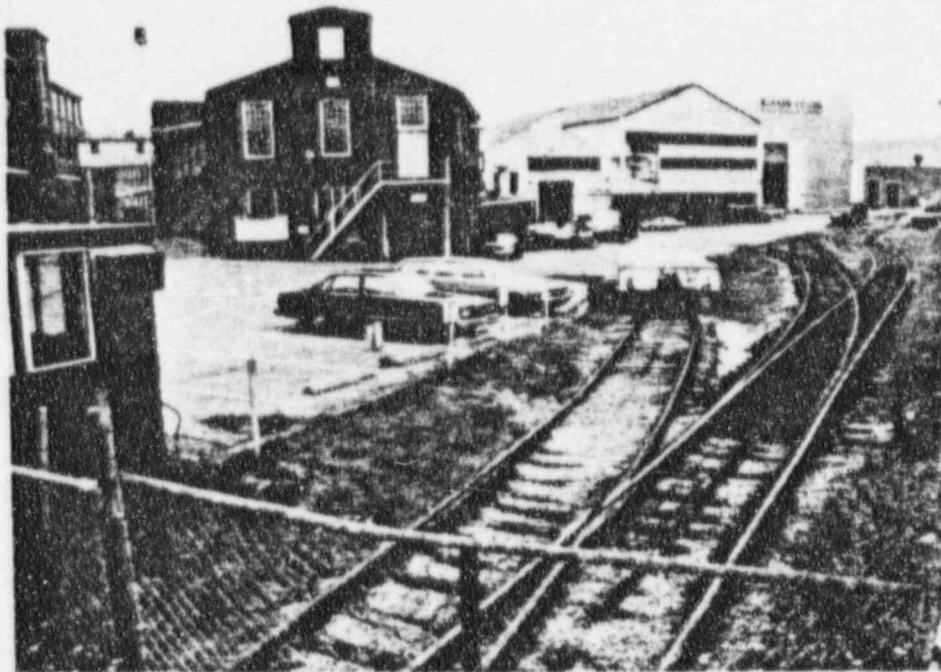
Area "A" Looking Northeast

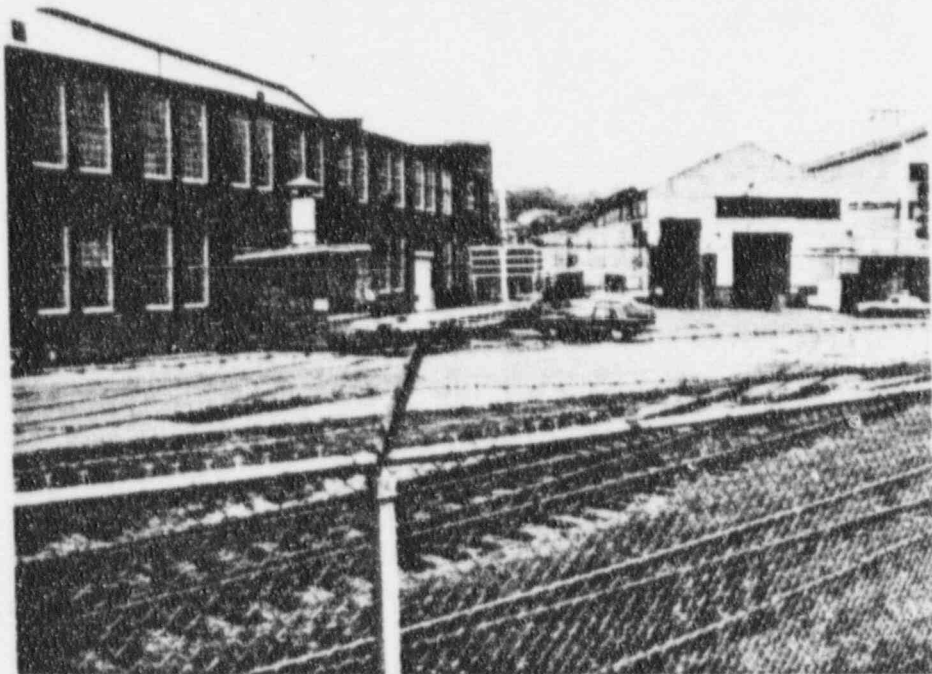
Area "B" Looking North

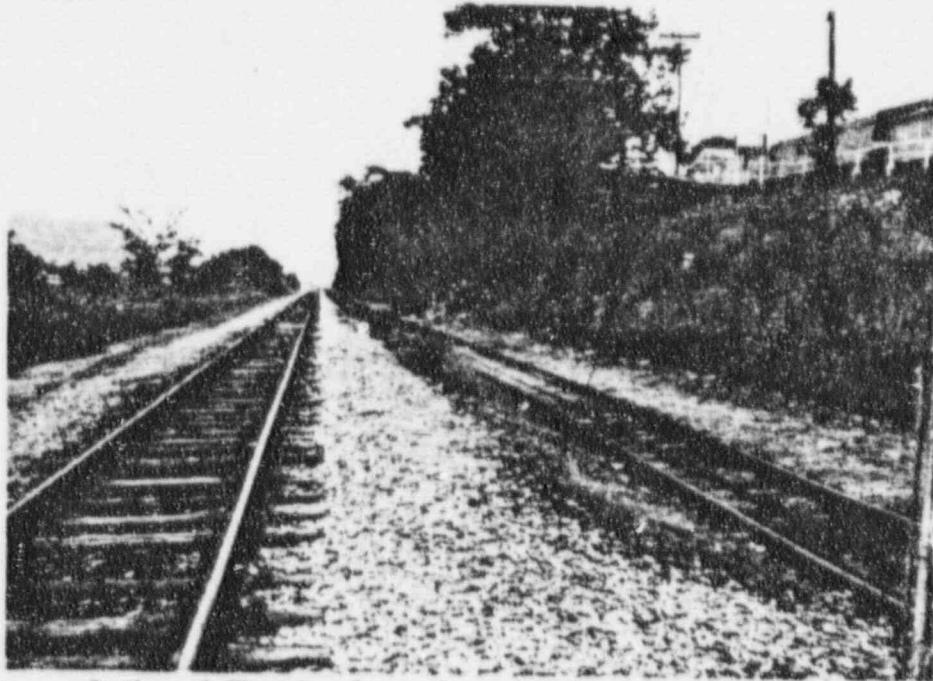
Railroad Tracks from Complex Looking Southwest

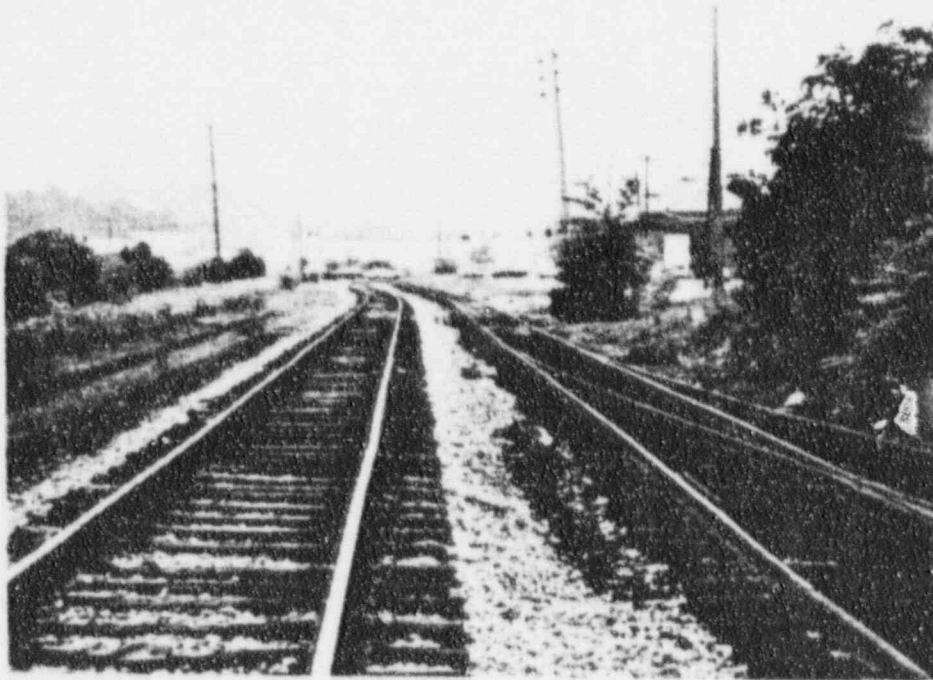
Railroad Tracks Looking Southwest
Toward Brush Run Creek Bridge

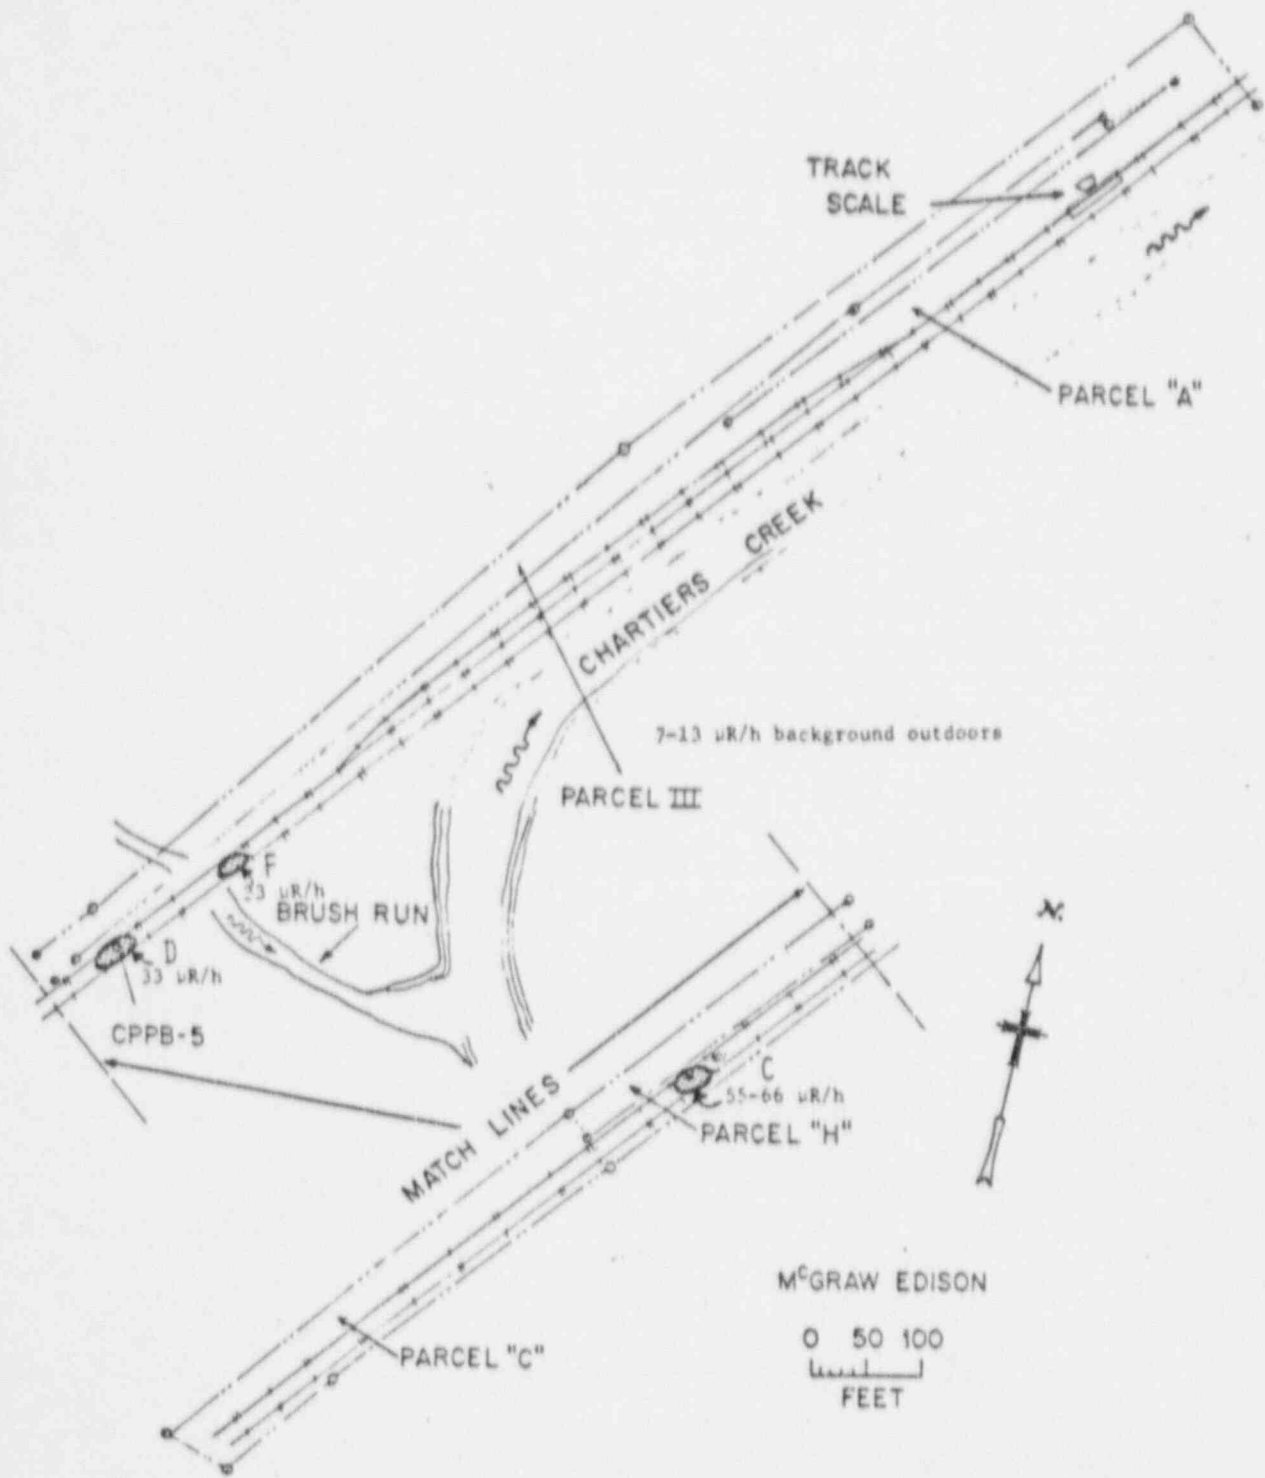
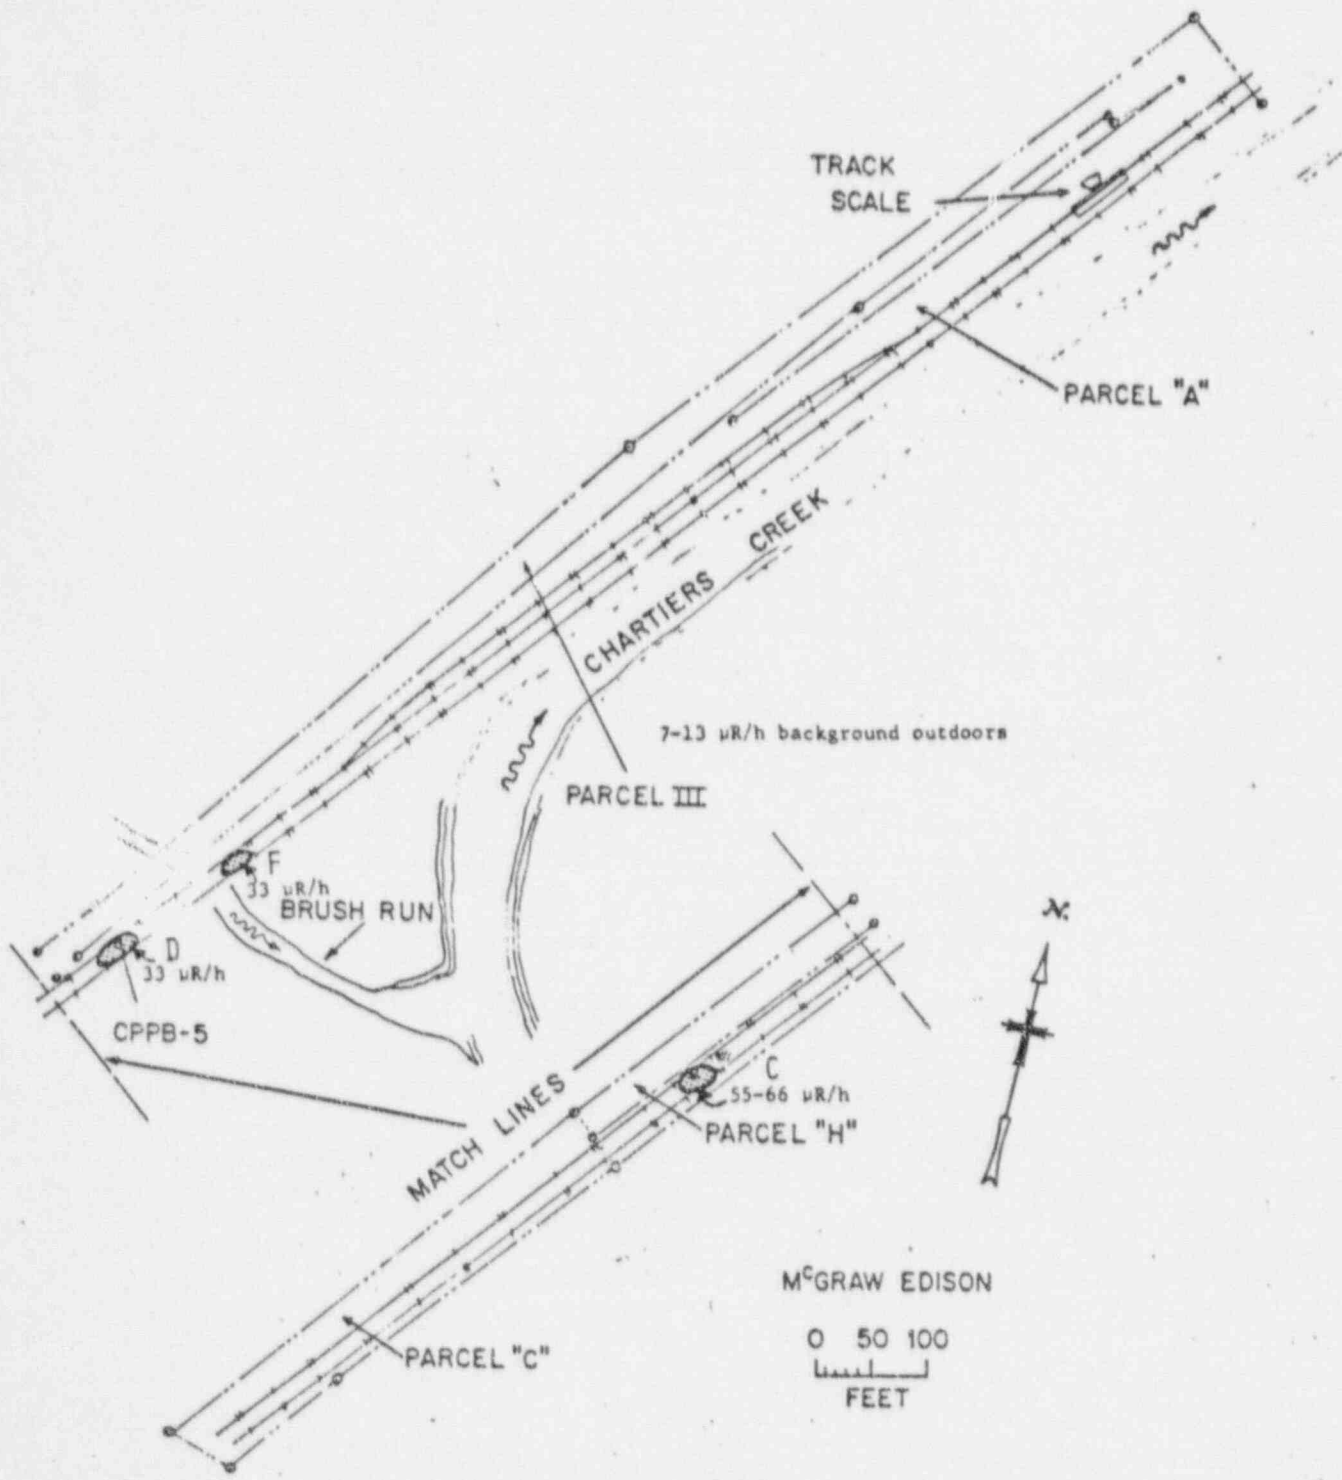
Fig. 10. Location CA00318 showing soil sampling location in Parcel III and contaminated areas in Parcel III and Parcel H.

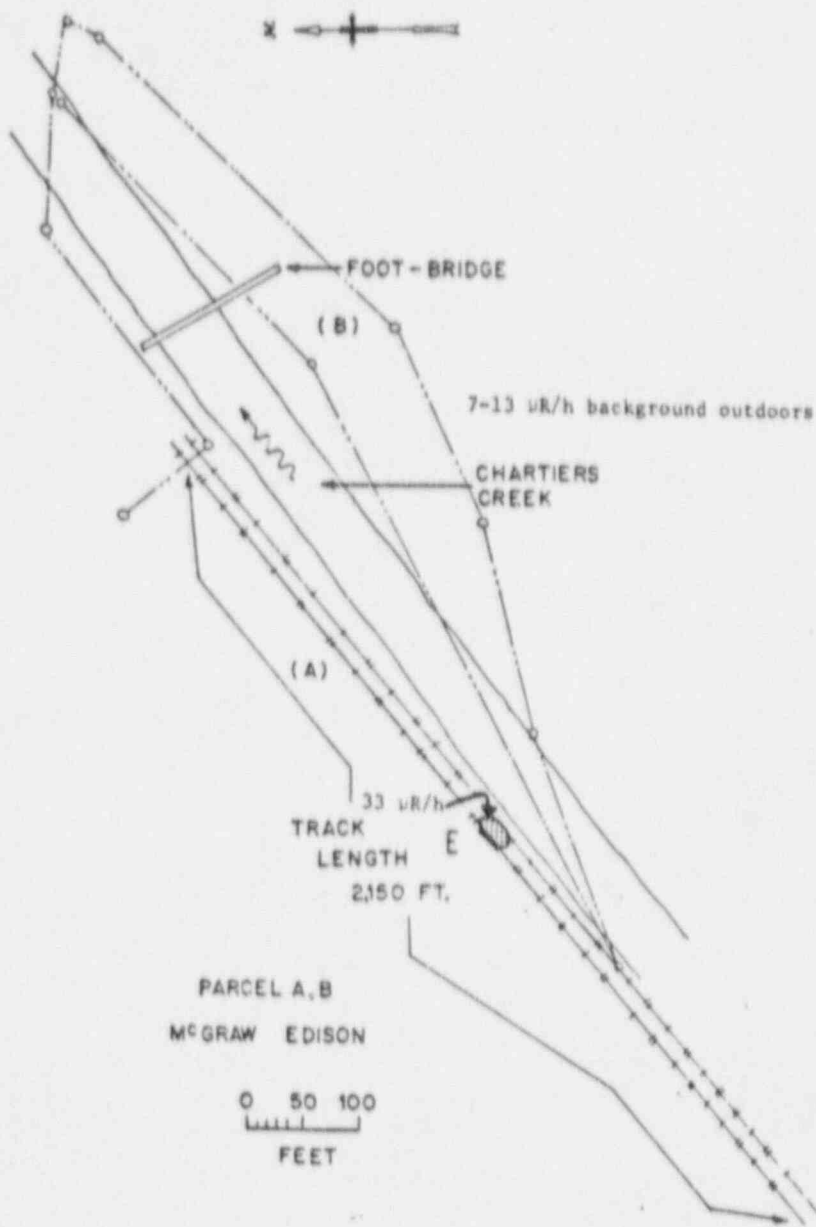
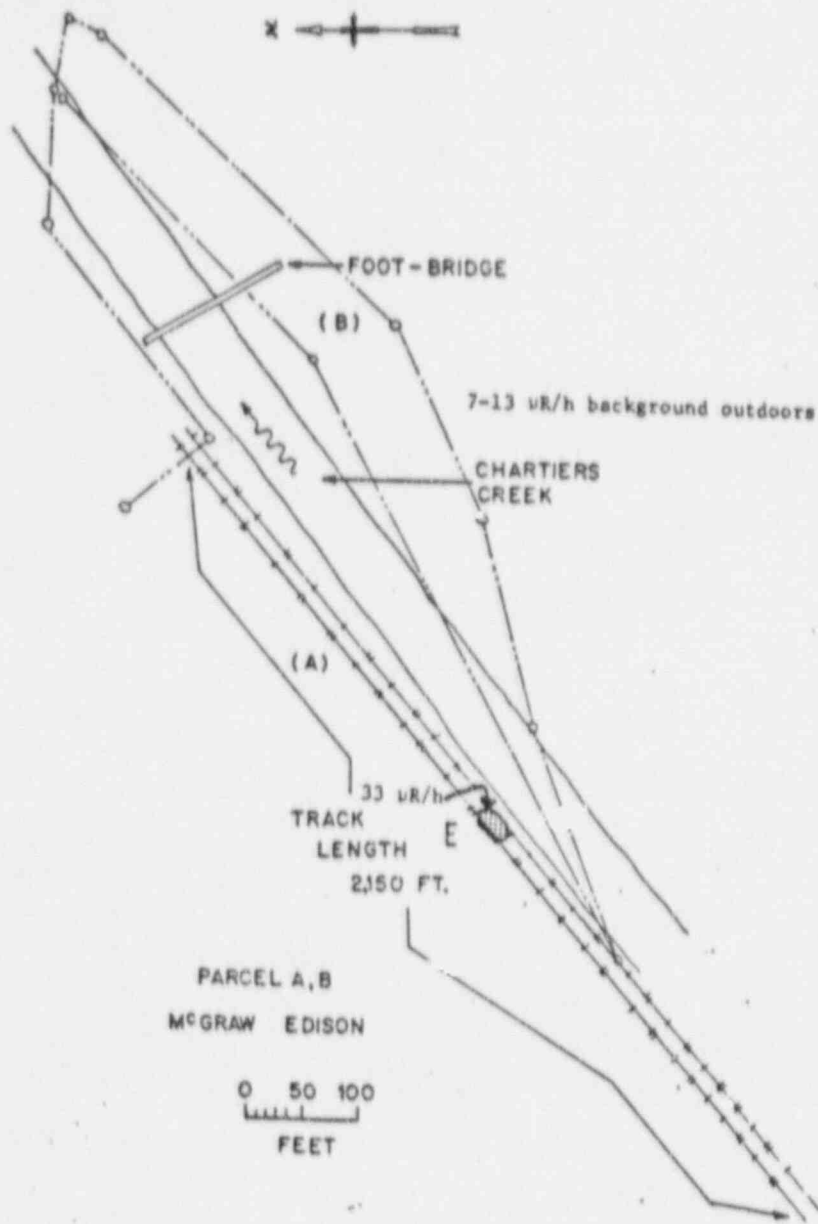
Fig. 11. Location CA00318 showing contaminated area in Parcel A.

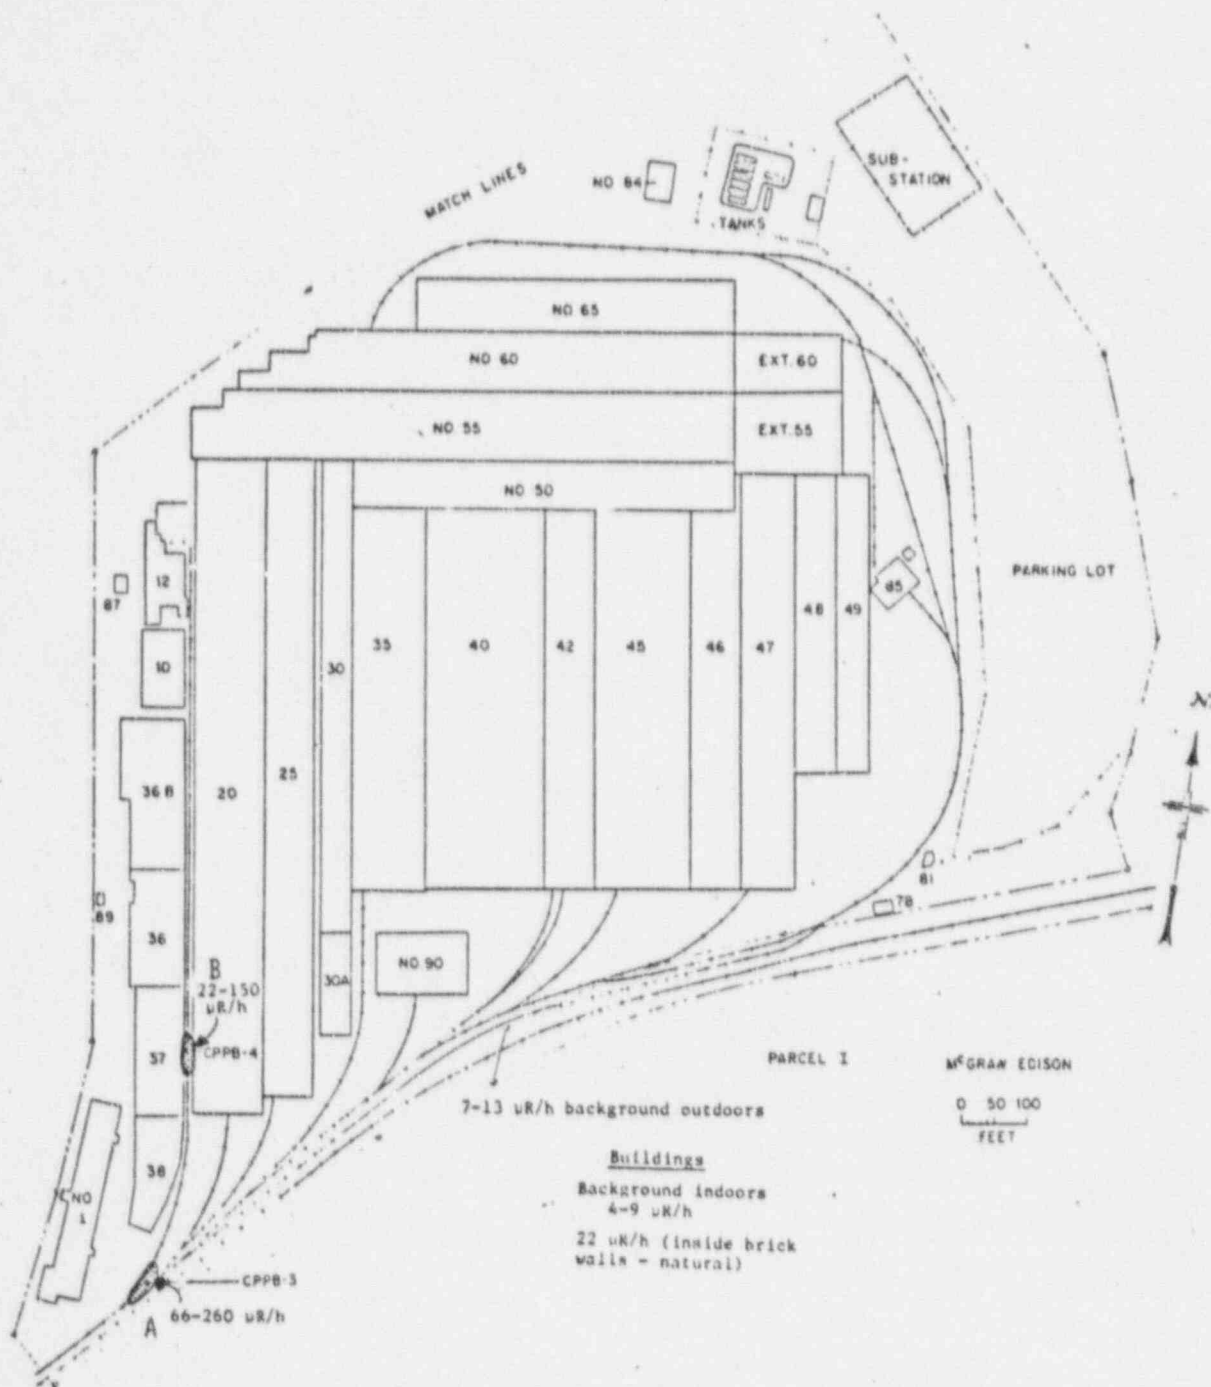
Fig. 1. Location CA00318 - McGraw-Edison Power Systems Division, P. O. Box 440, Canonsburg, Pennsylvania.

Based on measurements taken in an uncontaminated region, the background gamma exposure rate is estimated to be 10 ± 3 $\mu\text{R}/\text{h}$, ranging from 7 to 13 $\mu\text{R}/\text{h}$. Elevated gamma levels ranged as follows in the regions indicated on Fig. 1: (A) 66 to 260 $\mu\text{R}/\text{h}$; (B) 22 to 150 $\mu\text{R}/\text{h}$; Fig. 10: (C) 55 to 66 $\mu\text{R}/\text{h}$; (D) 33 $\mu\text{R}/\text{h}$; (F) 33 $\mu\text{R}/\text{h}$, and Fig. 11: (E) 33 $\mu\text{R}/\text{h}$. The high outdoor gamma was measured in a 3 m^2 area north of the pedestrian foot bridge in parcel I at the southwest corner of the property. The total contaminated area equals ~ 32 m^2 .

Nine surface soil samples and eight subsurface samples were taken at the locations shown in Fig. 1. The ^{226}Ra concentrations in the surface samples from locations CPPB-1 through CPPB-9 ranged from 1.5 to 330 pCi/g. The ^{226}Ra concentrations in the subsurface samples from the same locations with the exception of CPPB-2, ranged from 1.5 to 110 pCi/g.

The six contaminated regions found outdoors in various areas of the property as shown on Fig. 1., encompass ~32 m². The results of the radionuclide analyses demonstrate that the concentration of ²²⁶Ka in both surface and subsurface soil in region B exceeds the respective inclusion criteria of 5 and 15 pCi/g above background when averaged over an area of 100 m². However, based on the location of the contamination, it is recommended that location CA00318 be included for further consideration by the UMTRA Project with the possible implementation of supplemental standards.

Inclusion with possible implementation of supplemental standards
