# Radiological and Engineering Assessment

Vicinity Property No. SLC 053 Rev. 1

Remedial Actions  
Contractor  
for the  
Uranium Mill Tailings  
Remedial Actions  
Project

AUGUST 26, 1986

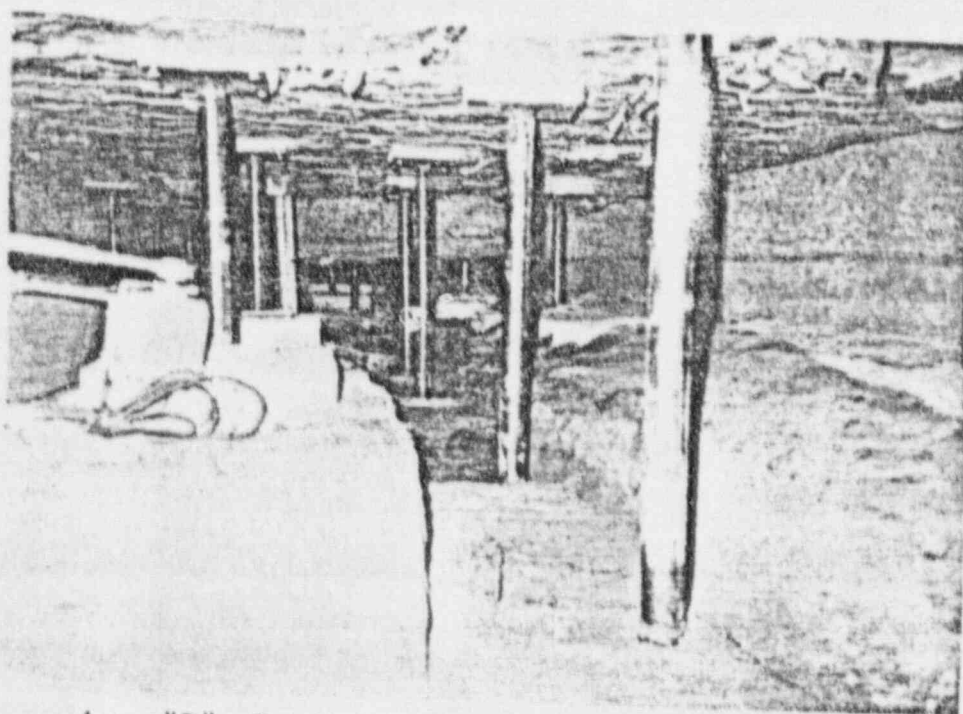
Area "D", Crawl Space Under Office Looking East

- o Underpin patio footer, remove existing and construct new concrete piers, remove and replace patio slab, remove and reinstall brick sidewalks.
- o Remove additional material from under the office building. △  
2

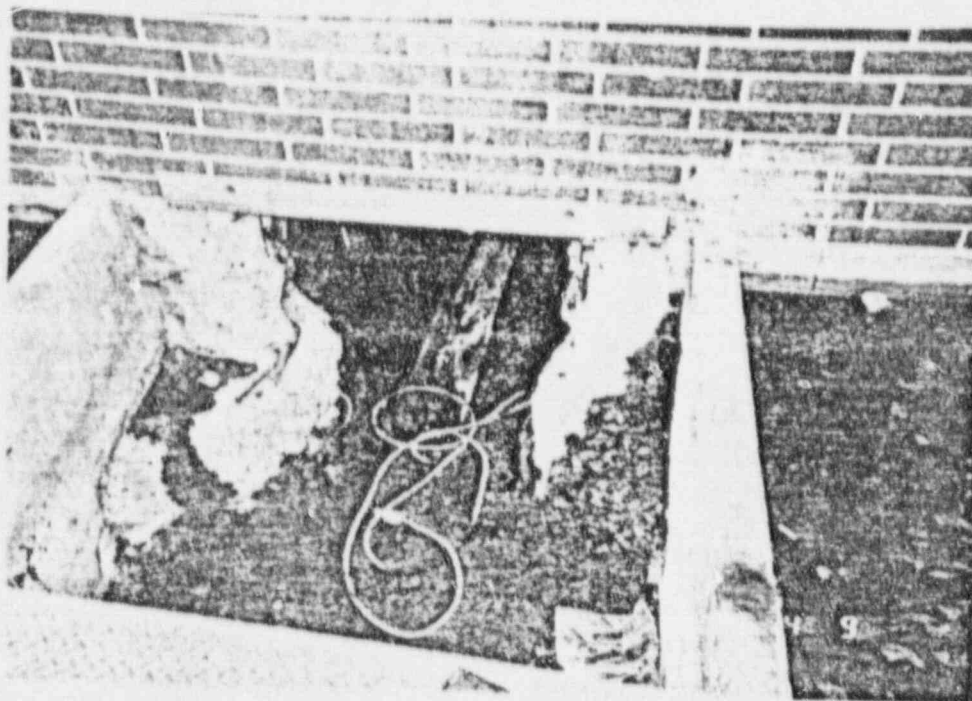
Crawl Space Access Pit Looking South

1. PIT AREA WITH STRUCTURAL  
CONSTRUCT THE REPLACEMENT  
FACE ACCESS PIT AS SHOWN IN  
ON DRAWING SL-053-023.

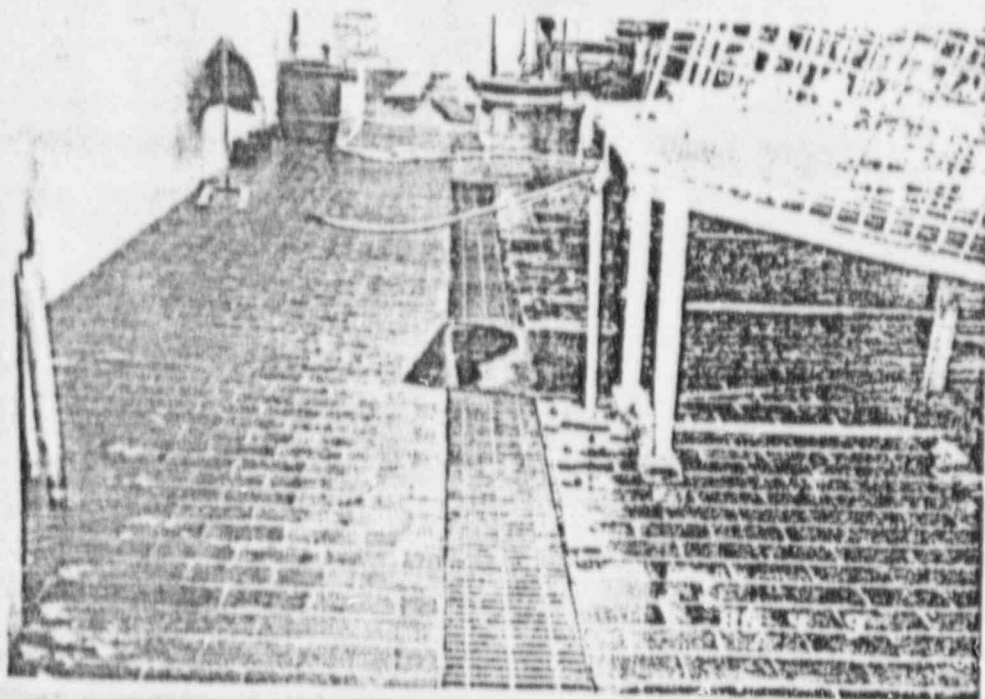
It is recommended that Supplemental Standards be applied for the area under the floor in the western one-third of Building 3 (smokehouse area). This recommendation is based on the premise that radon daughter concentrations are below the 0.01 WL guideline. RDC measurements indicated 0.003 and 0.006 WL in March of 1985.

Smokehouse Floor Looking North

Since the estimated cost of remedial action under the smokehouse is unreasonably high relative to the long-term benefits, and since any residual radioactive materials do not present a clear present or future hazard, Supplemental Standards shall apply, in compliance with the criteria established in 40 CFR 192.21(d). Section 3.5 of this report contains more information on the application of Supplemental Standards.

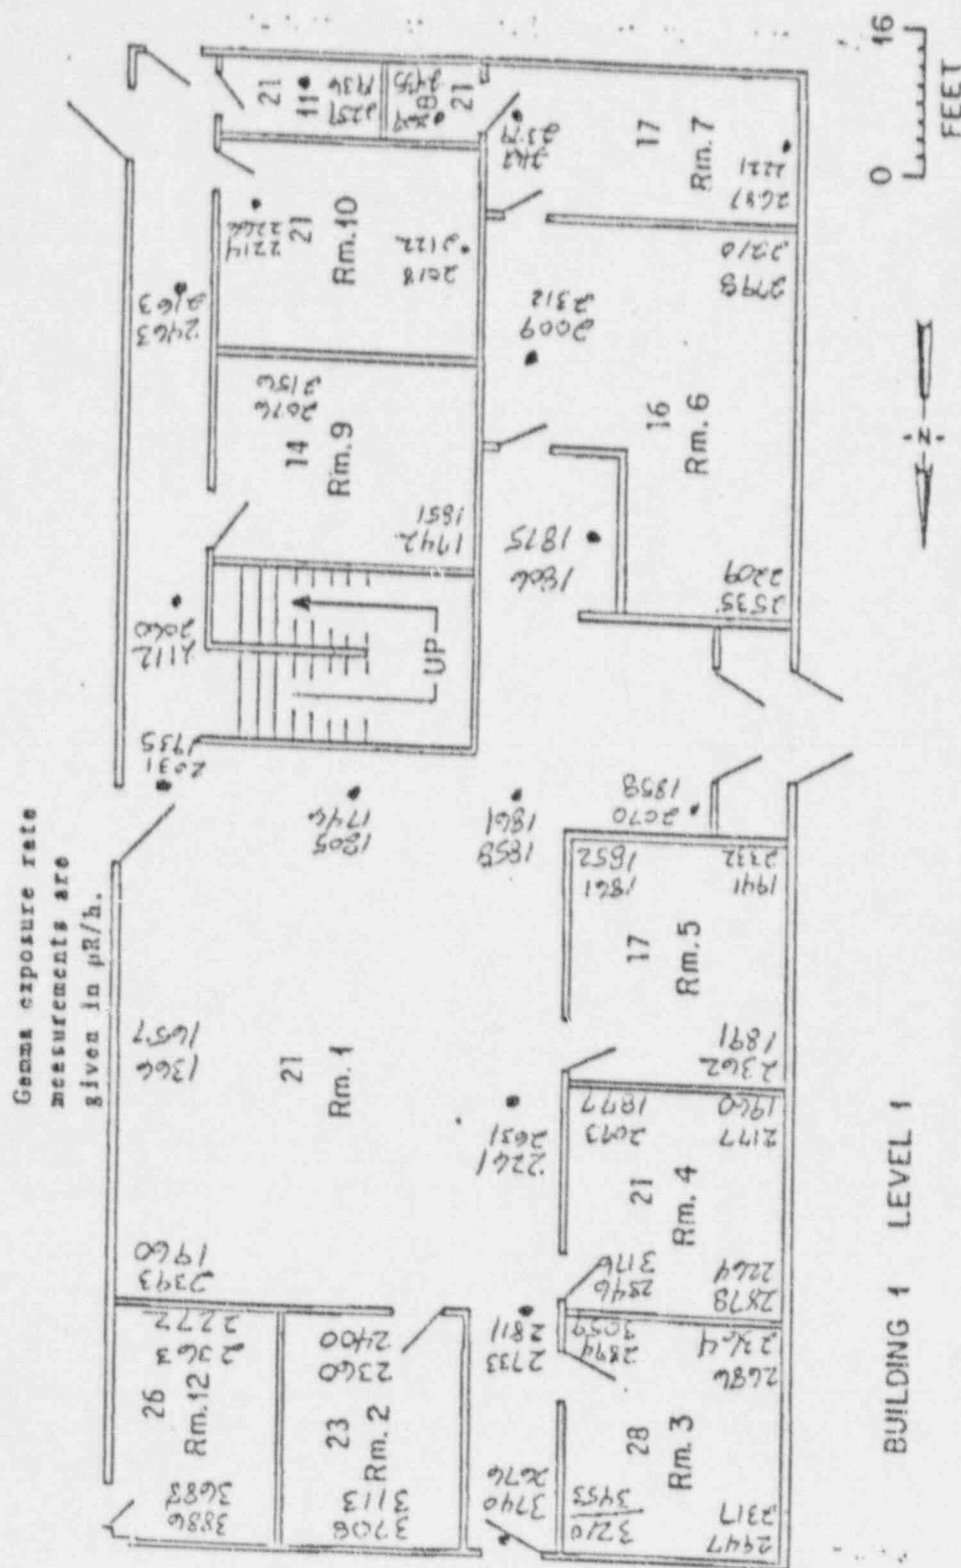
Fig. 4. Floor plan and gamma exposure rates at 1 m above floor surfaces in Building 1, level 1, at property SL053.
