Radiological and Engineering Assessment

Vicinity Property No. CAN-133

THE RADIOLOGICAL AND ENGINEERING ASSESSMENT
AND FINAL DESIGN

June 25, 1984

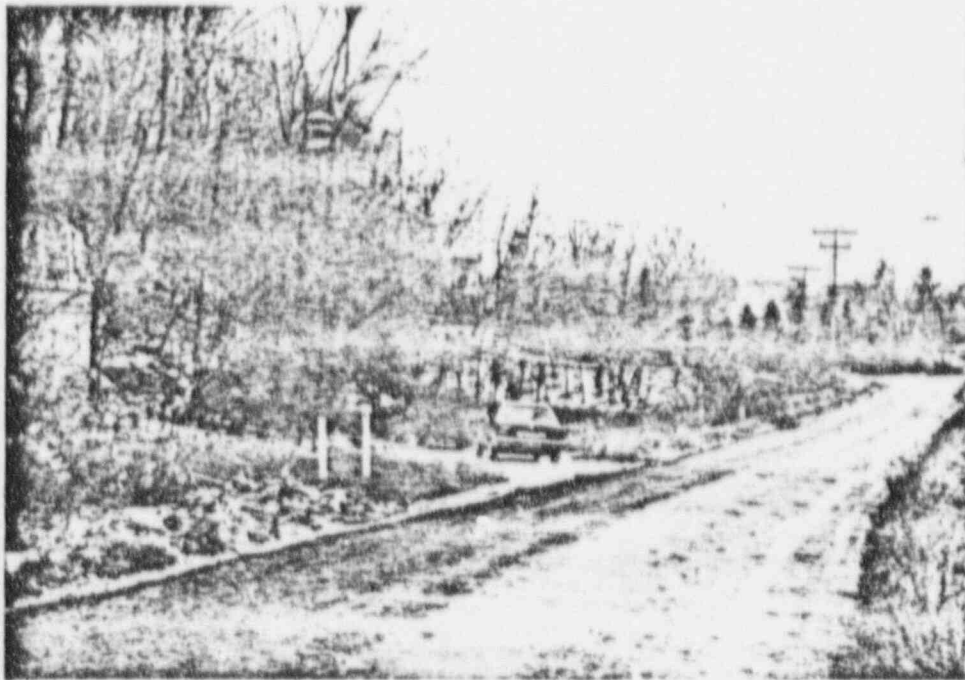
View of Property Looking North

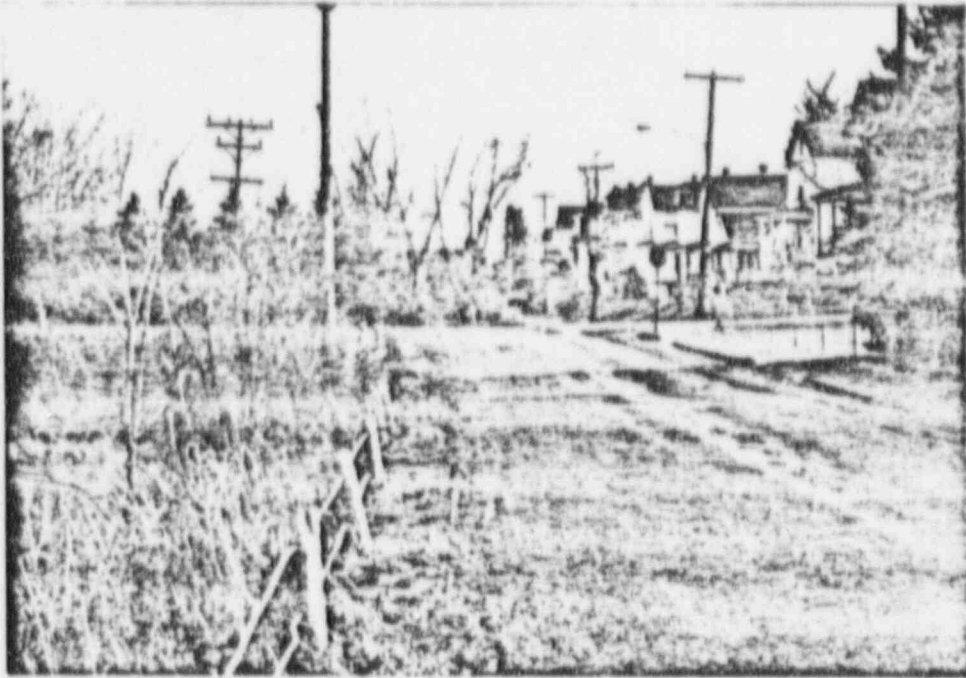
Figure 2.3 Property Photos

View of Lot and Road Barrier Looking South
