FACILITY NAME (1) **CONSUMERS ENERGY COMPANY
PALISADES NUCLEAR PLANT**

TITLE (4) **Revised Licensee Event Report 98-005-01 - Actuation of Containment Isolation Caused by an Inadvertent Containment High Radiation Signal**

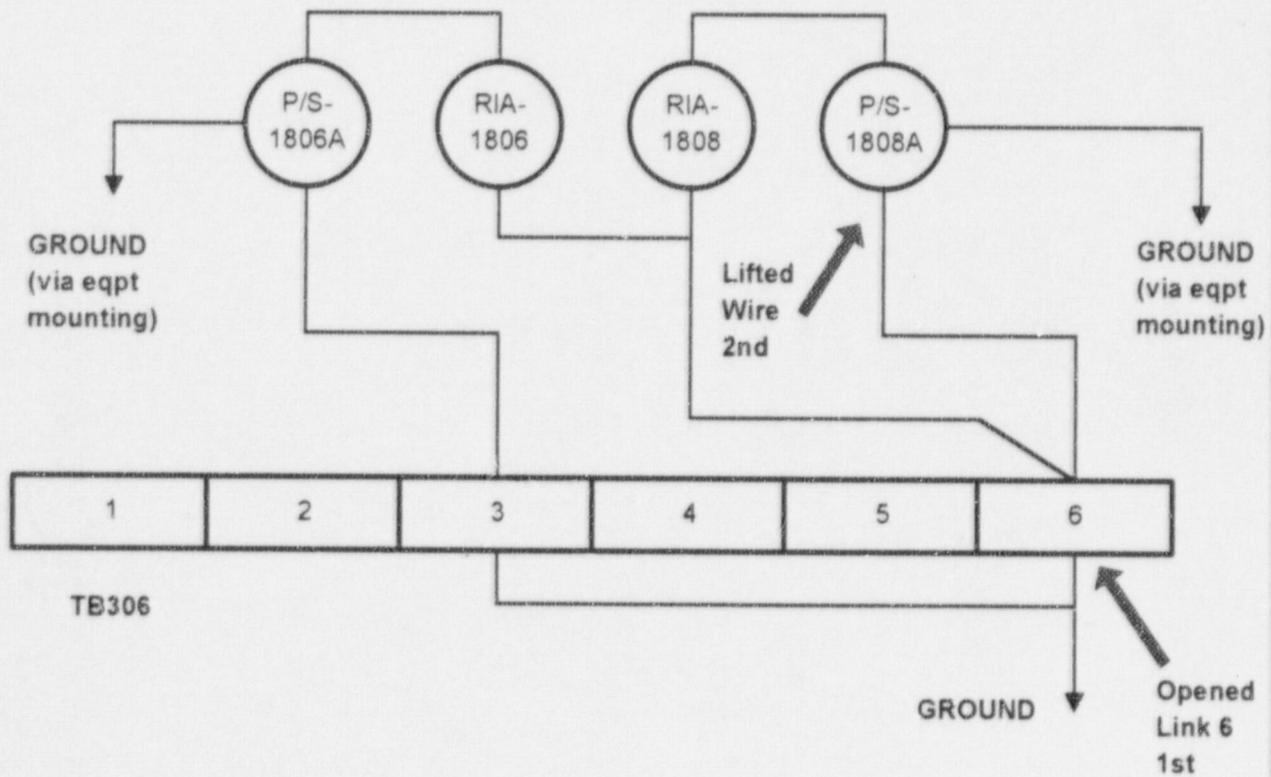
RIA Common Ground Circuit

This event revealed that the two redundant right channel monitors RIA-1806 and RIA-1808 share a common daisy-chained ground connection which allows a single failure (opening the common ground) to effect the two RIA's. A review was also performed for the opposite left channel monitors RIA-1805 and RIA-1807. This review determined that RIA-1805 and RIA-1807 also share a common daisy-chained ground connection. The review also determined, however, that left channel monitors RIA-1805 and RIA-1807 do not share common ground connections with right channel monitors RIA-1806 and RIA-1808.

An unauthorized field change made as part of a 1986 modification to install new containment isolation radiation monitors created wiring deficiencies that violated FSAR design criteria related to separation of redundant safety related equipment. RIA-1806 and RIA-1308 share a common daisy-chained ground connection as do RIA-1805 and RIA-1807. These common daisy-chained ground connections allow a single failure to affect two RIA's.

1. Modify containment isolation radiation monitors circuit wiring to satisfy FSAR design requirements.
2. Review drawings associated with containment isolation radiation monitor circuits, correct drawing inconsistencies, and eliminate inappropriate safety-related "Q" status indication for equipment depicted.
