PRECURSOR DESCRIPTION AND DATA

NSIC Accession Number: 103111

Title: Condenser Circulating Water Valves Fail to Open at Oconee 3

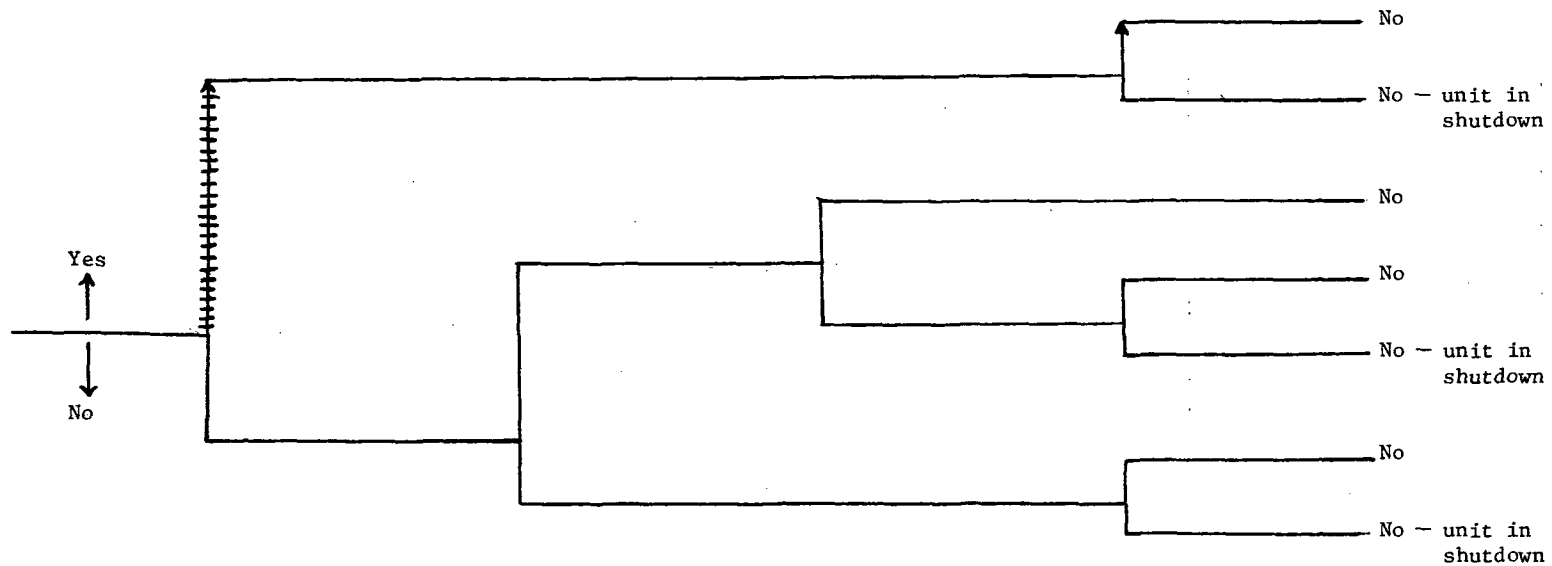
1. Due to inadequate procedure, switches which select valve operation for the condenser discharge valves were improperly positioned, preventing discharge valve closure during loss-of-offsite power.
2. During a CCW system gravity and recirculation flow test, three discharge valves failed to reposition. Since the emergency valves are interlocked with the discharge valves, the emergency valves did not open when the discharge valves failed to close.

NSIC 103111 - Actual Occurrence for Condenser Circulating Water Valves Failure to Close at Oconee 3
 (Emergency valves interlocked to open on closure of normal discharge valves.)

1. The operating procedure was revised to specify the required position of the control switches.

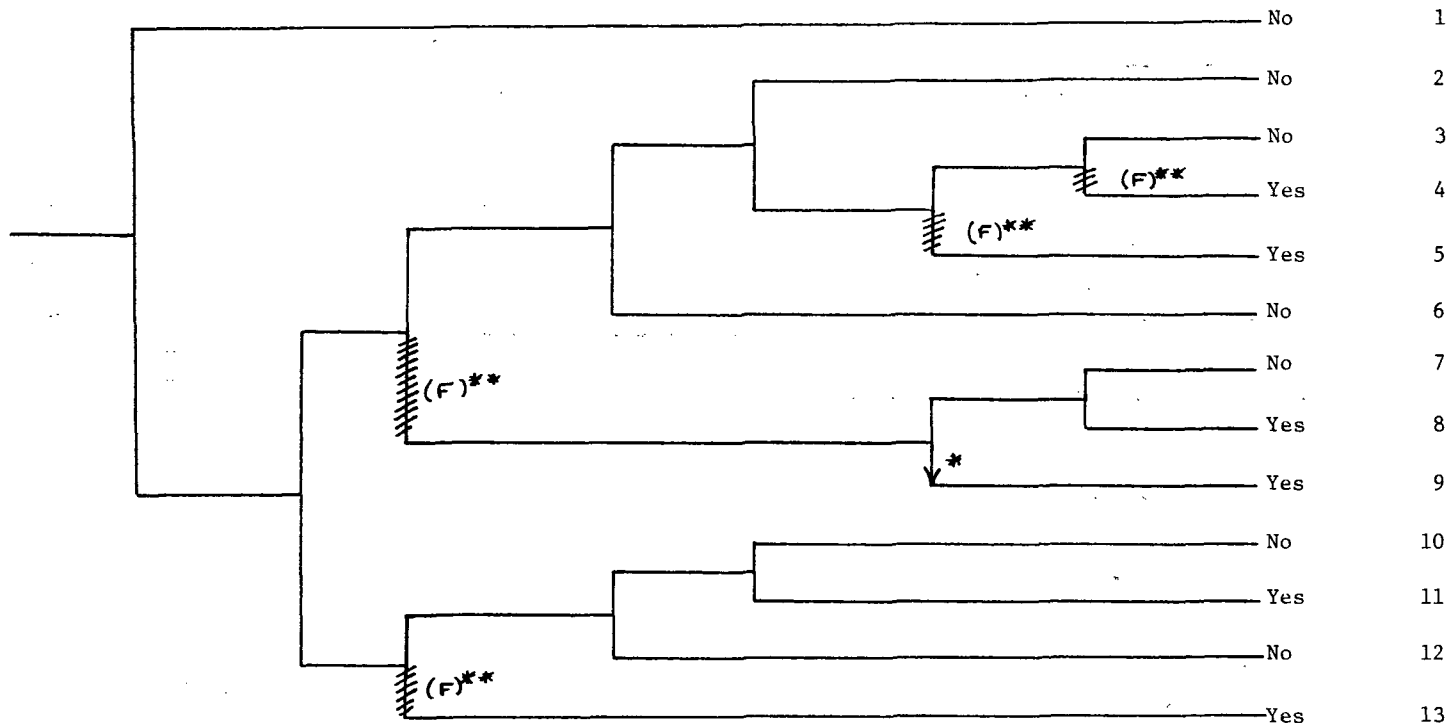
NSIC 103111 - Sequence of Interest for Condenser Circulating Water Valves Failure to Close at Oconee 3

* not included in mitigation procedures.

** success requires manual operation of emergency discharge valves to establish circulating water flow.

COMMENT: A common mode failure of the six discharge valves, combined with operator failure to manually open the emergency cooling discharge valves will result in the loss of the ultimate heat sink.
