U.S. NUCLEAR REGULATORY COMMISSION  
REGION I

Report No. 50-412/87-68

Facility Name: Beaver Valley Unit No. 2

Inspection Summary: Inspection on November 18-21, 1987 (Inspection Report No. 50-412/87-68)

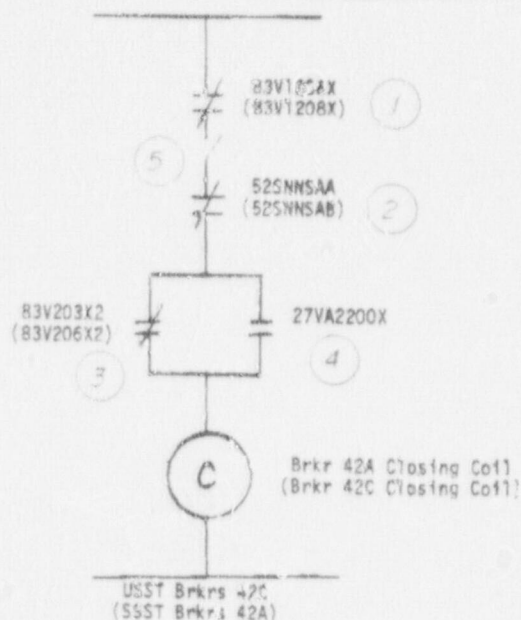
### 4kV Bus Breaker Control Circuit\*

3. There is an unintentional overlap in the 52S closing coil circuit contacts (see Attachment B and C) on the pallet switches of the USST and SSST breakers. These contacts are of an "early D" design to provide fast transfer from the USST to the SSST and vice versa. The intent of the design is to ensure that one set of breakers cannot reclose if the opposite set is closed and to keep to a minimum the time that the unit and system 4kV Breakers are both open with an unpowered bus. However, the design did not function entirely as intended because of the above contact overlap combined with the fast transfer feature in both directions (i.e., fast transfer from the unit generator to the offsite grid or a fast transfer from the offsite grid to the unit generator) and the use of non-seal in type of relays as noted in items 1. and 2. above. When the momentary thrust bearing failure trip signal cleared, the relays reset. This allowed the USST breakers to reclose, although the SSST breakers were closed.

The licensee determined by tests performed (see Section 3.3) on the 4kV bus breakers that an "early b" contacts closed overlap condition existed in the automatic close circuits of these breakers. This condition would permit simultaneous closure of both supply breakers on each 4kV bus if the trip signal to the USST side breakers were removed before the SSST side breakers had fully closed.

\*The simplified sketch shown is for the USST breaker 42C and 42A closing coil. However, it is typical of all the USST and SSST breakers (42C, 142C, 242D, 342D, 42A, 142A, 242B and 342B).

1. 90% voltage relay contact (Device 83V1206X): closes when the USST voltage is above 90%
2. The "early b" contact of each opposite side breaker (e.g., 42A and 42C) when the breaker begins to open is used to initiate closing of its opposite breaker. Thus, when USST breaker 42C starts to open its "early b" contact in the closing circuit of breaker 42A closes initiating closure of 42A before 42C is fully open. Conversely, the "early b" contact of breaker 42A is closed when breaker 42A is open thus providing a close permissive for breaker 42C. This "early b" contact should open when breaker 42A begins to close. The design intent is to provide fast transfer from the USST to the SSST and to prevent reclosing of the USST breaker if the SSST breaker is closed.

5. Knife Switch: added in the circuit as a modification to allow fast transfer only in one direction (i.e., from USST to SSST). The knife switches on the USST side breakers will be kept open and those on the SSST side will be closed to permit such a transfer.

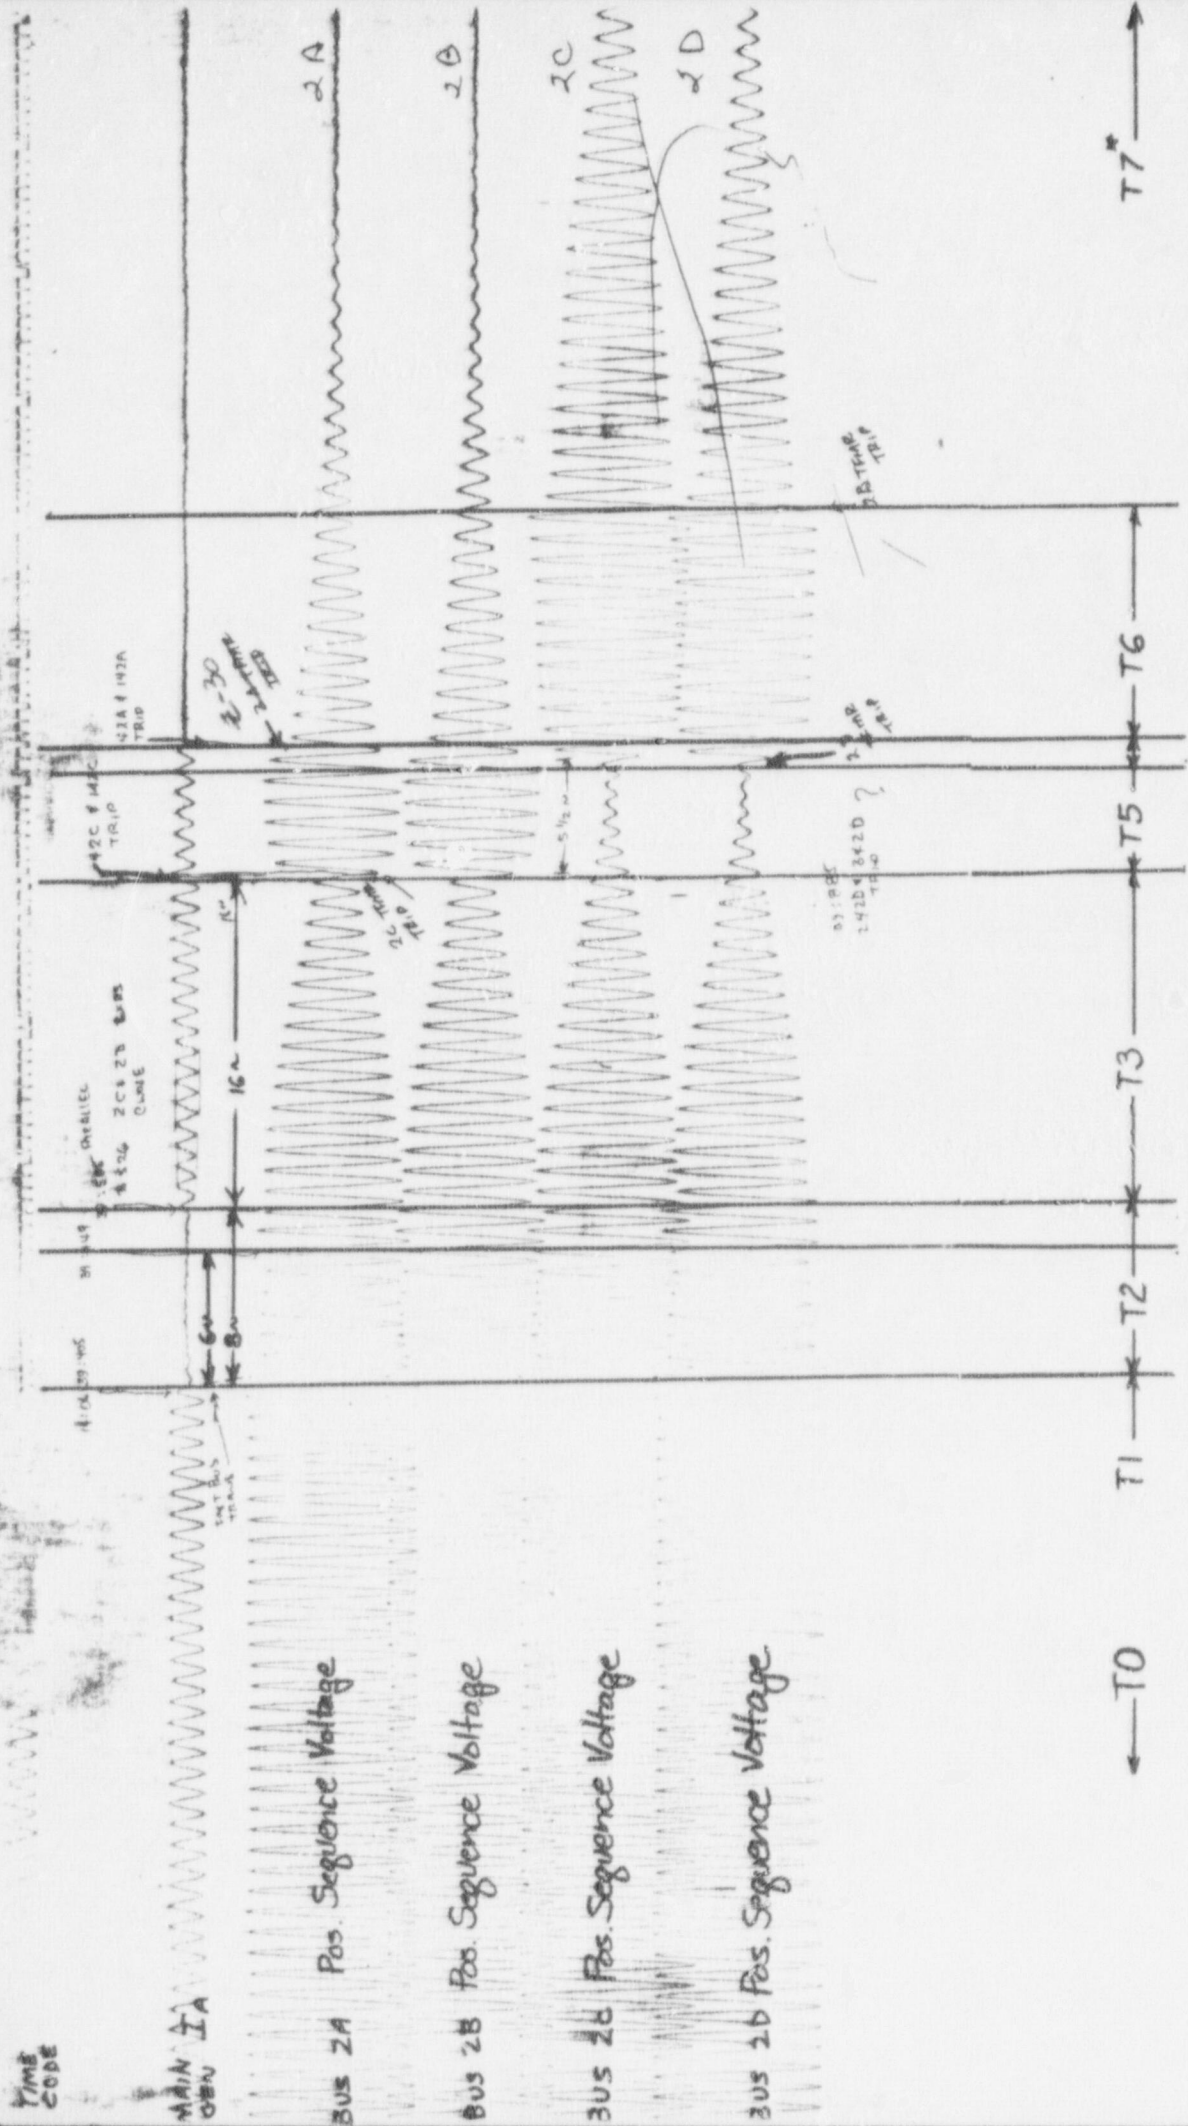
# Breaker Operational Sequence

- The USST breakers immediately reclosed due to an unintentional electric breaker contact overlap allowing the tripped generator to be backfed (motorized) from the offsite source through the SSSTs and USSTs. At the time the USST breakers reclosed, the momentary turbine thrust bearing signal was cleared.

- The 138kV Breakers 94 and 85 to the grid tripped. The over-current on USST 2D (caused by the motorizing of the generator) caused all four USST breakers to retrip and lock open. (The 138kV Breaker 94, which had tripped on overcurrent, locked out
