# Geologic and Seismologic Study of Bodega Head

BY  
Pierre Saint-Amand

This report is Dr. Saint-Amand's analysis and conclusions concerning the hazards posed by the Pacific Gas and Electric Company's anticipated construction of a 325 megawatt nuclear reactor at Campbell Cove on Bodega Head.

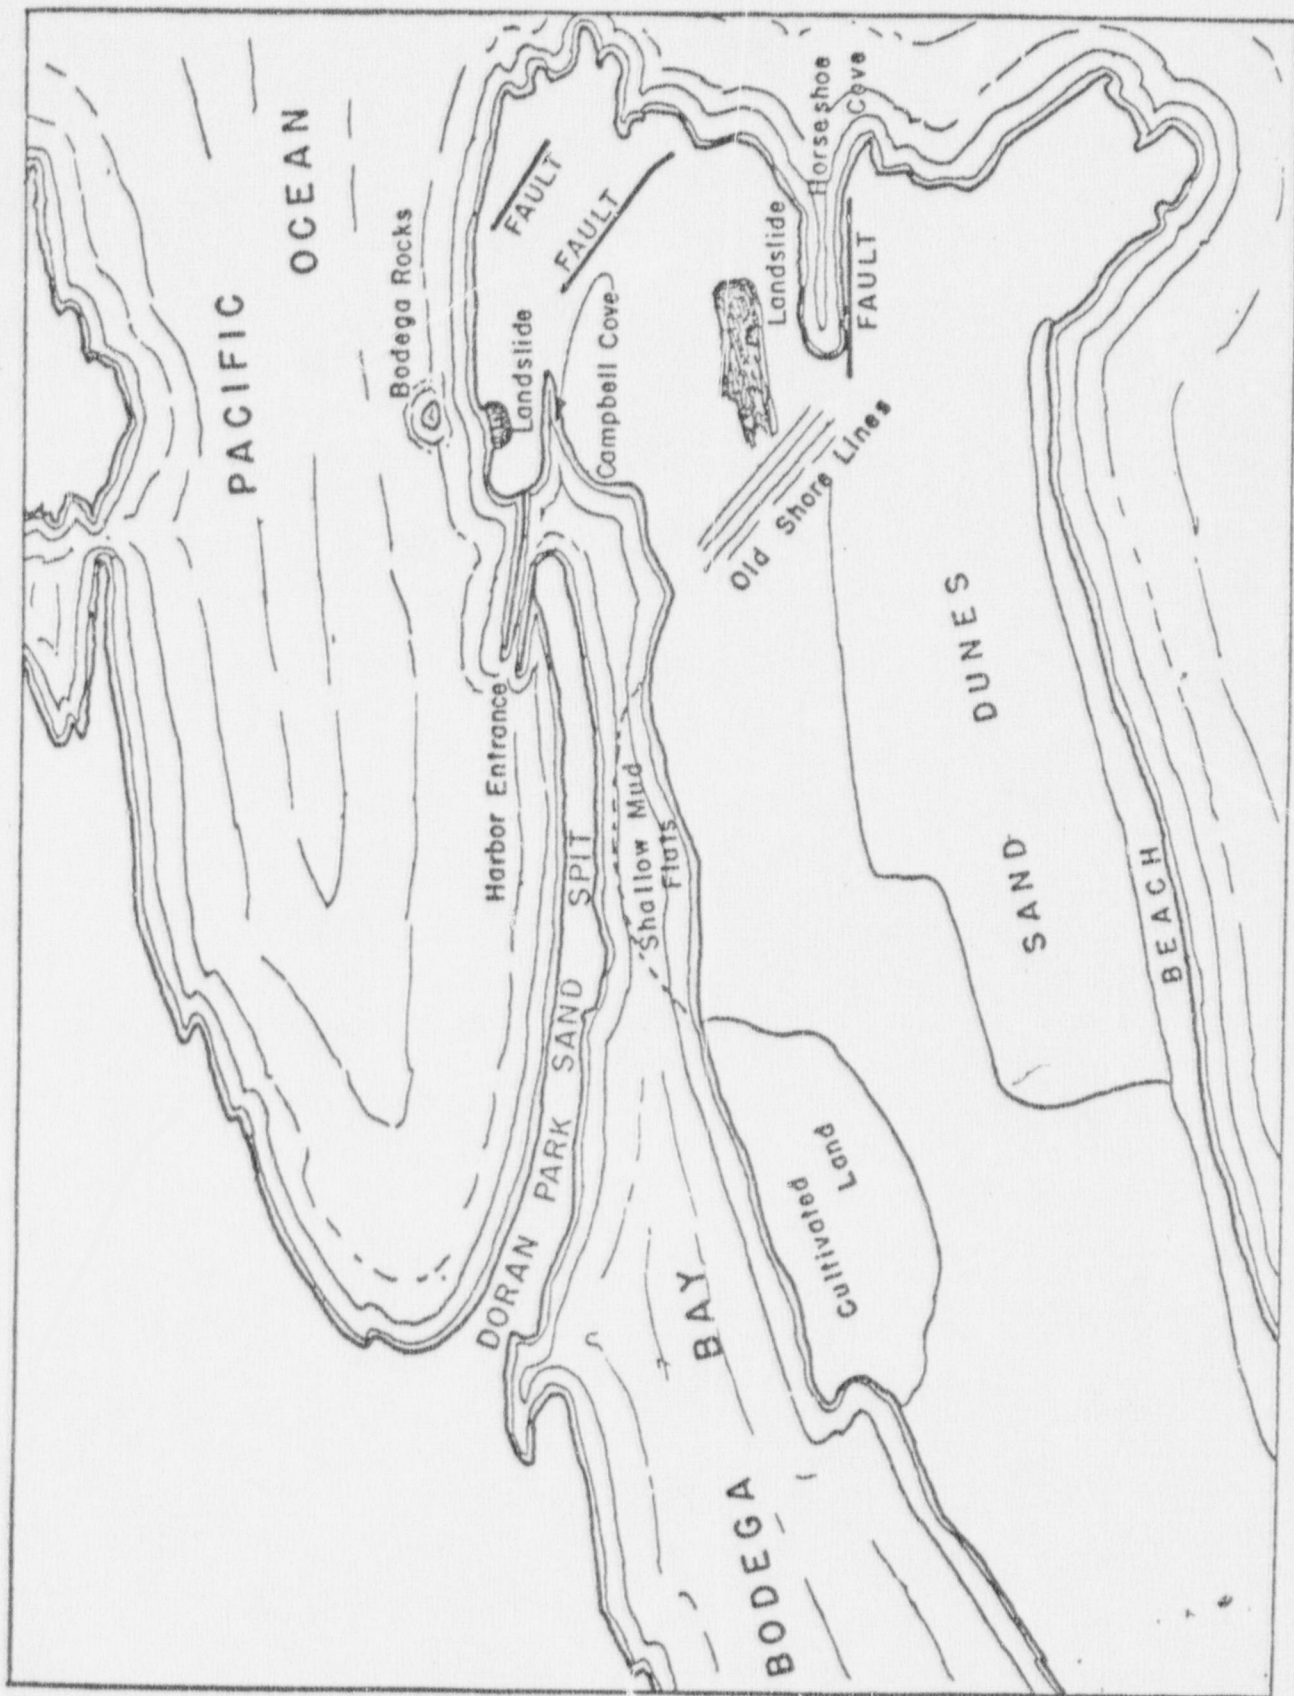
FIG. 2. Bodega Head and Harbor. Note shoreline near  
Horseshoe Cove, also wave-cut platform.

The fault lying along Points F and B, Fig. 3, on the northwesterly side of Horseshoe Cove, clearly offsets the pattern of the old shorelines, as may be seen in Fig. 2. Another fault, at Point C, leaves a faint scarplet running sub-parallel to the shorelines.

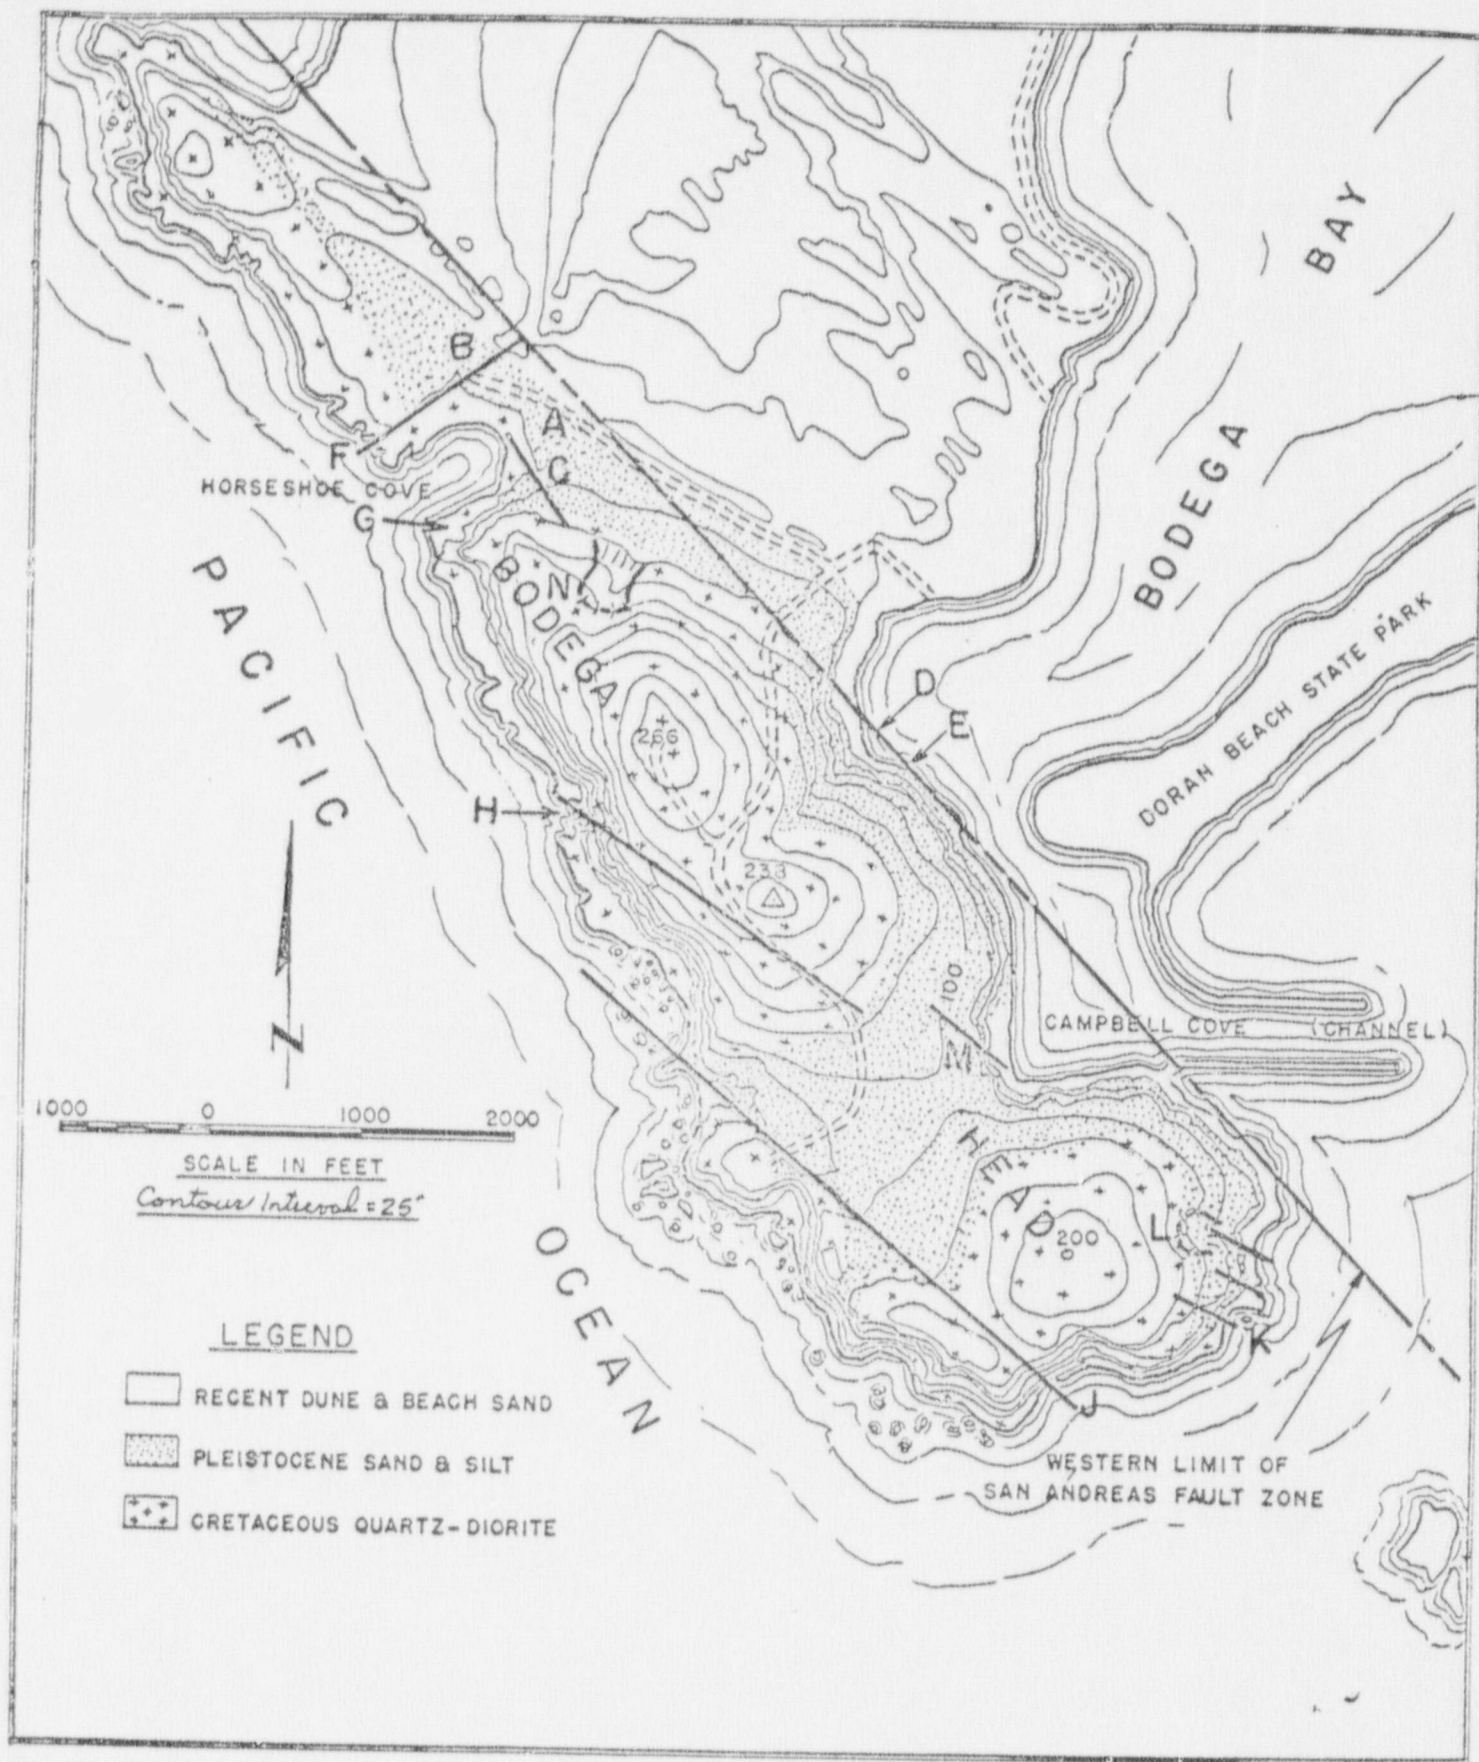
FIG. 3. Topographic and Geologic Map of Bodega Head.  
 Modified from Tocher and Quaide.

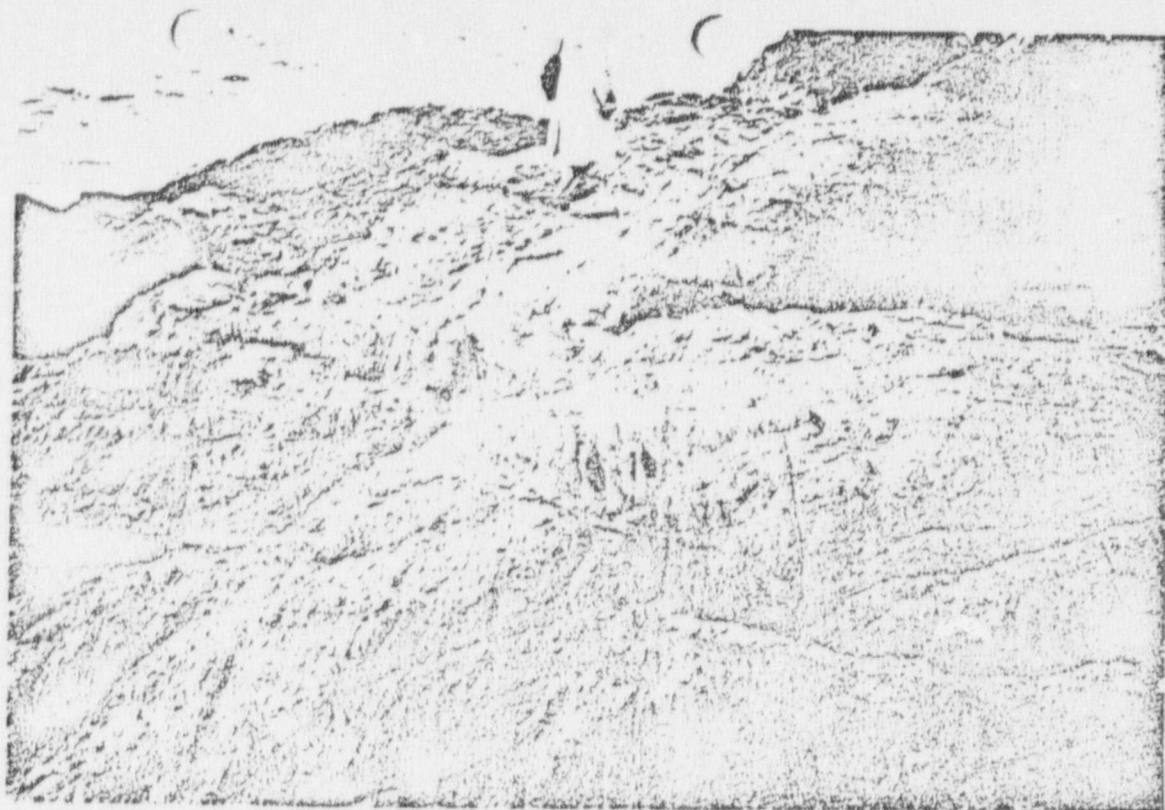
2 - 6. Fracturing. Tocher and Quaide describe the rock of Bodega Head as extensively sheared and broken. Johnson (1934, pp. 24-25) reports the same. The rock is indeed severely fractured, as Figs. 4 and 5 show, the fracturing being most intense near faults. In many places it is difficult to find sound rocks larger than a man's head.

FIG. 4. Crushed and Broken Rock Along Shore

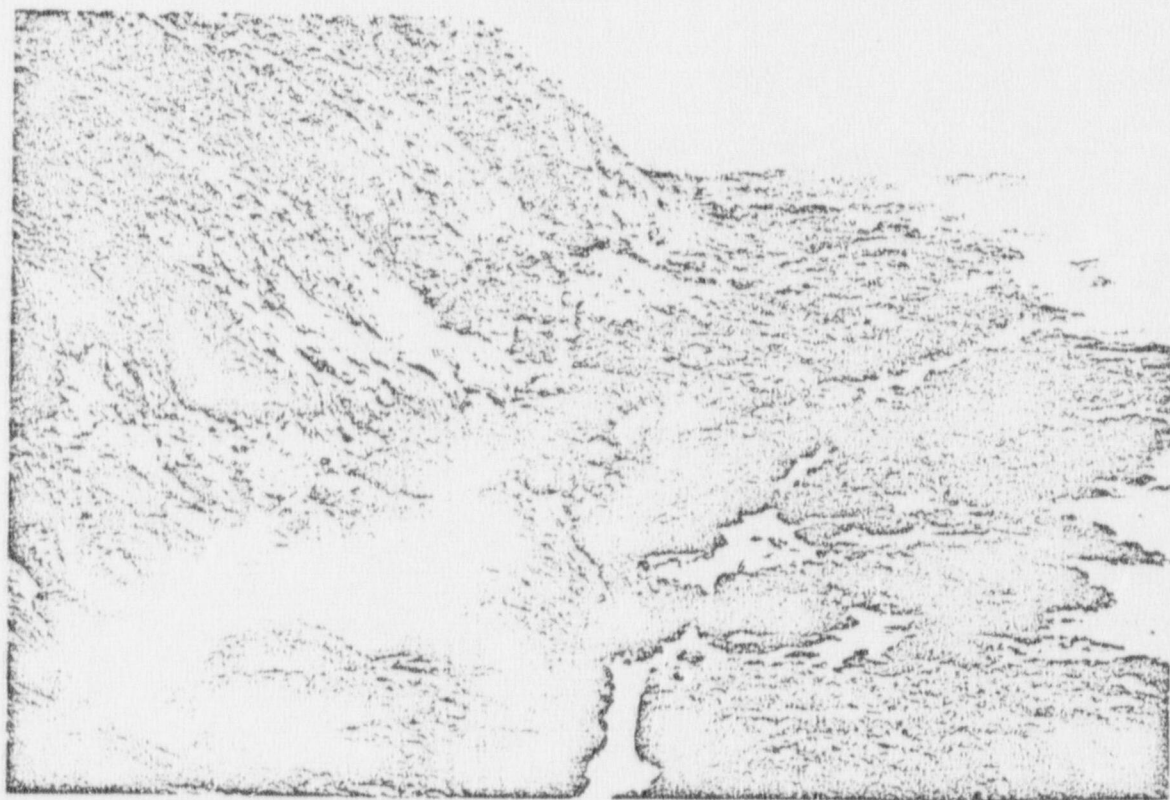
FIG. 5. Portion of Wave-cut Platform, Showing Crushing and Minor Faulting.

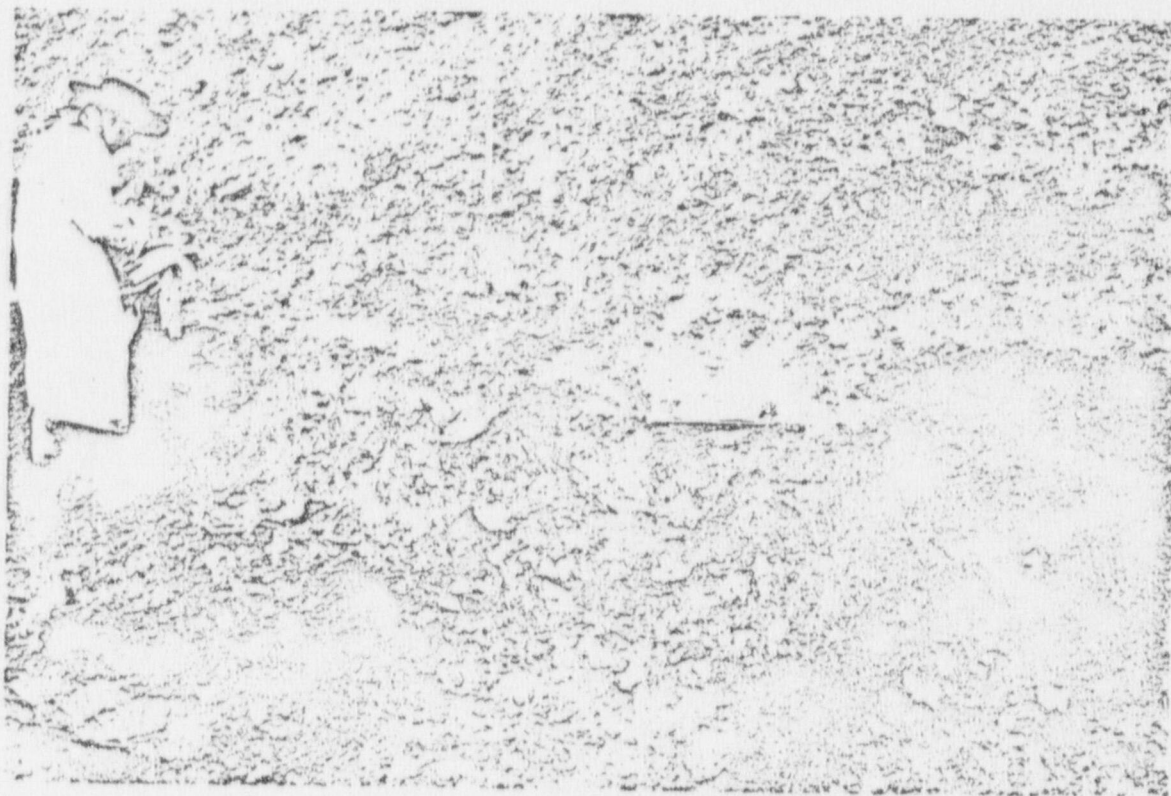
One spectacular fault is exposed on a bedrock high on the northwest face of the excavation for the reactor, the approximate location being at Point M; the original banks on the northwest and southwest sides of Campbell Cove have been removed by the excavation and precise location was difficult, especially in the rain. The fault lies near a temporary road, a temporary drainage culvert, and a stake marked "Top Bench 55.0". The fault extends up and down the road for at least 50 meters, strikes N45°W, and dips vertically, as nearly as can be seen in the partial exposure. Numerous small fractures

delineate the zone; these are interspersed with septa of crushed rock and curtains of mylonite and gouge measuring 2 meters wide. The majority of the stria indicate dextral strike-slip displacement, but some clearly indicate vertical movement. Figure 9 shows a section of one wide gouge zone.

This fault alone might well concern the builders, and is ample reason to recommend against the use of the site because of the possibility of movement thereon during or following an earthquake.

FIG. 9. Mylonite Zone in Large Fault  
in Excavation for Power Plant.
