ENGINEERING GEOLOGY OF THE PROPOSED NUCLEAR POWER PLANT SITE ON  
BODEGA HEAD, SONOMA COUNTY, CALIFORNIA

Julius Schlocker and Manuel G. Bonilla

December 1963

Prepared on behalf of the U. S. Atomic Energy Commission

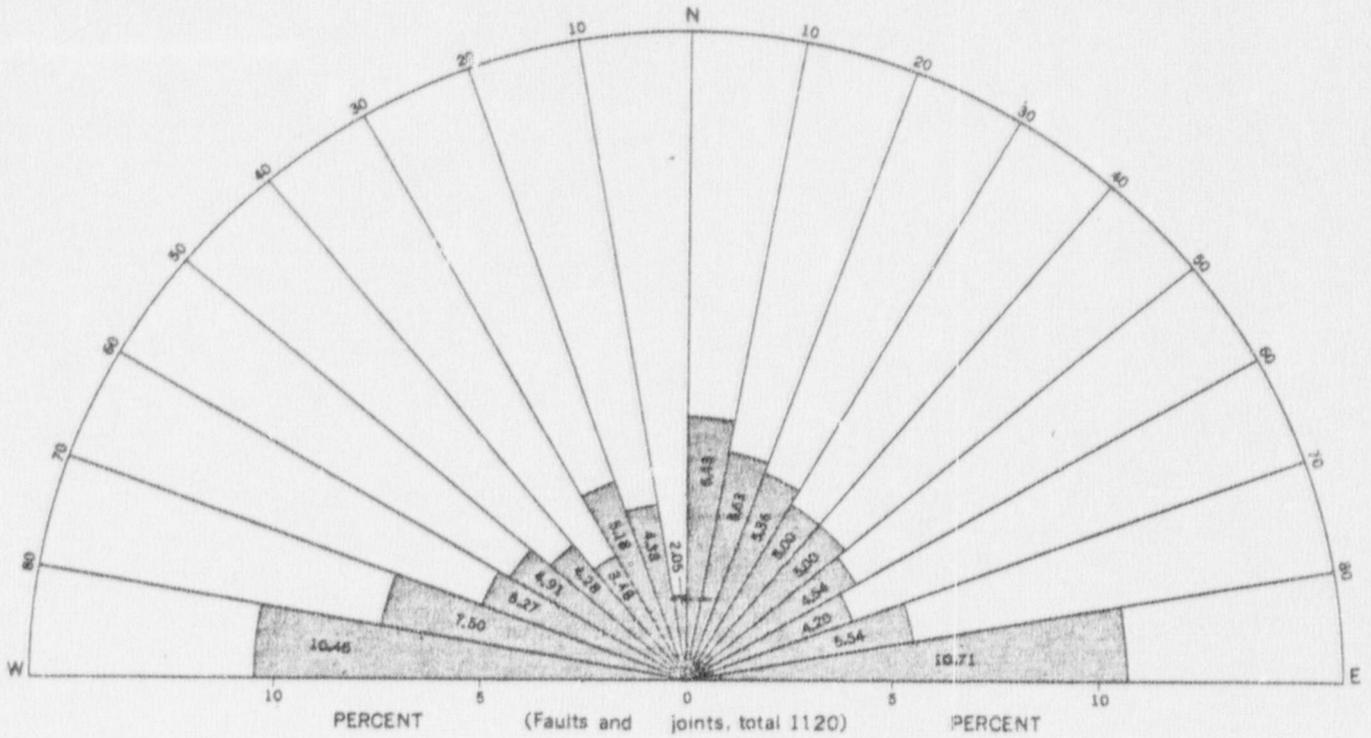
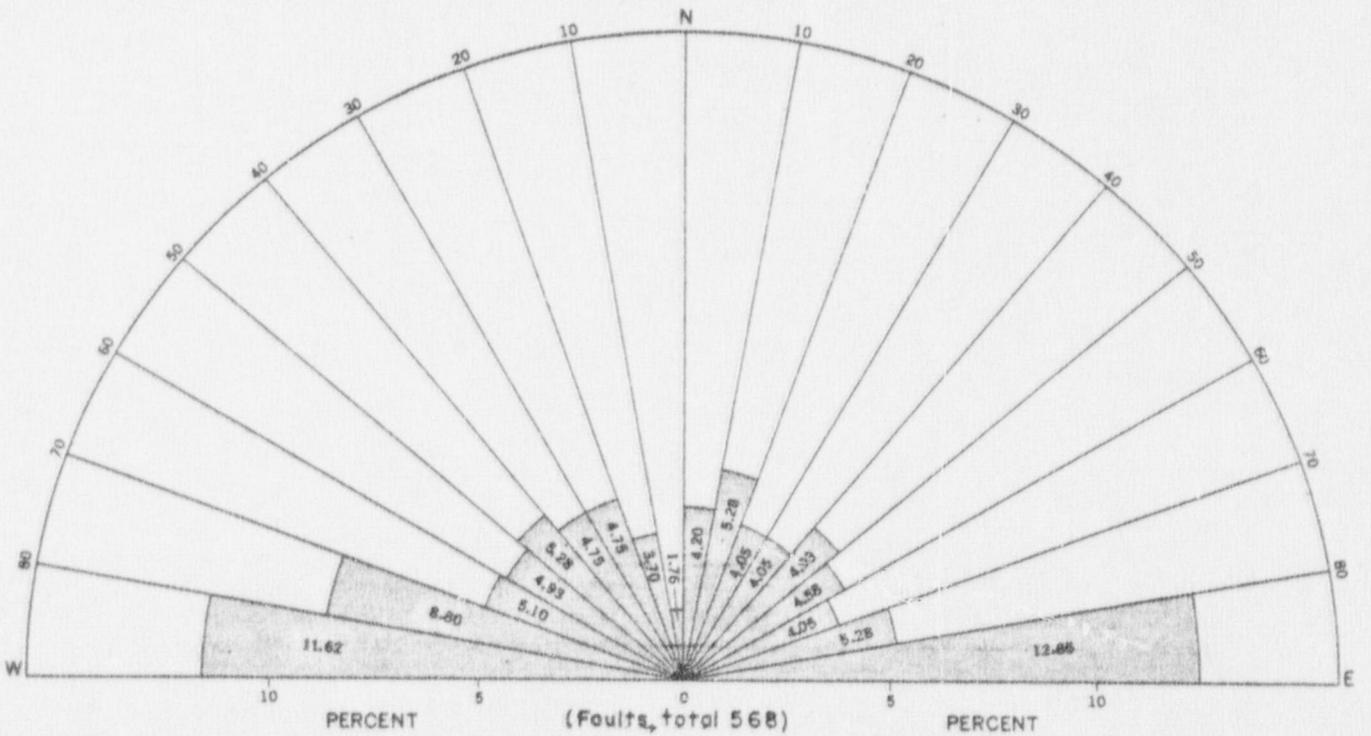
The orientation of faults and joints in the granitic rock exposed on the shaft wall is shown on plate 4 and in figures 1 and 2. Figure 1 shows the percentage of faults and joints having various strikes (bearings) grouped by 10 degree arcs. That is, all faults and joints whose strike is within the range N. 20° to 30° W. were considered as one group. One of the diagrams on figure 1 shows the distribution of 1,120 measurements made of the strike of faults and joints at all levels in the shaft. Thus if a fault or joint persists from one level

to a lower level its orientation was measured at each level. Use of repeated measurements on the same feature at several levels in figures 1 and 2 tends to weight the data in the direction of persistent, continuous features. Another diagram on figure 1 shows strike-frequency of only the faults included in the 1,120 measurements used in the other diagram. Both diagrams show that the predominant strike of faults and joints is in a narrow zone 10 degrees on either side of east-west and that the least-favored strike is between north and N. 10° W. The second most-favored strike is between N. 70° W. and N. 80° W. The average dip of all the fault and joint measurements is 63 degrees.

Figure 1. - Strike(bearing)-frequency diagrams of faults and joints observed in wall of reactor shaft, showing percent mapped within 10 degree intervals of strike. Includes repeated observations of faults and joints that persisted from level to level.

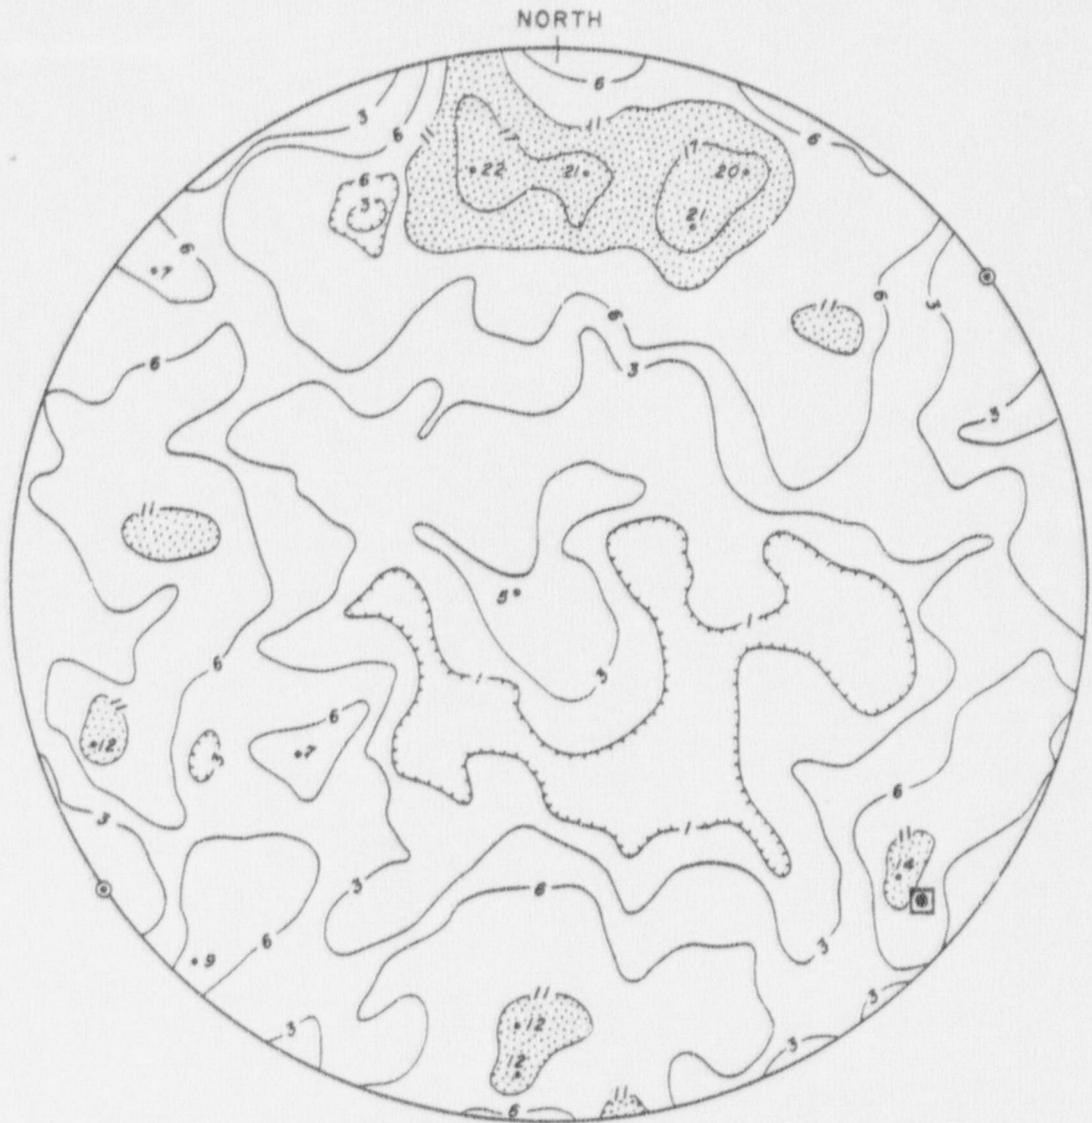
Figure 2.- DIAGRAM SHOWING ORIENTATION OF FAULTS

Figure 2 shows both dip and strike of the faults in the form of a contour map of the concentration of poles to the faults. A pole is a line drawn perpendicular to a fault plane. It confirms what is shown in figure 1 and, in addition, shows that the predominant dip direction of the west-trending faults is 50° to 75° S., but the general range is 65° N. to 45° S. Many fault surfaces seen in the wall bend in open curves through large angles. Slickensides or striations caused by relative movement on fault surfaces are common and generally plunge at large angles though on some faults they plunge at low-angles or are nearly horizontal.

Contour diagram of 568 poles of faults on wall of reactor shaft. Plotted on lower hemisphere of equal-area net. Includes repeated observations on faults that persist from level to level. Contoured on 1, 3, 6, 11, and 17 pole concentration intervals; unit area for counting poles is one percent.

⊙ indicates pole to San Andreas fault zone, which for this diagram is assumed to be vertical strike N37 W. ⊠ indicates pole to Shaft fault, dip 77 degrees N. W., strike N 40 E.

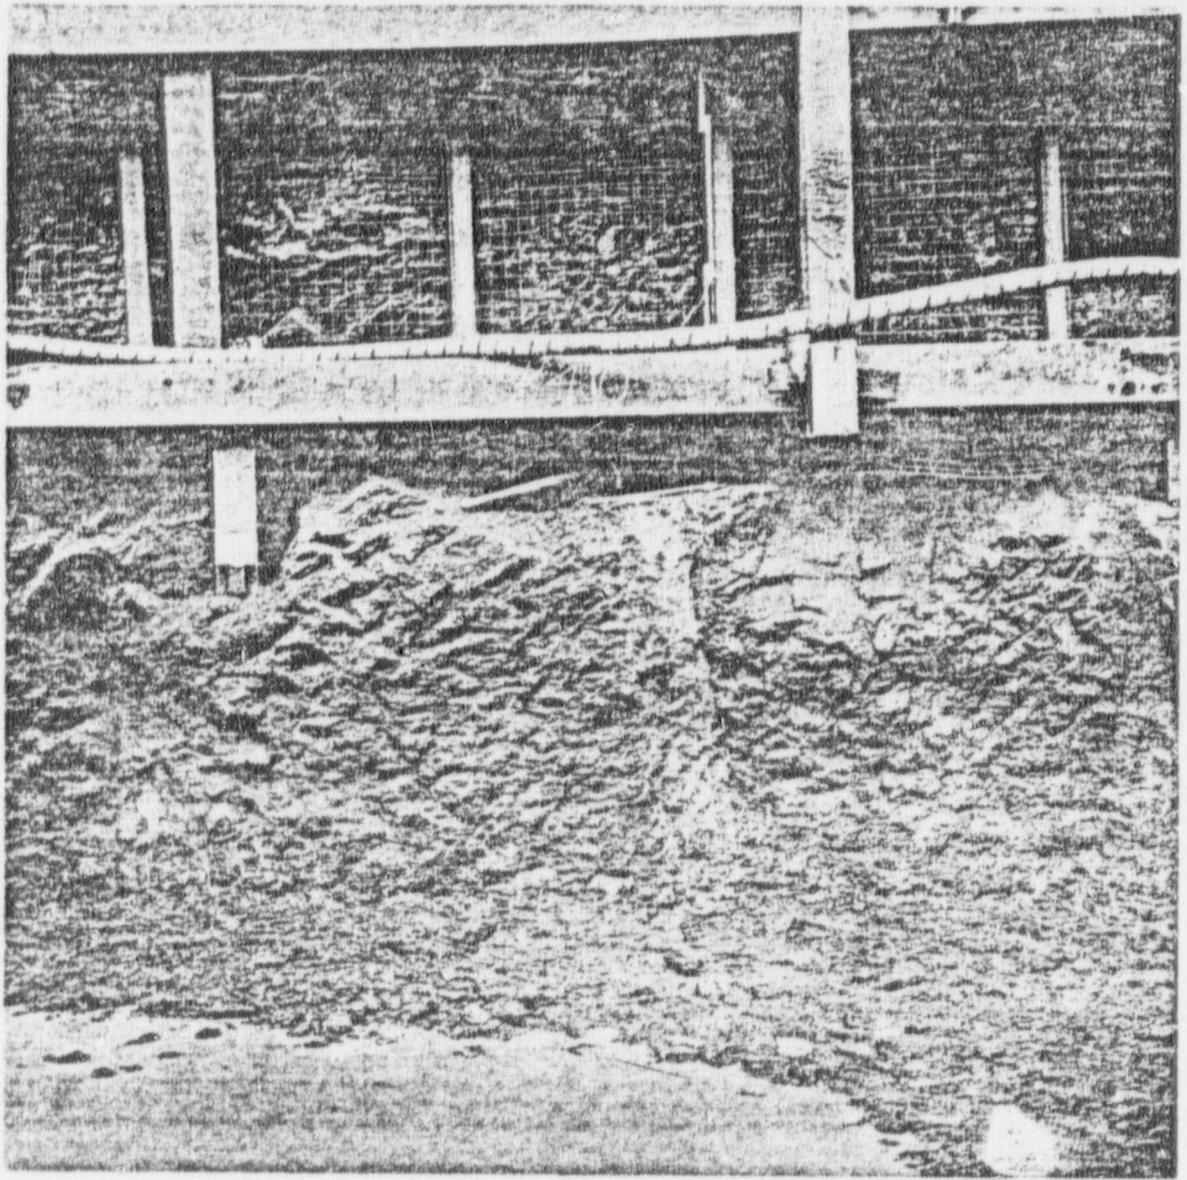
Fig. 3.--Shaft fault on south wall of shaft, elevation -75 feet.

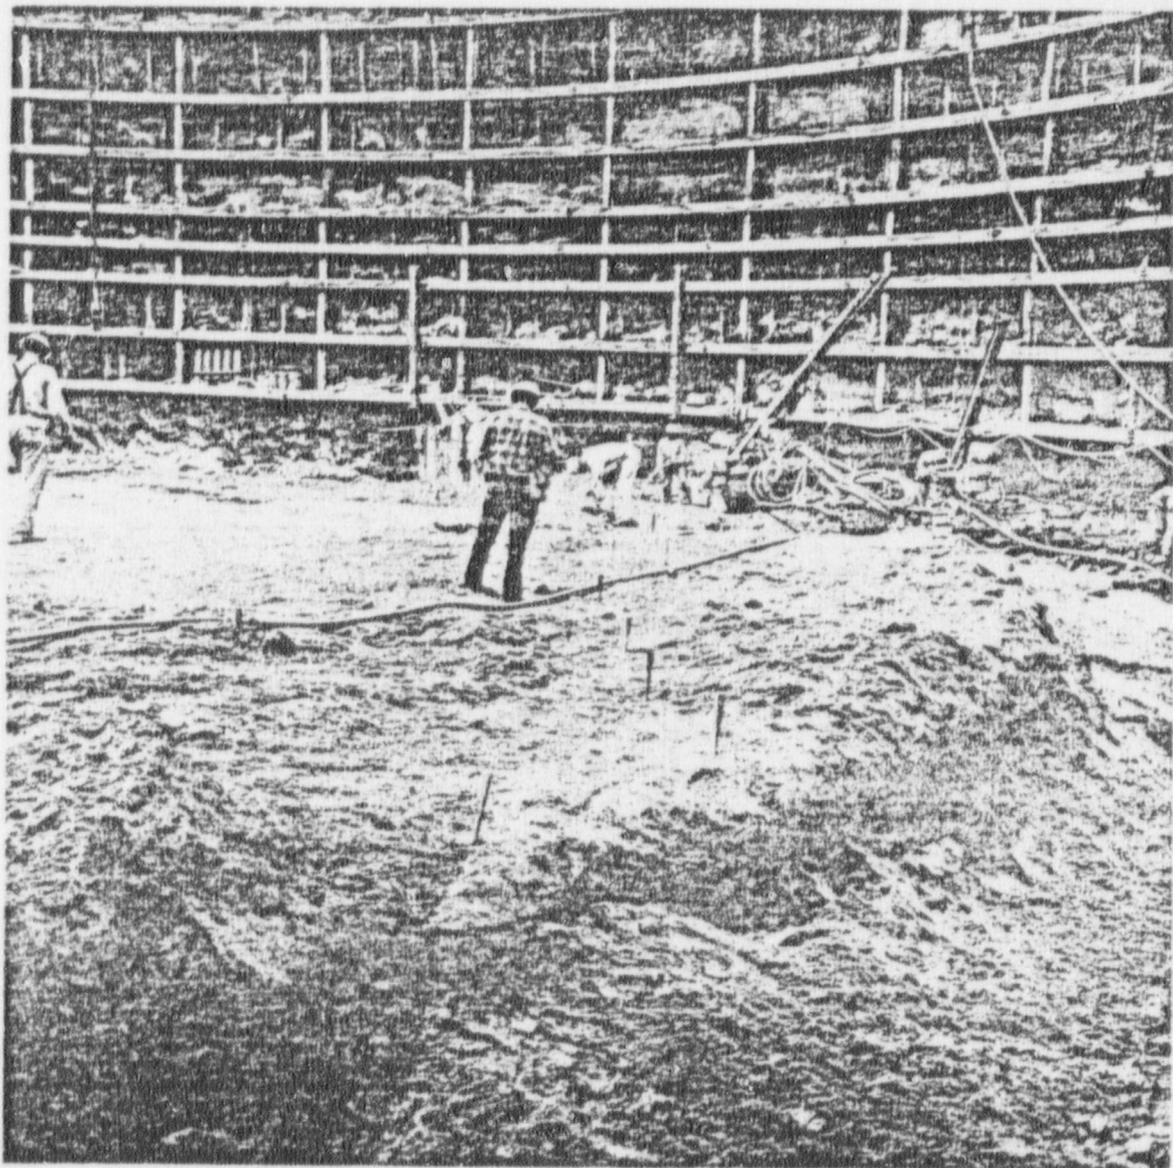
Fig. 4.--Shaft fault on floor of shaft, elevation -42 feet.

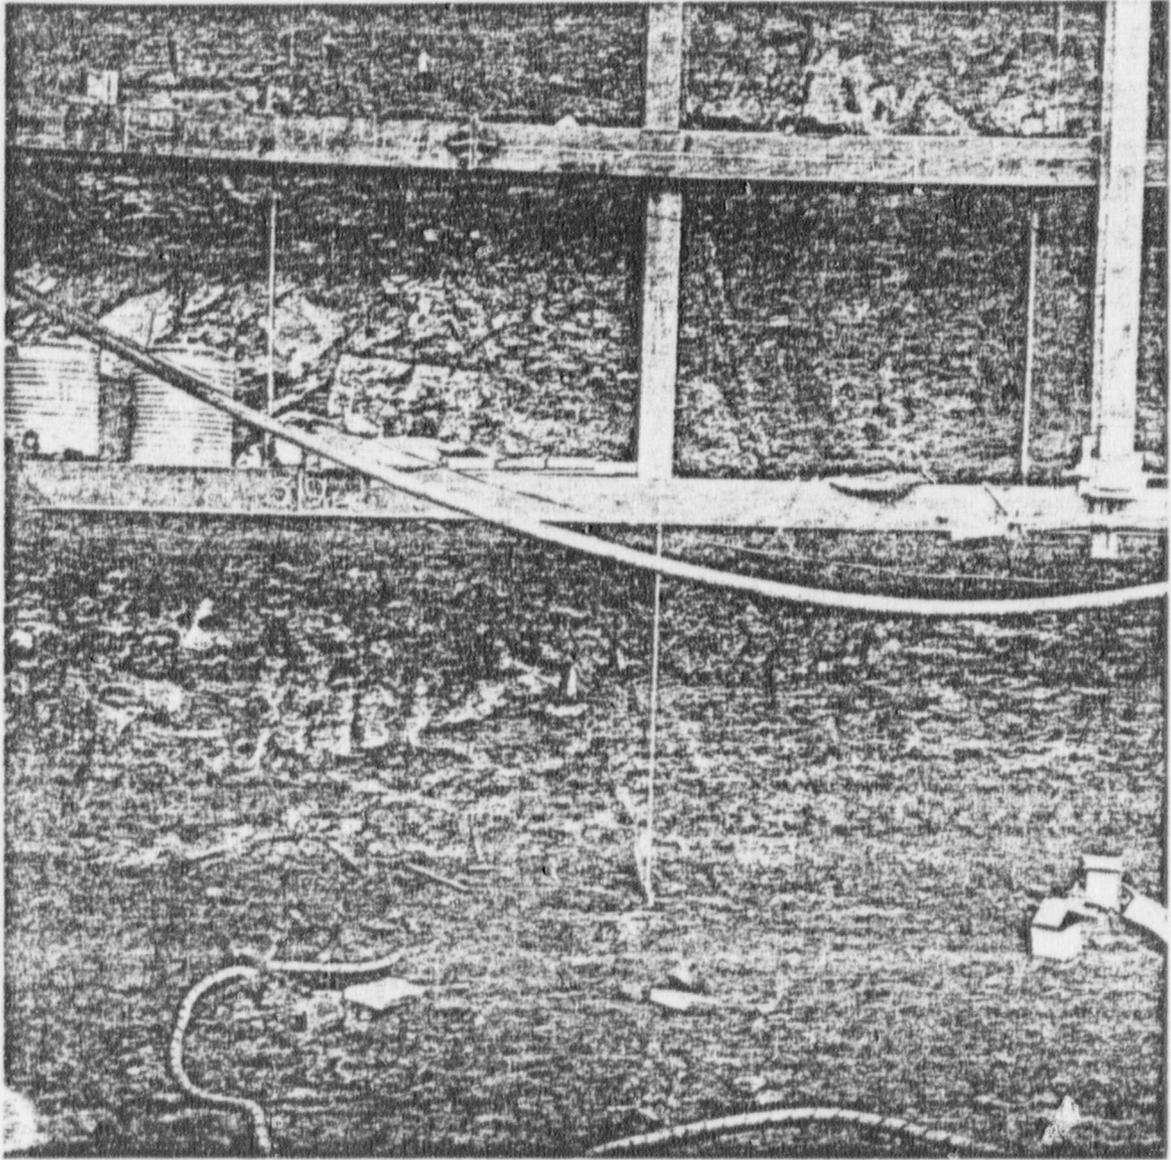
At this locality each fault is a gouge and breccia zone 1 to 2 inches wide. From elevation -55 to -51 the fault zone is a foot wide and made up of gouge and breccia. Between elevation -41 to -46, the fault was traced from the south wall to the northeast wall (pl. 3 and fig. 4). At this elevation the fault is 2 to 12 inches wide and consists of several intersecting and branching faults separated locally by breccia. Near elevation -24 between vertical control lines 25 and 26 the fault splays out into several branches about 5 feet below the top of the granitic rock (pl. 4). No rupture was seen in the overlying gravelly sandy clay.

Fig. 5.--Shaft fault in granitic rock on south wall of shaft,  
elevation -41 to -51 feet.
