LICENSEE EVENT REPORT (LER)

FACILITY NAME (1) SAN ONOFRE NUCLEAR GENERATING STATION, UNIT 3										DOCKET NUMBER (2) 0 5 0 0 0 3 6 2 1 OF 0 4				PAGE (3) 0 4		
TITLE (4) HIGH PRESSURE SAFETY INJECTION (HPSI) PUMP BYPASS VALVE FOUND NOT FULLY CLOSED																
EVENT DATE (5)			LER NUMBER (6)			REPORT DATE (7)			OTHER FACILITIES INVOLVED (8)							
MONTH	DAY	YEAR	EAR	SEQ. NUMBER	REV. NUMBER	MONTH	DAY	YEAR	FACILITY NAMES				DOCKET NUMBER(S)			
0 6	2 4	8 7	8 7	0 1 3	0 0	0 7	2 4	8 7					0 5 0 0 0 0			
OPERATING MODE (9) 3		THIS REPORT IS SUBMITTED PURSUANT TO THE REQUIREMENTS OF 10 CFR §: (Check one or more of the following) (11)														
POWER LEVEL (10) 0 0 0		20.402(b)		20.405(c)		50.73(a)(2)(iv)		73.71(b)

SAN ONOFRE NUCLEAR GENERATION STATION	DOCKET NUMBER	LER NUMBER	PAGE
UNIT 3	05000362	87-013-00	2 OF 4

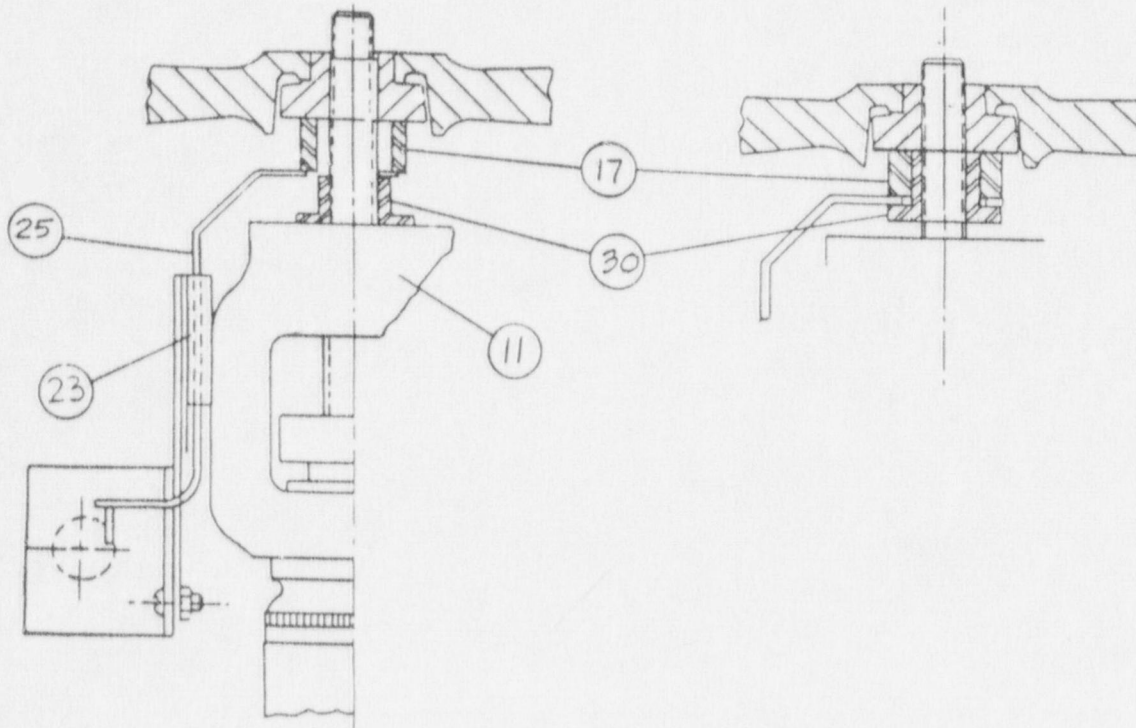
HPSI 3P018 (AS FOUND 6/24/87)

The HPSI pump bypass valves are two-inch, manually operated globe valves, fitted with a mechanically actuated remote position indicating switch, as shown in the sketch below. The switch actuating arm (25) fits over a collar (30), which is threaded to the valve stem and retains the actuating arm between the collar shoulder and the spacer (17) as the spacer makes contact with the valve handle. The collar turns with the valve stem and handle when the valve is operated. The actuating arm is intended to move vertically with the valve stem in a guide (23) attached to the yoke (11). An oversized hole in the arm retaining ring prevents the arm from rotating with the collar and stem. With the valve in the fully closed position, approximately 1/2 inch clearance should exist between the bottom of the collar and the top of the yoke.

On the bypass valve for HPSI pump 3P018, the collar was found to have backed out of the spacer and was making contact with the top of the yoke. The actuating arm had shifted laterally, along with the spacer, and the valve handle was compressing all three parts against the yoke. The valve stem could not be moved further in the closed direction.

It was apparent that the collar had loosened either by friction with the guided actuating arm during valve opening operations or due to flow induced vibrations when the valve was in the open position. The collar had become loosened and threaded its way down the stem, preventing further valve closure once the collar made contact with the yoke. The limit switch arm continued to move in the guide, however, the existing design allowed the limit switch to actuate before the valve was fully closed. As a result, control room indication showed the valve closed while in fact the valve disc was off the seat. The lack of a collar retaining device and the limit switch actuation sequence are considered to be design deficiencies and the root cause of failure to recognize the valve was not fully closed.

A positive locking mechanism to lock the collar in position on the valve stem will be incorporated during the next refueling outage in both Units 2 and 3.

The limit switch will be re-adjusted such that the control panel status light will be illuminated as the valve disc leaves the seat, and will remain lighted until the disc is seated.
